Current and Historic Coastal Geomorphic (Feeder Bluff) Mapping of San Juan County, Washington

Prepared for: Friends of the San Juans
By: Coastal Geologic Services, Inc.

September, 2010

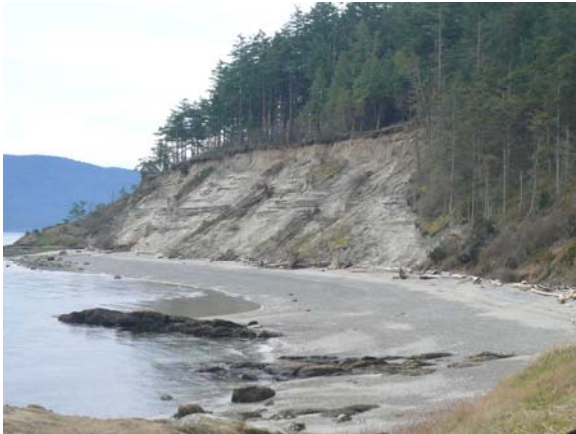
a) Feeder bluff exceptional - north Waldron Island

Figure 1. Photos of representative geomorphic shoretypes for the study area. Photos a-e by CGS.

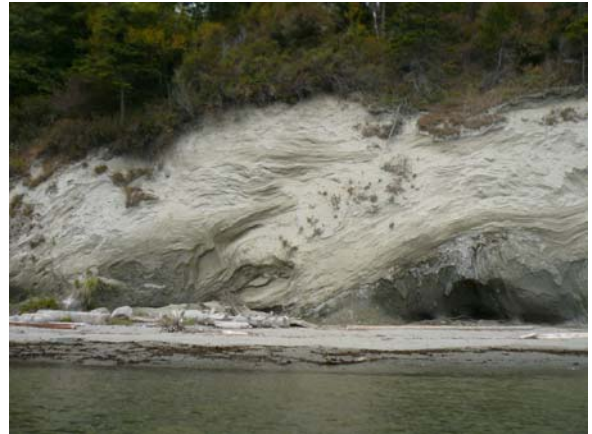
b) Feeder bluff - White Cliffs, Decatur Island

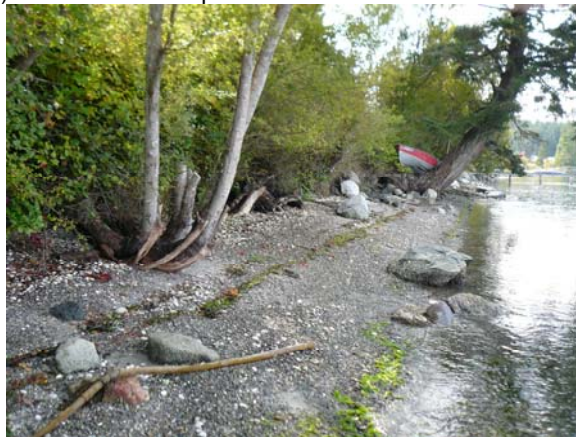
c) Transport zone - Blind Bay, Shaw Island

Transport zones were mapped along approximately 25% (3,458 ft) of the Shaw Island study area and appeared to be the most abundant shoretype within the study area (Figure 1c). All five drift cells of Shaw Island exhibited a moderate to high degree of modification; ranging from 18% to 66%. These modifications typically consisted of residential bulkheads as well as road revetments such as those found in Blind Bay. The average percent of modified shore mapped per drift cell was 45%. The average modified length of shore was 195 ft. Modified shores cumulatively accounted for 40% (1 mile) of the Shaw Island study area.

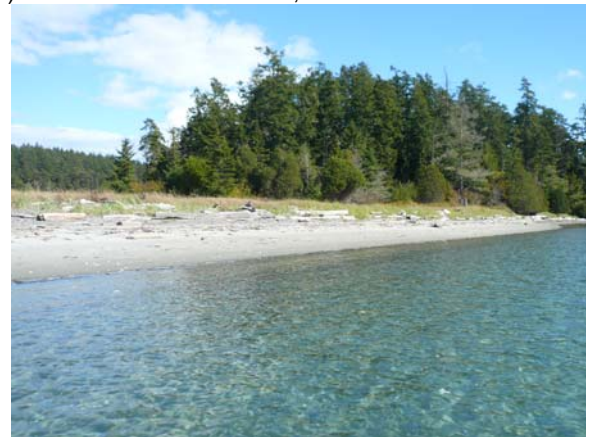
d) Accretion shoreform - Indian Cove, Shaw Island

The **Accretion Shoreform** classification was used to identify areas that were depositional in the past or present. These segments were classified based on the presence of several of the following features: broad backshore area (greater than 10 ft), backshore vegetation community, spit and/or lagoon landward of a spit. Additional indicators for delineating an accretion shoreform were the presence of relatively fine-grained sediment or very old drift logs in the backshore (Figure 1d).

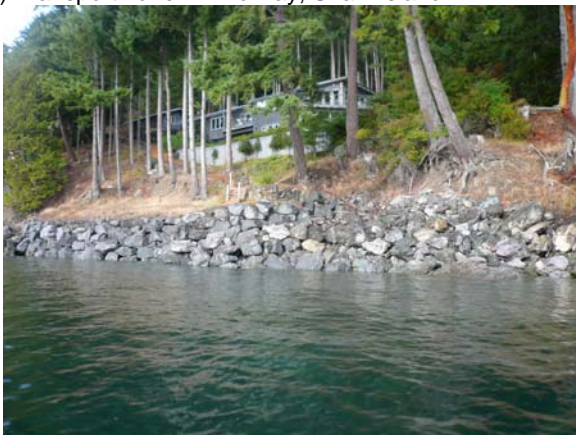
e) Modified - southeast East Sound, Orcas Island

The **Modified** classification was used to designate areas that have shore modifications such as bulkheads or have otherwise been altered to a state where the natural geomorphic character of the shore is largely concealed such that the bank no longer provides sediment input to the beach system (Figure 1e). This included armored areas where the bulkhead was still generally intact and functional, as well as areas with substantial fill at the shore. Fill areas could be large, industrial areas, marinas with revetments, road ends extending over the beach, or residential areas with smaller amounts of fill and structures.

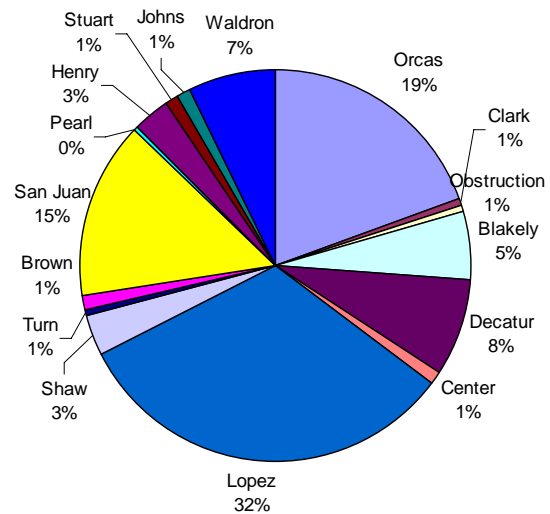
Figure 3. Percent of San Juan County historic feeder bluffs found on each Island.

historic distribution of sediment sources was very similar to current conditions – with the greatest ratio of feeder bluffs found within the major Islands such as Lopez, Orcas, and Shaw islands, although historically Orcas Island encompassed 19% of the feeder bluffs, while currently it encompasses 16% (Figures 2 and 3). The decrease in percent from historic to current conditions is due the extent of armored historic feeder bluffs on Orcas Island. Decreased ratios in the distribution of feeder bluffs from historic to current conditions were also observed on Center, Shaw, Brown, San Juan, and Pearl Islands. In contrast, Lopez Island had an increase in the percent of feeder bluffs (32% historic versus 33% current conditions mapping) due to there being more intact sediment sources on Lopez than elsewhere in the County, despite the fact that many feeder bluffs on Lopez also incurred considerable armoring. Similarly, Waldron, Blakely and Decatur islands each had a small decrease in the percentage of feeder bluffs from historic to current conditions, which is generally a relict of the countywide distribution calculation – rather than representing an increase in sediment sources. Because feeder bluffs occurrence was historically more widespread than it is currently; the relative distribution of the resource has increased among these islands that maintain considerable lengths of intact feeder bluff.

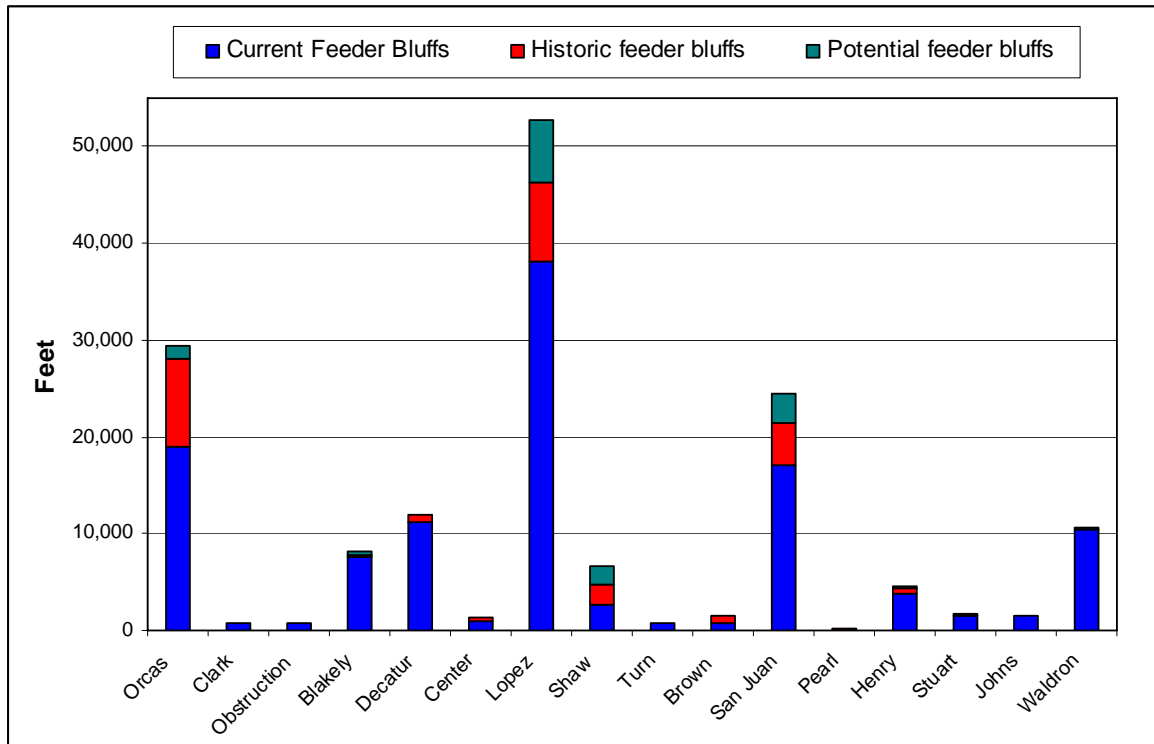
Figure 5. The linear extent of current, historic and potential feeder bluffs in San Juan County.

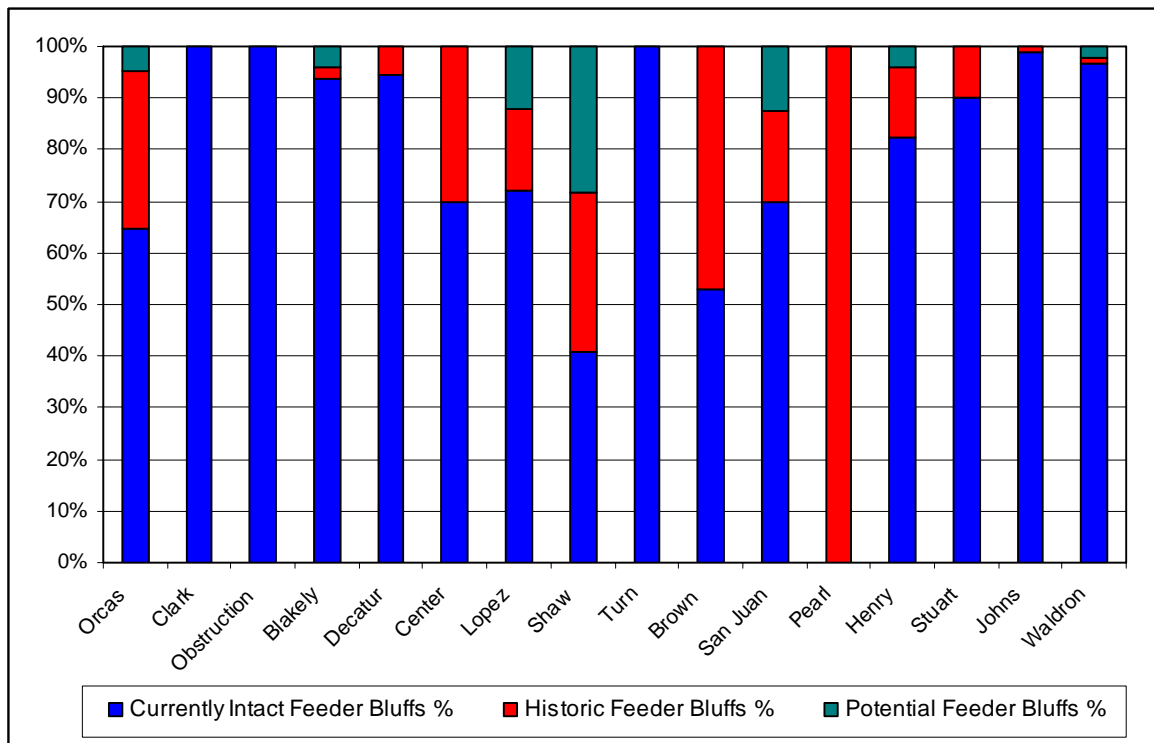
Figure 6. Ratio of currently intact feeder bluffs versus historic feeder bluffs and potential feeder bluffs in San Juan County.

The percent of lost sediment sources on each island was calculated to highlight which islands have incurred the greatest decline in sediment supply relative to the historic extent (Figures 5 and 6). Many small islands have small lengths of armored feeder bluffs, which can mistakenly appear to cause minimal impact. By comparing the current and the historic extent of feeder bluffs in a given drift cell one can attain a more accurate measure of the impact to sediment supply (Figure 6). For example, many small islands often have naturally low-volume sediment budgets, in which 200 ft of armoring can have a much greater impact in a drift cell with only 300 ft of (historic) feeder bluff compared to a drift cell with 4000 ft of (historic) feeder bluff. In these cases, feeder bluffs are already in low supply and therefore adequate conservation or restoration is necessary. Additionally, there are often fewer drift cells on many smaller islands, and the habitats associated with feeder bluffs and down-drift accretion shoreforms are unique and often the only habitats of that kind for many miles of shoreline. The rarity of these shoreforms emphasizes their value as conservation priorities in the marine landscape. Such is the case with Brown and Center Islands, in which armored feeder bluffs account for 20% and 17% (respectively) of the Islands' net shore-drift cell shoreline (not including potential feeder bluffs, Figure 6).

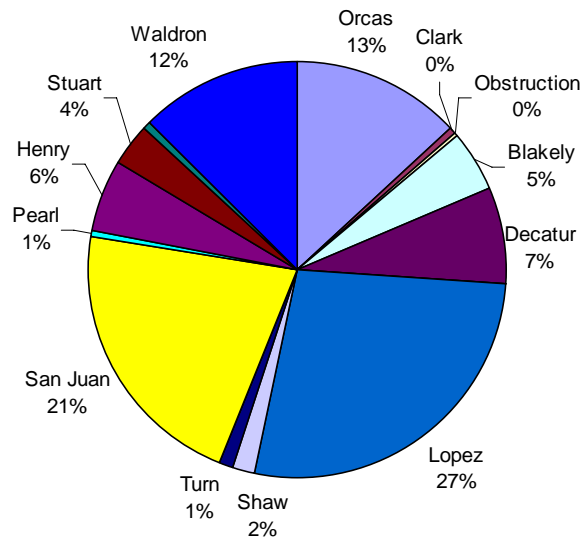
Figure 7. Percent of San Juan County accretion shoreforms found on each Island.

Accretion shoreforms were scattered throughout the study area, cumulatively representing approximately 25% (22 miles) of the length of the entire study area shore (in current conditions, Table 23, Figure 7). Analysis of the distribution of accretion shoreform throughout the entire study area showed that 27% of them were mapped along Lopez Island, followed by San Juan (21%), Orcas (13%) and Waldron (12%) islands. These features are typically associated with coastal wetlands (salt marshes) and valuable habitats for many species, particularly juvenile salmonids. The average length of accretion shoreforms over the entire study was 462 ft. Pearl Island had the most cumulative accretion shoreform percentage per island study area with 41%. However, Waldron Island, with a study area almost 27 times that of Pearl Island, consisted of 38% accretion shoreform (Table 23). Restoration and conservation planning associated with accretion shoreforms should address the condition of up-drift sediment sources that sustain these important habitats.

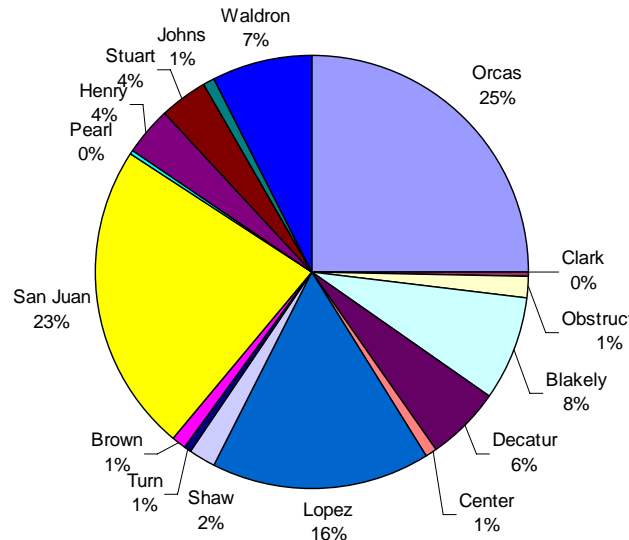
Figure 8. Percent of San Juan County accretion shoreforms found on each Island.

Transport zones were mapped along approximately 37% (33 miles) of the study area shore. As to be expected the largest islands encompassed the greatest ratio of shoreline mapped as transport zone including: Orcas (25%), San Juan (23%) and Lopez (16%) islands (Table 23, Figure 8). Over 50% of the shorelines on some islands, including Obstruction and Brown Islands, were mapped as transport zone. Transport zones were mapped in many areas where bedrock outcropped above the beach but contiguous littoral drift was maintained waterward of the bedrock. Due to the abundant bedrock in San Juan County, this occurred frequently and transport zones occurred more frequently than in other counties where this mapping typology has been applied.

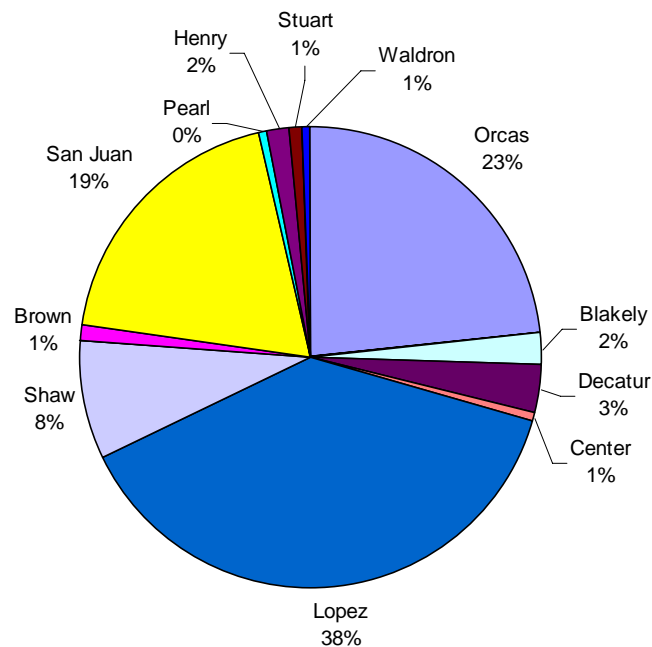
Figure 9. Percent of San Juan County shoreline modifications found on each Island.

Shore modifications were mapped along 14% (12.2 miles) of San Juan County drift cells (Table 23). The largest ratio (38%) and linear extent (4.7 miles, 24,674 ft) of shore modifications were found on Lopez Island. Historic analyses showed that most of the modified shores were historic feeder bluffs (41%) with an additional 21% of potential feeder bluff (Table 24). Twenty-three percent of the modified shores were located within drift cells on Orcas Island (Figure 9). San Juan Island drift cell shores encompassed 19% of the modifications mapped in the San Juan County study area (Figure 9). Much of the remaining modified shore was mapped within drift cells on Decatur, Henry and Brown Island(s) (Tables 23). When comparing the extent of modified shores within each Island study area, Shaw Island had the greatest (cumulative) ratio of modified shore (40%) followed by Lopez and Brown Islands (20%, Table 23). Other islands with a larger ratio of modified shore included Center, Orcas, Pearl and San Juan Islands. Modifications predominantly consisted of residential bulkheads and docks. However, larger infrequent segments of modified shore were formed by marinas, road revetments and miscellaneous industrial infrastructure.
