Soft Shore Protection/Structure Removal Blueprint for San Juan County Forage Fish Beaches

Appendix 2: Recommendations for sites scoring below the top ten, sorted by island (east to west)

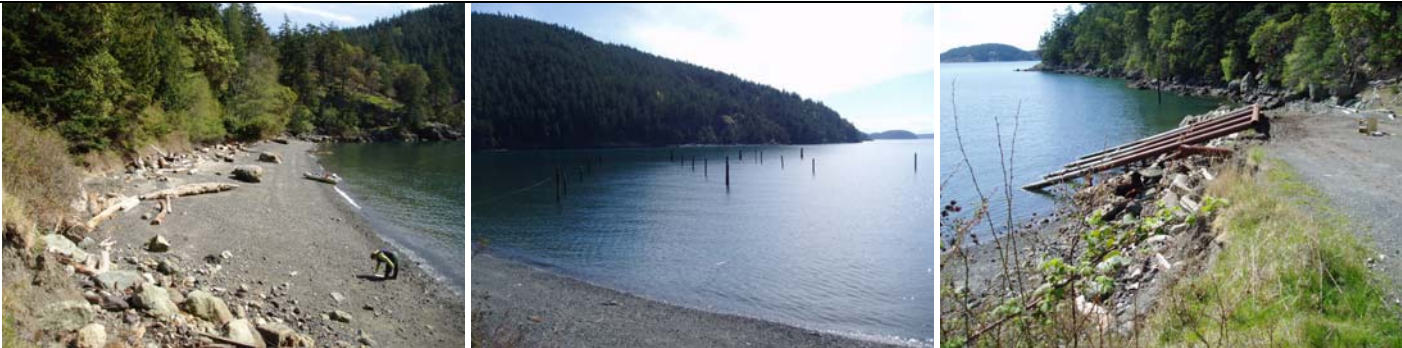
Blakely Island, N Thatcher Bay

Restoration Recommendation:	Remove 20+ creosote piles and dolphins in Bay. Remove concrete debris, steel cables and boulders on beach adjacent to the ramp (that have fallen from damaged rock revetment).				
Rank Score (total score)	na	Beach restoration feasibility score:	na	Habitat enhancement value	na

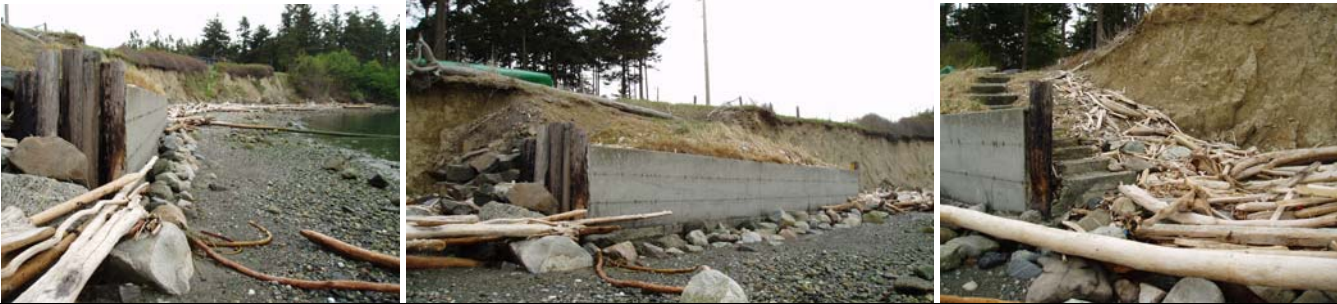
Lopez Island – Aleck Bay-north

Restoration Recommendation:	Redesign/reconfigure current beach access. Remove (threatened) cement wall and rockery protecting access. Cut notch into bank for new simple stairway to limited quantity of retained rock (keyed 2+ ft below grade) at base only. Install protective cobble-pebble berm along upper-most beach surrounding beach access. Anchored driftwood should also be used to deflect direct wave energy around beach access. Riparian vegetation should be planted atop the bluff, which will help to slow erosion rates along this community owned shore.				
Rank Score (total score)	5.2 (33)	Beach restoration feasibility score:	4.8	Habitat enhancement value	5.6

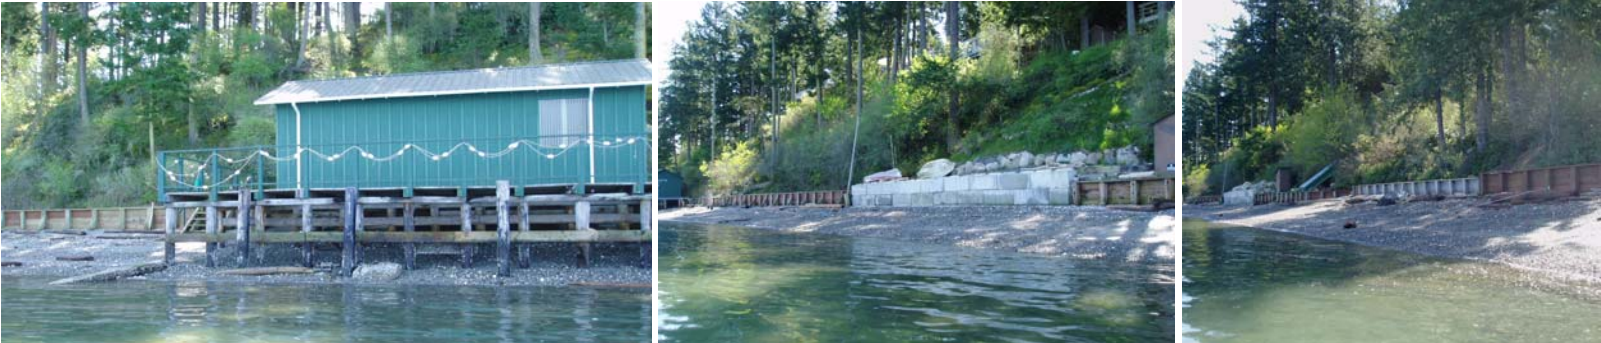
Lopez Island – East Shoal Bay - east

Restoration Recommendation:	Remove bulkheads and overwater structure over time. If shore protection is truly required, avoid creosoted wood and have structures against bank toe.				
Rank Score (total score)	4.9 (31)	Beach restoration feasibility score:	4.5	Habitat enhancement value	5.3

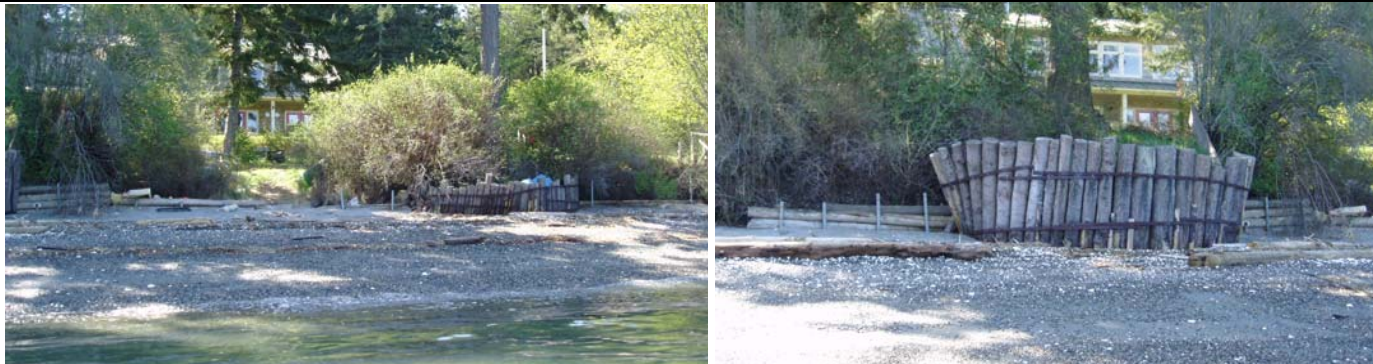
Lopez Island – East Shoal Bay-west

Restoration Recommendation:		Remove “home-made” erosion control structures that do not substantially slow bank erosion, but make habitat unavailable. Use alternative erosion control techniques including possibly narrow protective berm along upper-most beach with composite structures (e.g. anchored driftwood), plant dune vegetation to help absorb wave energy and recreate lost habitat.					
Rank Score (total score)		5.4 (34)	Beach restoration feasibility score:		5.8	Habitat enhancement value	5.0

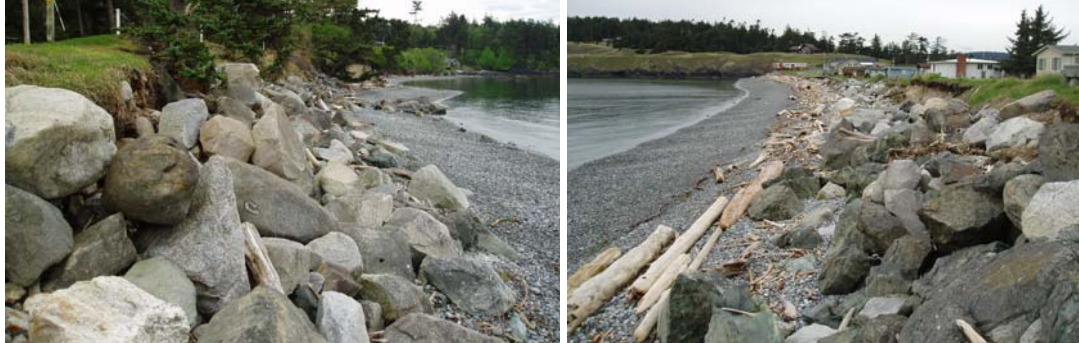
Lopez Island, Agate Bay

Restoration Recommendation:		Decommission road that runs adjacent to beach and relocate road or use alternate road that runs landward of homes. Remove riprap from bank and beach install soft shore protection design. A large volume of material should be distributed across the upper beach with composite structures designed to provide additional protection to the toe of the bank during high water storm events. Requires further work.				
Rank Score (total score)		na	Beach restoration feasibility score:	na	Habitat enhancement value	na

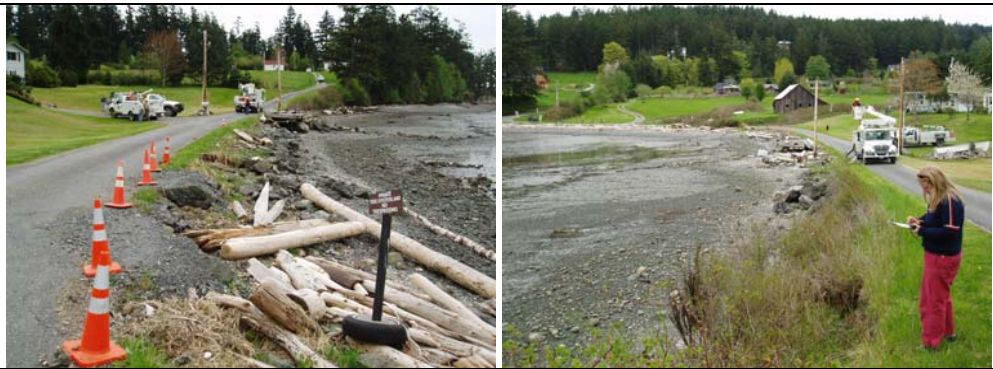
Orcas Island, Buck Bay

Restoration Recommendation:	Remove rockery and broken concrete from beach. Relocate road landward to avoid beach narrowing. Nourish upper beach with mix of sediment defined by sampling adjacent unmodified reference beach. Install protective berm with composite materials (including driftwood/root wads), to help absorb wave energy. Plant native vegetation (shrubs and conifers) along bank to enhance bank stability and overhanging marine riparian vegetation.				
Rank Score (total score)	2.7 (16)	Beach restoration feasibility score:	2.6	Habitat enhancement value	2.8

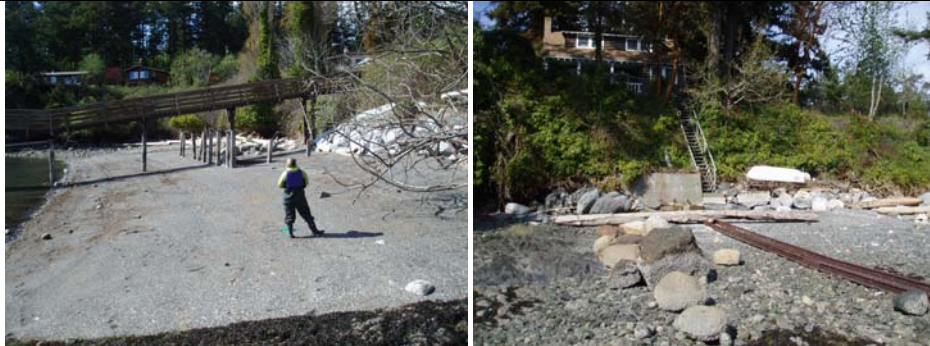
Orcas Island, Olga residences

Restoration Recommendation:		Remove creosote piles from intertidal habitat, eradicate invasive species and remove steel debris and boulders from the intertidal.			
Rank Score (total score)	na	Beach restoration feasibility score:	na	Habitat enhancement value	na

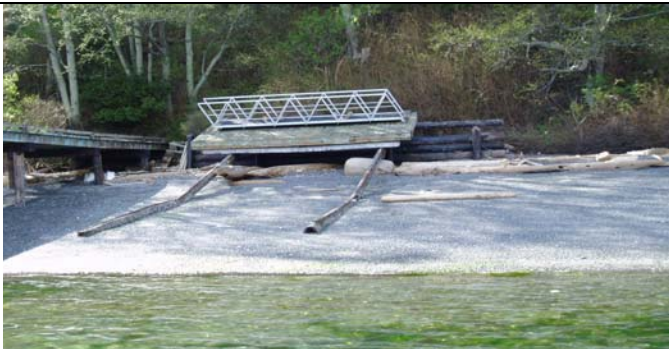
Orcas Island, White Beach

Remove (dock-related) heavily-creosoted structure from backshore as it is toxic to fish and other species.			
Restoration Recommendation:					
Rank Score (total score)	na	Beach restoration feasibility score:	na	Habitat enhancement value	na

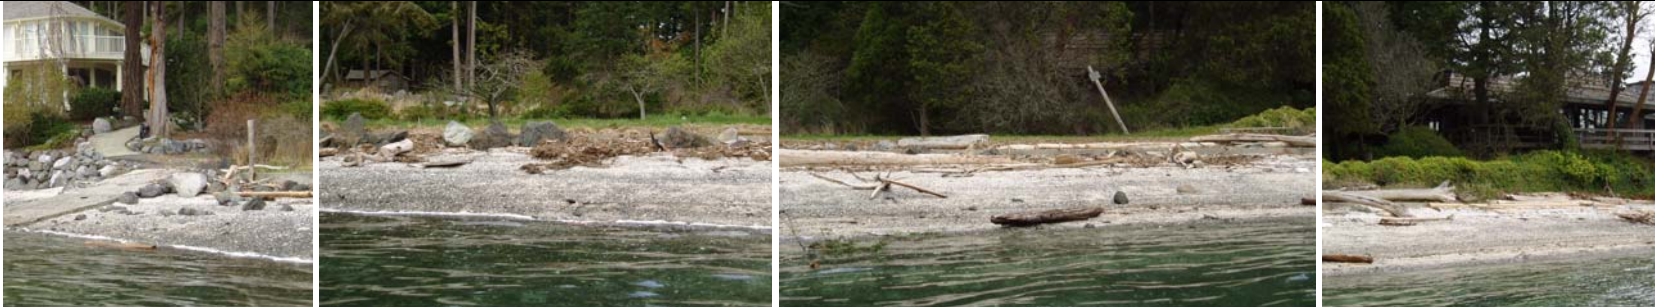
Orcas Island, West Sound, on leeward side of Double Island

Restoration Recommendation:	Remove rockery along lot located between 2 homes, nourish upper beach profile and create higher berm with driftwood and dune vegetation in place of rock.				
Rank Score (total score)	na	Beach restoration feasibility score:	na	Habitat enhancement value	na

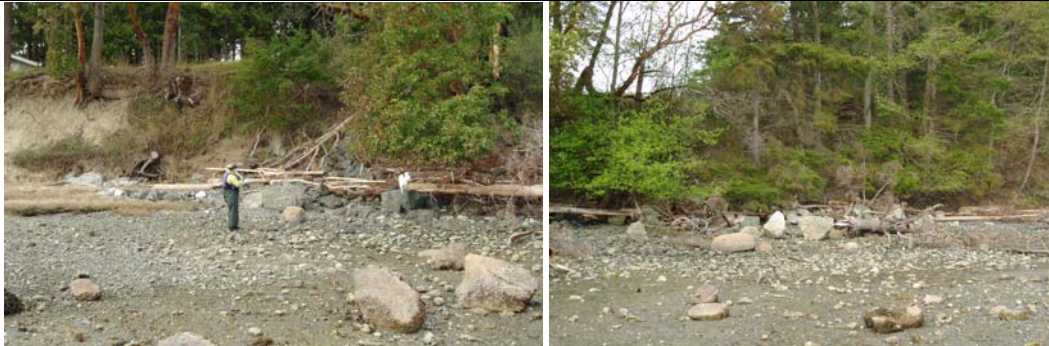
Orcas Island – North Pole Pass – northern property

Restoration Recommendation:	Remove rockery and nourish the upper beach with mix of sediment defined by sampling adjacent unmodified (reference) beach. Beach nourishment design could include the installation of berm with driftwood/root wads, to help absorb wave energy. Plant native vegetation (shrubs and conifers) along bank to enhance bank stability, prevent erosion exacerbated by run-off and enhance overhanging marine riparian buffer.				
Rank Score (total score)	3.3 (21)	Beach restoration feasibility score:	5.5	Habitat enhancement value	1.3

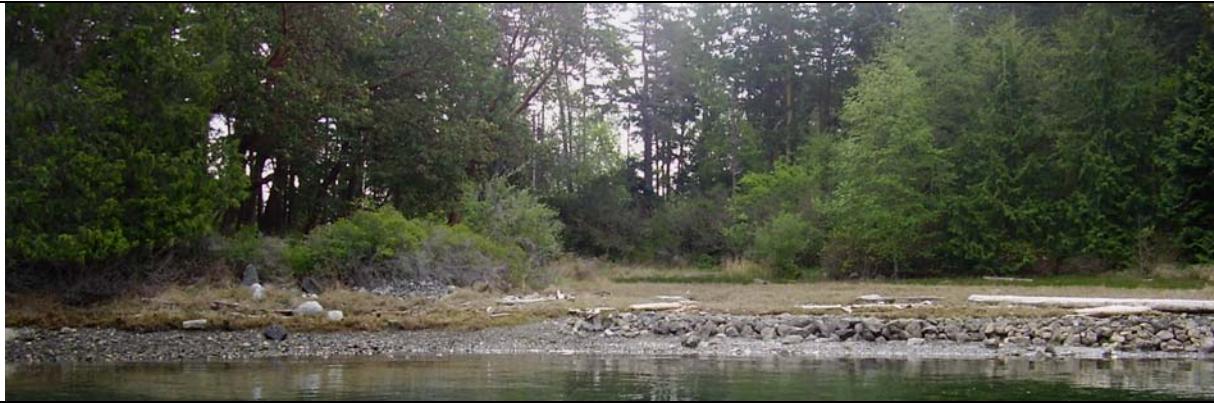
San Juan Island – Turn Point marsh (eastern corner of Bay)

Restoration Recommendation:	Remove small intertidal rockery along marsh front. Rockery is not at all necessary along this accretionary beach. This will free upper beach habitat as well as enable natural berm, and possibly inlet channel to reform. This would add clear habitat benefits and could be termed true restoration.				
Rank Score (total score)	5.1 (32)	Beach restoration feasibility score:	7.4	Habitat enhancement value	2.8

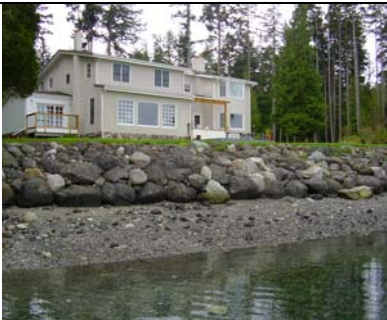
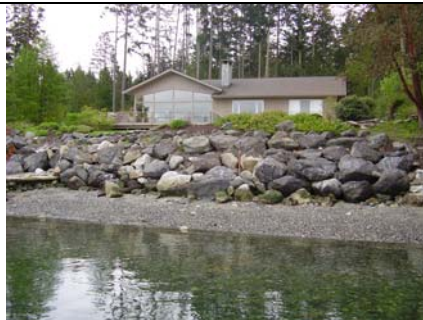
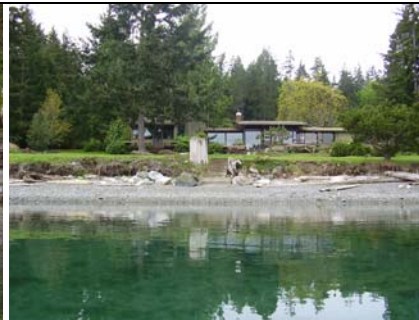
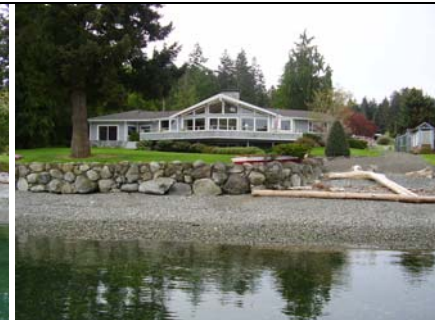
San Juan Island – Turn Pt – east and central properties

Restoration Recommendation:	Remove rockeries and nourish upper beach profile with mix of sediment defined by sampling adjacent (east) unmodified reference beach. Install driftwood/root wads to help absorb wave energy (and ferry wake). Plant native vegetation (shrubs and conifers) along bank to enhance bank stability and overhanging marine riparian vegetation.				
Rank Score (total score)	2.9-3.0 (18-19)	Beach restoration feasibility score:	5.2-5.5	Habitat enhancement value	0.6-0.9

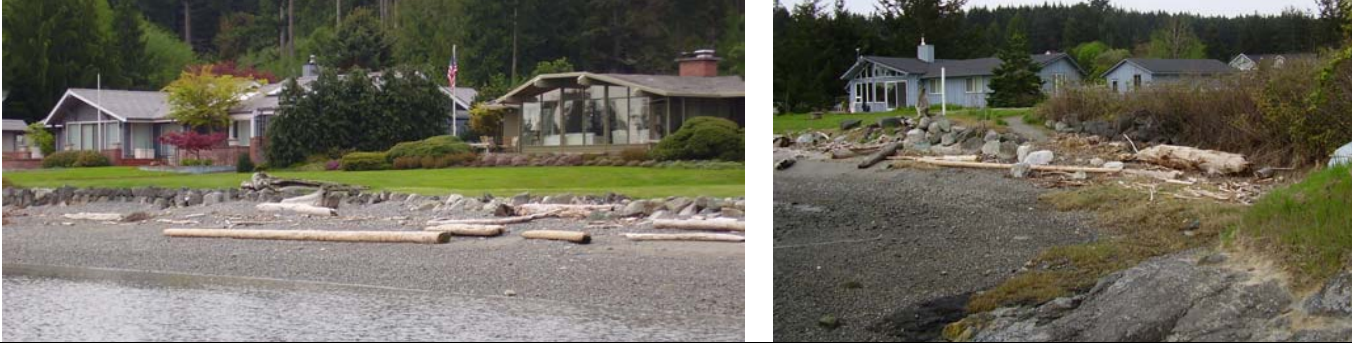
San Juan Island – Turn Pt – western properties (including county-owned property)

Restoration Recommendation:	Remove unnecessary small rock wall. Nourish upper beach from MHHW to extreme high water (EHW), plant dune vegetation and some native shrubs. Place anchored drift logs in former location of rock to buffer wave attack during storms. Clear out culvert that flows out onto beach near county property's southern boundary. Best solution would be to remove culvert and daylight small creek around house and recreate mini-estuary at shore for habitat.				
Rank Score (total score)	3.7-3.5 (22-23)	Beach restoration feasibility score:	5.5-6.1	Habitat enhancement value	0.9-1.9

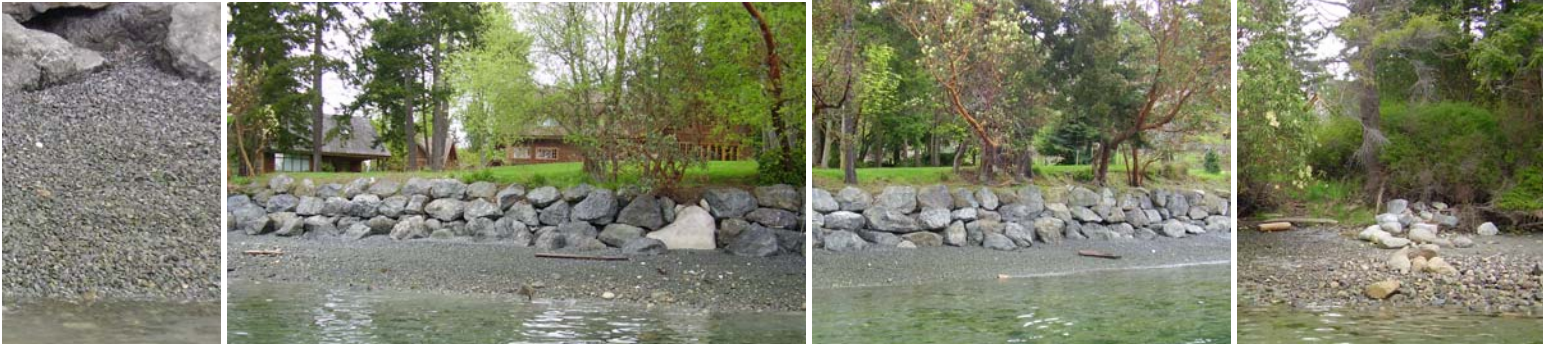
San Juan Island – Friday Harbor South – north and central properties

Restoration Recommendation:	Remove rockery, rock groin and non-native angular beach sediment that are inappropriate for beach habitat. Nourish upper beach profile with mix of sediment defined by sampling adjacent unmodified (reference) beach. Install protective berm with composite materials (including driftwood/root wads), to help absorb minor wave energy (and ferry wake). Plant native vegetation (shrubs and conifers) along bank to enhance bank stability and overhanging marine riparian vegetation.				
Rank Score (total score)	3.7 (23)	Beach restoration feasibility score:	5.2	Habitat enhancement value	2.2

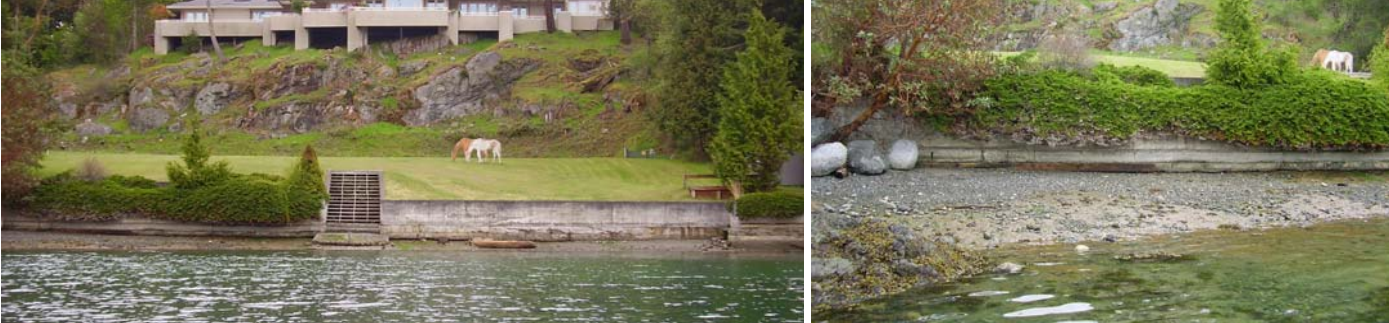
San Juan Island – Friday Harbor South –central

Restoration Recommendation:	Remove degraded concrete bulkhead and restore natural bank. should be nourished with a mix sand and gravel to be determined by sampling nearby reference beach. Large logs should be integrated into the nourishment design to help dissipate wakes, as well as terminal groins to maintain beach sediment. Additional alternative erosion control methods could also be utilized to curb erosion (if necessary) including vegetation and storm water management. Native shrubs and trees should be planted restore marine riparian bluffer, which will also aid in reducing bank erosion.				
Rank Score (total score)	3.7 (23)	Beach restoration feasibility score:	5.2	Habitat enhancement value	2.2

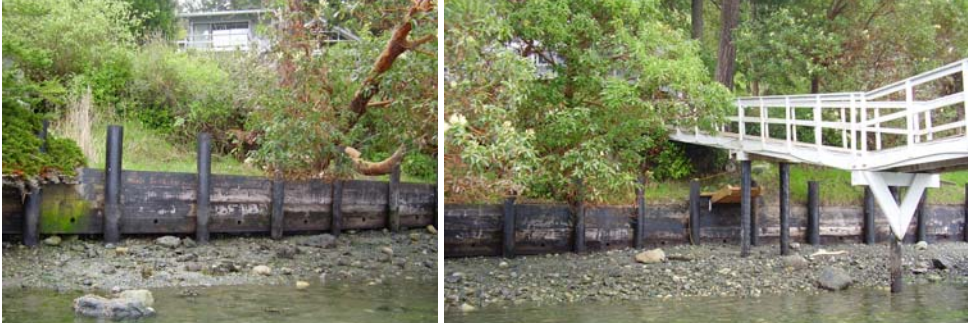
San Juan Island, Friday Harbor South – southern property

Restoration Recommendation:	Remove creosote bulkhead and restore natural bank. Beach should be nourished with a mix sand and gravel to be determined by sampling nearby reference beach. Large logs should be integrated into the nourishment design to help dissipate wakes. Drift logs should also be utilized as terminal groins to maintain beach sediment. Additional alternative erosion control methods could also be utilized to curb erosion (if necessary) including vegetation and storm water management. Native shrubs and trees should be planted to enhance marine riparian bluffer.				
Rank Score (total score)	3.8 (24)	Beach restoration feasibility score:	4.8	Habitat enhancement value	2.8

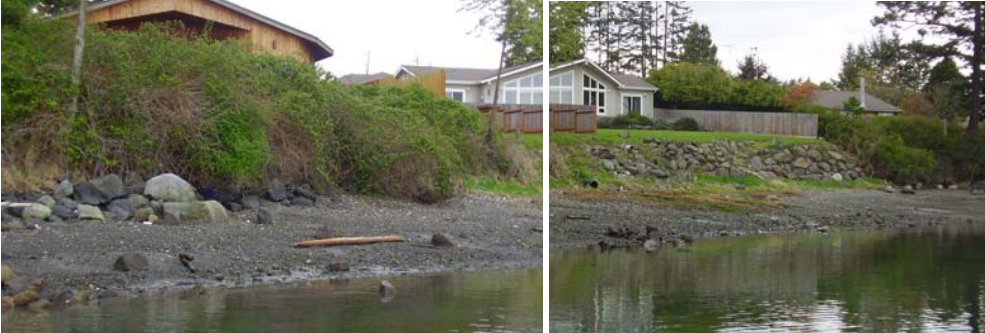
San Juan Island, Friday Harbor West- southern properties

Restoration Recommendation:	Restore natural bank by removing riprap and allowing natural beach profile to reform. Beach should be nourished with a mix sand and gravel to be determined by sampling nearby reference beach. Additional alternative erosion control methods should be considered to curb erosion (if necessary) including vegetation and needed storm water management. Native shrubs and trees should be planted to restore marine riparian bluffer.				
Rank Score (total score)	4.1 (26)	Beach restoration feasibility score:	6.5	Habitat enhancement value	1.9

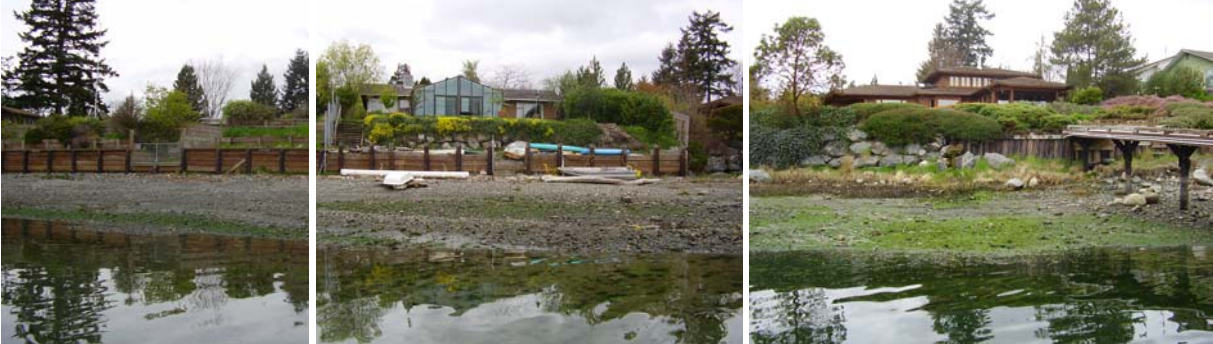
San Juan Island – Friday Harbor West – central properties

Restoration Recommendation:	Remove rockery, soldier pile and creosote bulkhead and other misc. materials below MHHW. Install limited beach nourishment with driftwood/root wads, to help absorb minor wave energy (and ferry wake). Plant native vegetation along bank to enhance bank stability and overhanging marine riparian vegetation. Some limited bank regrading may be required.				
Rank Score (total score)	3.7 (23)	Beach restoration feasibility score:	5.2	Habitat enhancement value	2.2

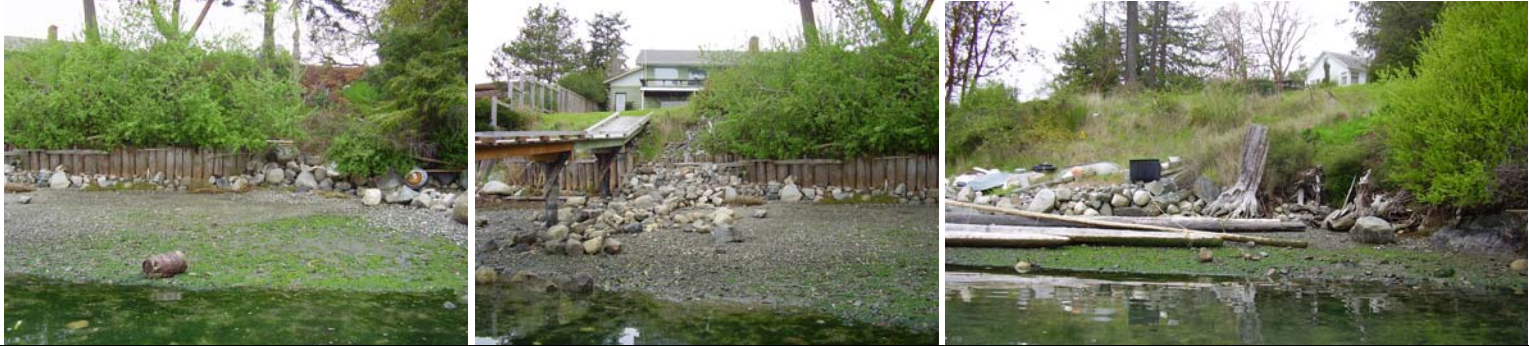
San Juan Island – Friday Harbor West – northern properties

Restoration Recommendation:	Remove rockery, solidier pile and creosote bulkhead and other misc. materials below MHHW. Install limited beach nourishment with driftwood/root wads, to help absorb minor wave energy (and ferry wake). Plant native vegetation along bank to enhance bank stability and overhanging marine riparian vegetation. Some limited bank regrading may be required.				
Rank Score (total score)	5.6 (35)	Beach restoration feasibility score:	6.5	Habitat enhancement value	4.7

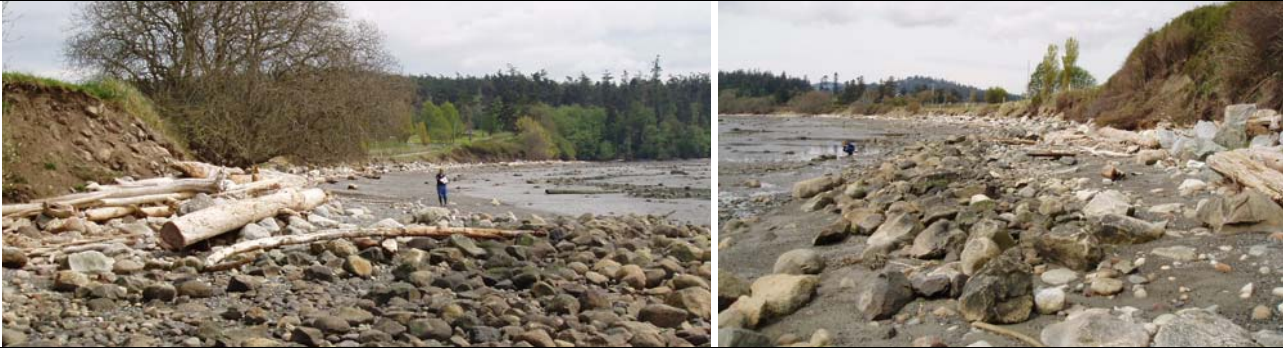
San Juan Island, False Bay Rd

Restoration Recommendation:	Remove the riprap and large boulder lag deposits both of which cover considerable upper intertidal area, including valuable habitat. Relocating the False Bay Road and nourishing the beach (and the aforementioned removal of rockery and lag deposits) will enhance habitats that are degraded under current conditions, as well as enabling beaches to naturally translate (migrate landward) under sea level rise scenarios. Relocating the road will also (likely) provide additional area for marine riparian restoration. Need s additional study for implications and details.				
Rank Score (total score)	4.4 (26)	Beach restoration feasibility score:	2.6-3.7	Habitat enhancement value	5.0-5.9

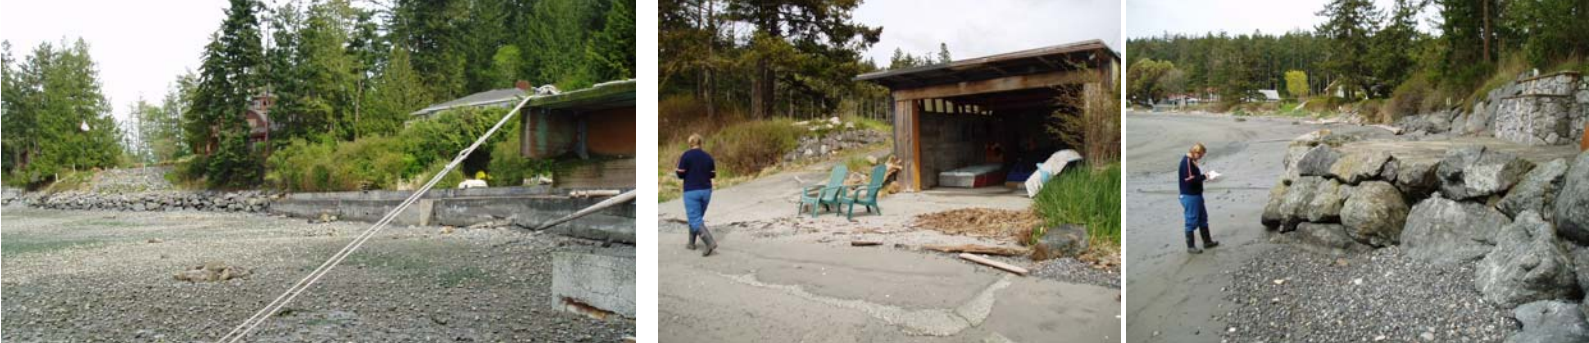
San Juan Island, Yacht Haven

Restoration Recommendation:	Remove boat ramp/paved intertidal and nourish beach (assuming it is not in use). Failing bulkhead in the southern portion of the beach should be relocated landward or removed. Relict concrete footings should also be removed. Remove infringing rockery from intertidal as it not only precludes access to upper beach substrate in forage fish spawning area, but is obstructing net shore-drift.				
Rank Score (total score)	na	Beach restoration feasibility score:	na	Habitat enhancement value	na

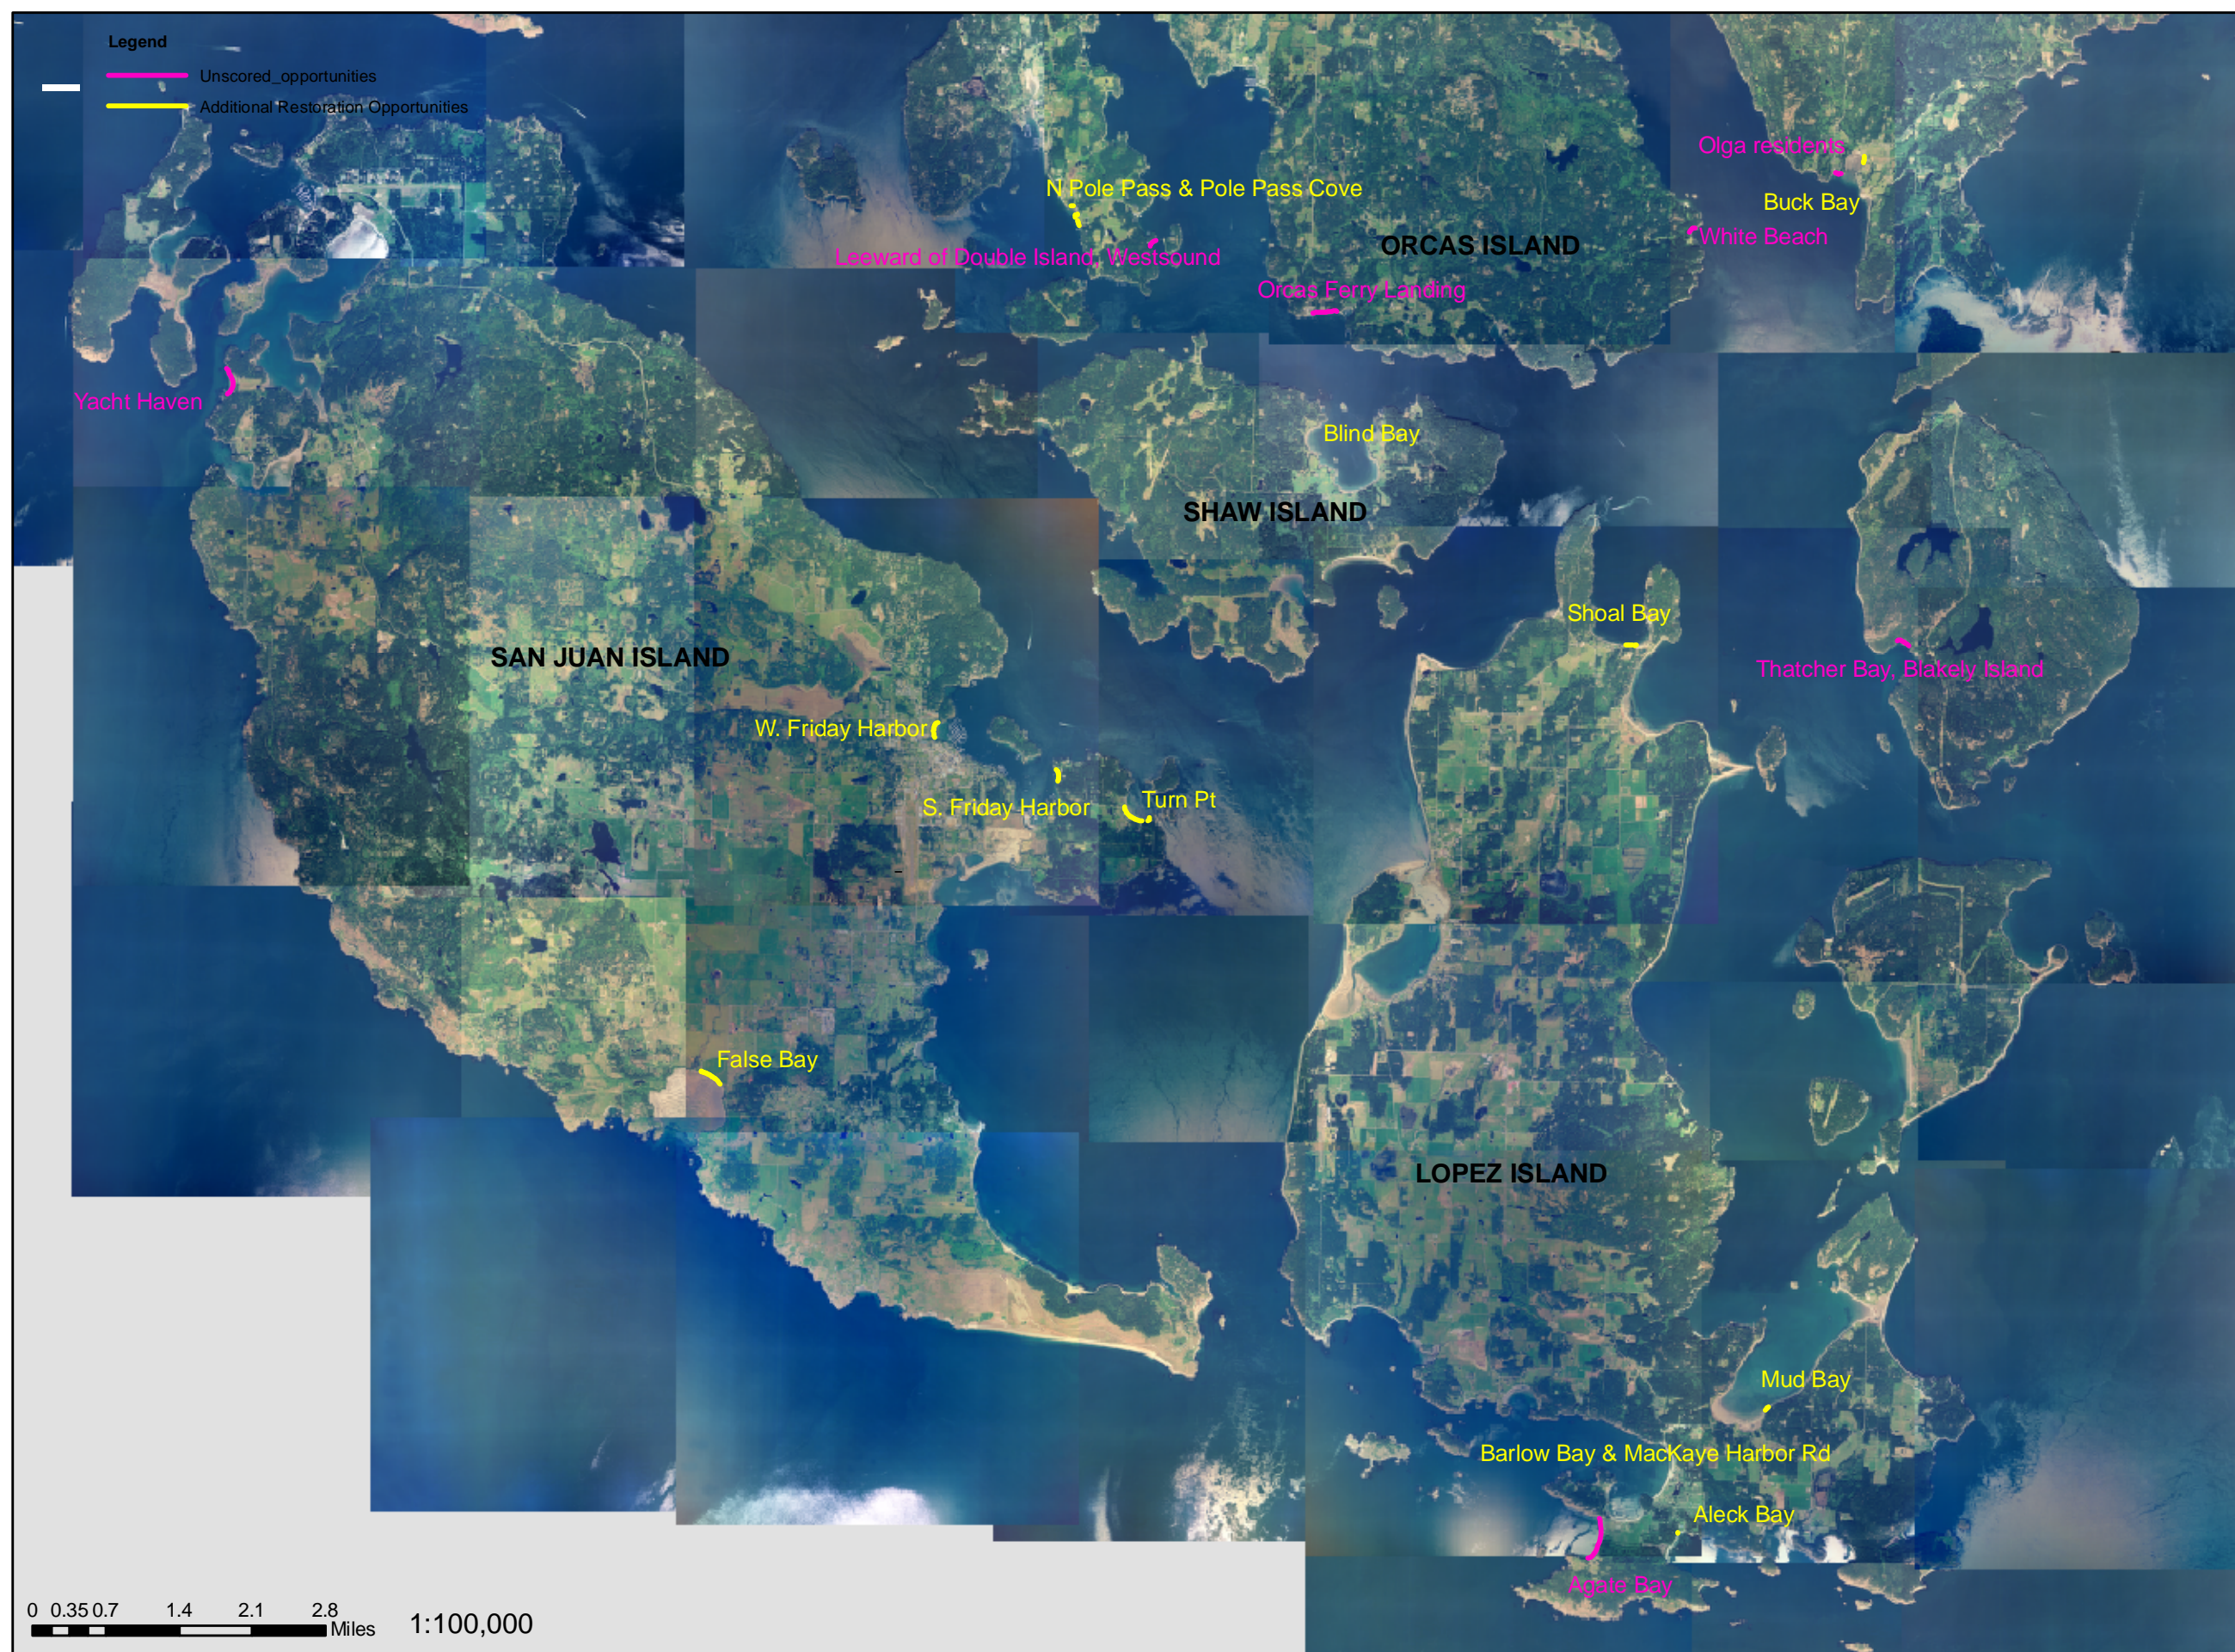
Figure 30. Restoration opportunities found throughout San Juan County
San Juan County Soft Shore Protection/Bulkhead Removal Blueprint
