# Soft Shore Protection/Structure Removal Blueprint for San Juan County Forage Fish Beaches

Prepared for:  
Friends of the San Juans

Prepared by:  
Jim Johannessen, MS, LEG and  
Andrea MacLennan, MS

**June 25, 2006**

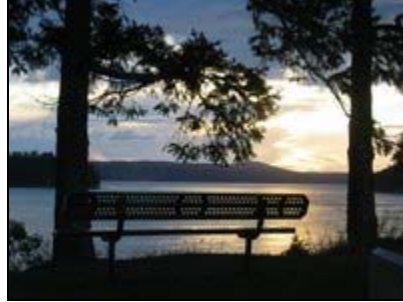
Roads have been relocated in the past in San Juan County. In the late 1990s the southern portion of Deer Harbor Road was relocated due to the short- and long-term threat of coastal erosion and the associated environmental impacts caused by the road and bluff armoring. The road removal project was successful and was positively received by agencies and the community. A popular walking path with park benches now occupies the scenic old road site.

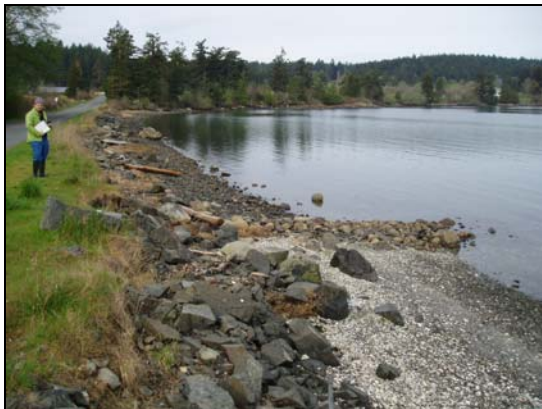
**Figure 3.** Blind Bay Rd - South

Site 1. Blind Bay(-S) Road Relocation, Shaw Island - The Blind Bay Road segment road relocation would encompass two potential enhancement projects in southern Blind Bay. These two top rated modifications for removal are located along the southern and eastern shores of the bay. The southern shore grades from no bank (Figure 3) to low bank (approximately 20 ft high) forested uplands. Modifications in this reach include an old riprap revetment, loose rock on the beach and a number of small groins on the high tide beach at the no-low bank shore and heavy riprap at the base of the low bank shore. East of this segment is Blind Bay Rd-east, which is heavily rip rapped low bank shore (Figure 4). The lowest extent of the shore modifications observed in this region was measured at approximately +6.5 ft MLLW.

Southern-most Blind Bay is considered a protected site with maximum fetch measuring less than 2 miles at each beach. Two net shore-drift cells were present that converge at the center of the southern beach (cells SH-3 and SH-4; Johannessen 1992). The modifications are in moderate condition, with some toppling of rock along both shores with more along the eastern shore. Toe erosion or bluff undercutting was observed along the unbulkheaded medium bank shore. The slope of the bank face was measured at 45 degrees during the field assessment. The unbulkheaded area is one of the few sediment sources in the bay and the local drift cell. Additional sediment sources are found up-drift in both cells (Johannessen 1992), in exposed low elevation bluffs composed of glacial till (WA DOE 1978). These two segments have little erosion potential, and if it were not for the extreme close proximity of Blind Bay Road (3-6 ft from bluff crest), erosion control would not be necessary along these shores.

The beaches of Blind Bay encompass valuable forage fish spawning habitat. Mid beach sediment was composed of pebble-sand dominant with minor quantities of granules. Upper beachface/lower backshore sediment was composed of sand with shell and some granules. Some upper beach areas appear to have been filled either to reclaim backshore wetlands, or as part of the road revetment. Scattered riparian vegetation is found along the Blind Bay shores, excluding the higher bank shore in the south-central portion of the Bay, where forested uplands with ample overhanging riparian vegetation are found (Figure 5). Marsh vegetation (*Distichlis spicata*, *Salicornia virginica*, *Triglochin maritimum*) was observed growing along the upper beach in the southwestern corner of the bay. Marsh vegetation is indicative of both a low energy environment, affirming the relatively low need for (substantial) erosion control along this shore.

Site 1. Enhancement Recommendations – The southern shore of Blind Bay provides an excellent opportunity for sustainable beach restoration for a variety of reasons. There is documented surf smelt spawning in the immediate area, the beach is at a drift cell convergence, the erosion potential is low, and the road appears to have minimal traffic. The sustainability of an enhancement project at this sites appears fairly high as the site is only exposed to northerly quadrant winds with limited fetch and Blind Island and adjacent rocks provide minor protection from north winds.

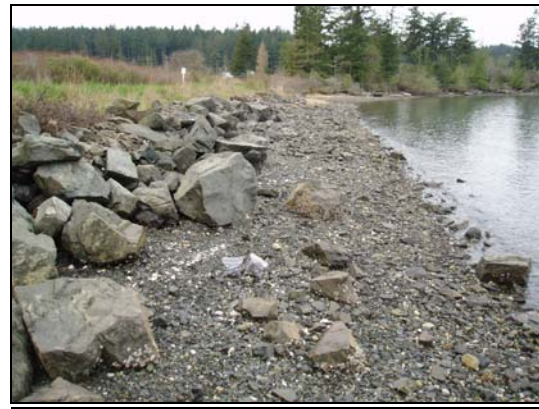
**Figure 4.** Blind Bay Rd – East

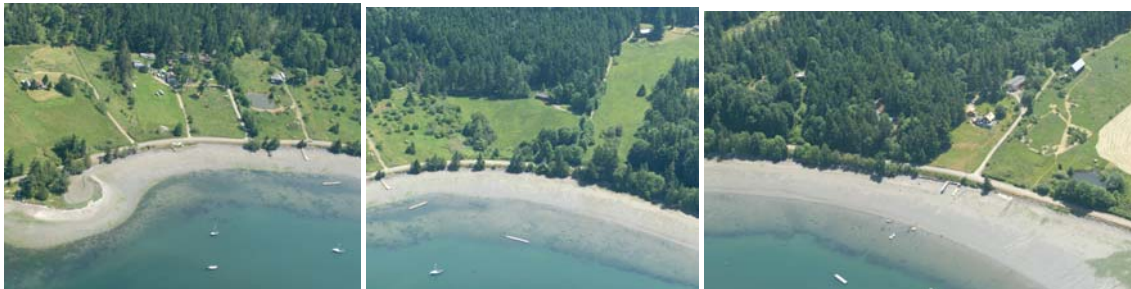
**Figure 5.** Blind Bay Rd (2002 oblique aerial images, WA Dept. of Ecology).

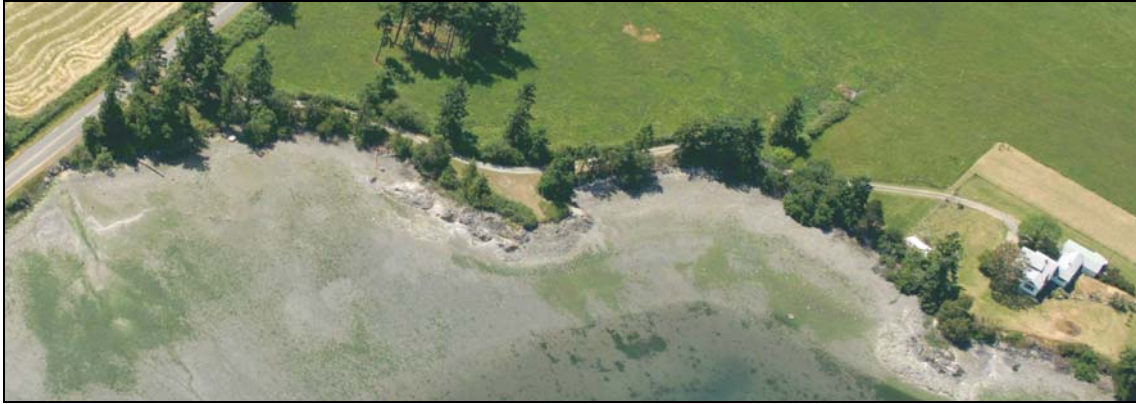
**Figure 6.** Shoreline oblique of private rd and shoreline modifications in southwest Blind Bay, Shaw Island. (Image 2002, WA Dept. of Ecology).

Site 2. Private Rd, West Blind Bay-SW, Shaw Island - The second rated site for bulkhead removal is also found in Blind Bay, Shaw Island. Riprap associated with a road that accesses private property is a priority for removal. Due to the similarity and close proximity of sites Private Rd-West-s Blind Bay (50 ft long) and Private Rd-West Blind Bay (460 ft long) are discussed along with Site 2 (the highest ranking of these sites). The modifications are located between numerous small bedrock prominences that create minor pocket beaches, which make ideal sites for beach nourishment (Figure 6). The roads along much of the shore of Blind Bay appear to have been in place right against the shore of the bay for over 100 years (Figure 7), suggesting that the location was picked for a simple track originally and not for long term use.

Forage fish spawning has been documented along several beaches in Blind Bay. Despite the fact that spawning has not been documented along this particular stretch of beach, spawning has been noted along both adjacent beaches to the north and east such that utilization seems fairly likely (the segment was scored as a documented forage fish spawning habitat). Intertidal sediments are pebble-dominant with sand. Backshore sediment was composed of sand with a high quantity of shell. A narrow band of riparian vegetation (confers and shrubs) lines the landward side of riprap along most of these beach reaches.

Site 2. Enhancement Recommendations – The best long-term beach enhancement would be to relocate the private road and remove the shore modifications in all three segments along this private road. As previously mentioned, this could encompass two other highly rated priority restoration sites that resulted from this analysis. Cumulative removal of the three modification areas could recover approximately 4,300 sq ft of intertidal habitat as well as additional supratidal/backshore habitat. The removal would encompass approximately 1,000 ft in total length between the two pockets. This would allow for restoration of the beach profile and backshore and lower bank vegetation. Ample land is available for road relocation, though relocation of the road may infringe on agricultural fields.

Nourishment of the pocket beaches and removal of the rock on the upper beach should be suitable as a short-term enhancement option in this relatively low wave energy environment. This would entail a more direct project with as complete a rock removal as possible, with rock removed from the beach placed atop the upper portion of the revetment. Suitable sediment would be transported to the site with nourishment focused upon the beach profile landward of lower-mid tide beach. As with Site 1, the location of the aquatic vegetation would need to be mapped in detail, however it appears that it is far enough waterward from the private road such that nourishment should be feasible without substantially impacting lower intertidal and subtidal habitats.

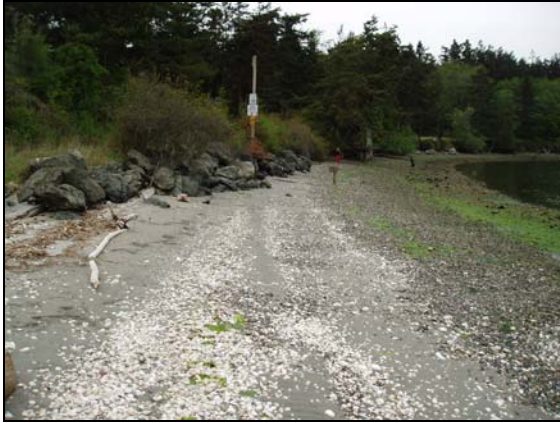
Figure 8. Barlow Bay Rd –Southwest, looking west.

Site 3. Barlow Bay Rd, Lopez Island - This segment of modified shore protects Barlow Bay Rd., which extends westward from southern Barlow Bay out to John's Point. The shoreline modification is comprised of 2-3.5 ft riprap intended to curb erosion along Barlow Bay Rd (Figures 8 and 9). However, there were no signs of active erosion occurring along the beach, even following the large on February 4<sup>th</sup>, 2006 storm event. As a result, removing this 173 ft stretch of riprap from the intertidal and upper beach could enhance over 4,314 sq ft of beach habitat.

The modified beach is composed of pebble and sand with cobbles. Upper beach sediment is comprised of sand with minor pebble and shell hash. Several species of algae are found along this beach including *Fucus spc.*, *Ulva spc.* and *Enteromorpha spc.*. Overhanging riparian vegetation is found landward of the modification, offering shade to approximately 70% of the uppermost beach. Historically an extensive wetland, likely salt marsh, was located landward of the beach (Figure 10). The beach actually appears to have been a spit that extended west to a tidal inlet. The inlet and wetlands are now mostly filled and the remaining wetland areas are hydrologically controlled by tide gates.

Site 3. Enhancement Recommendations - There are a number of opportunities to enhance the condition of the nearshore at Barlow Bay (Barlow Bay Rd. and adjacent MacKaye Harbor Rd.). Removal of the riprap adjacent to Barlow Bay Rd should be the highest priority restoration action (Figure 8). This site does not appear to require shore protection along most of its length for erosion control. The site is in a very low (wave) energy environment and there is a buffer of variable width between the rock and the road. This would allow for rehabilitation of the valuable spawning habitat that the rock is infringing upon. Following rock removal, the beach would be nourished to restore upper beach sediment suitable for forage fish spawning and reduce erosion potential.

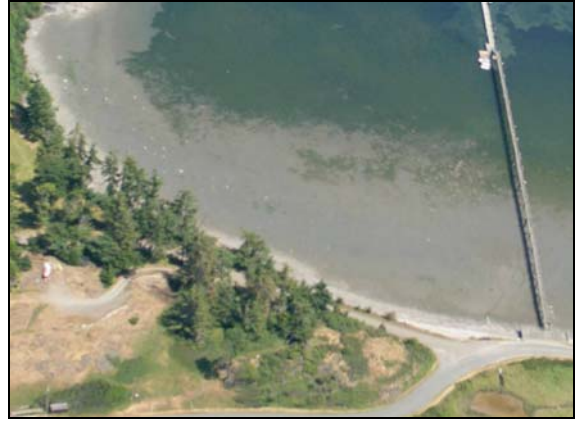
Figure 9. Barlow Bay Rd, 2002 DOE oblique.

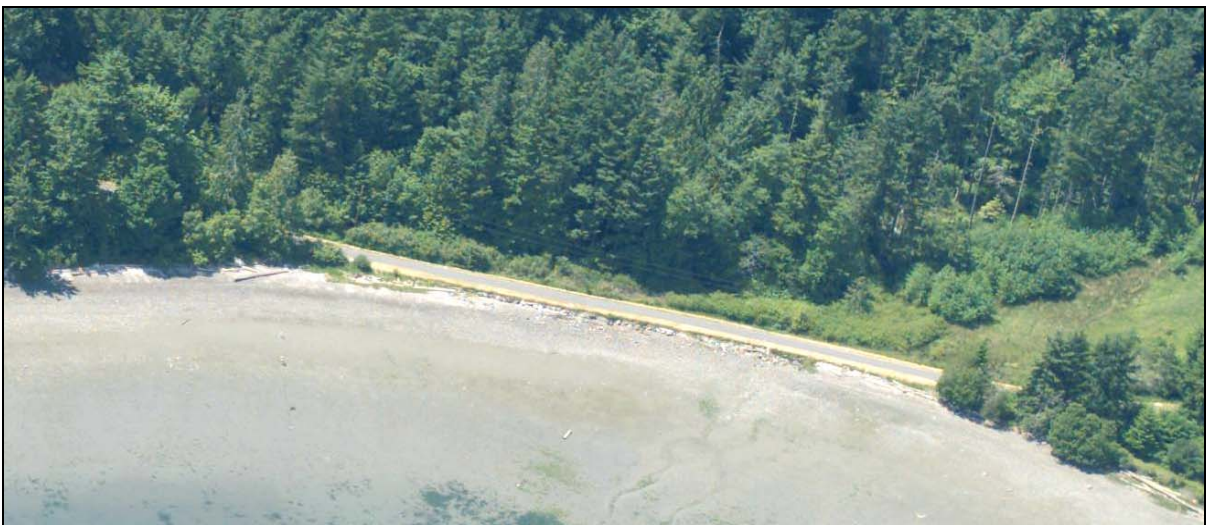
**Figure 11.** Smuggler's Cove Rd, Northwest Blind Bay, Shaw Island (2002 DOE oblique).

Site 4. Smuggler's Cove Rd. (northwestern Blind Bay), Shaw Island - The fourth-ranking shore modification for removal/enhancement was located in northwestern Blind Bay, adjacent to Smuggler's Cove Rd. Smuggler's Cove Rd. extends north along the western shore of Blind Bay (Figure 11), where it links with Runnymede Lane and Newton Beach Rd. The modification consists of a low elevation rock revetment along road edge. The structure protects Smuggler's Cove Rd.. West of where the road setback is least, is the base of Cooper Hill.

This beach faces east and similar to other Blind Bay sites, has low erosion potential due to limited wave energy. Fetch measures approximately 1.5 miles. The distance from the edge of the road to MHHW was generally around 4 ft. The beach is swash aligned, and is found in the middle of drift cell SH-2. This cell exhibits southward drift, evident by decreasing sediment size and a stream mouth offset to the south (Johannessen 1992). The sediment source for the cell is glacial till, which occurs at the cell origin and over most of the length of the cell (Johannessen 1992). A small stream appears to drain through the north-central portion of this site.

WDFW has documented forage fish spawning along the southern half of this beach. Adjacent no-back shorelines possess a narrow band of driftwood. Riparian vegetation is patchy, and found both north and south of the road revetment. Sediment is composed of sand with overlying pebble.

Site 4. Enhancement Recommendations - Removing the 240 ft of riprap overlying this beach could recover approximately 1,685 sq ft of forage fish spawning habitat. Rock prominences located at either end of the beach minimize large losses of sediment from the beach system, making this shore well suited for beach nourishment. The area around the small stream could be enhanced and provides additional restoration opportunities.

Due to the very close proximity of the road and the intertidal, the most obvious and viable long-term restoration action at this site is to setback Smuggler's Cove Rd. to the base of Cooper Hill. This would allow for full restoration of the beach profile (including the berm and backshore) and enhancement of forage fish spawning areas. It would also allow for marine riparian enhancement adjacent to the shore, which could have numerous positive effects on the beach. Beach nourishment could be used to reestablish the beach and backshore profile and augment potential spawning habitat. If road setback were minimal, composite large woody debris (LWD) structures could be used to help retain nourishment sediment, especially along the central portion of the beach, which appeared to be more impacted by the road. However, this would offer more limited habitat improvement than the option described above.

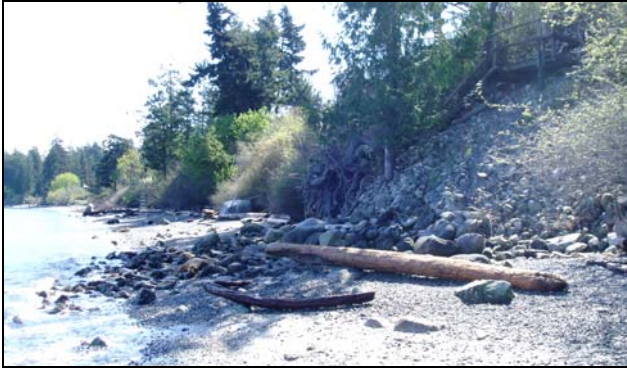
**Figure 12.** West Shoal Bay modification.

Site 5. West Shoal Bay, Lopez Island - This residential property spans across two adjacent lots in southwestern Shoal Bay, located on northern Lopez Island. This fifth-rated site for enhancement is found at the toe of a moderate height bank (approximately 30 ft). The modified area extends approximately 69 ft alongshore and is in very poor condition (Figures 12 and 13). It appears that boulders were dumped from the bank crest down the bank face to curb toe erosion. The lack of careful and targeted rock placement and presence of additional rock on the slope has caused the rock to migrate waterward (down to mid-tide level) during high tides, resulting in the burial of the natural intertidal beach. It is unlikely that the modification is providing much erosion control in its poor state, and is clearly degrading beach habitat. The beach sediment surrounding the modified area was composed of sand with moderate pebble and granules, and has been documented as valuable forage fish spawning habitat. Removing this shore modification would recover approximately 1,665 sq ft of intertidal area.

West Shoal Bay faces directly north with fetch measuring approximately 5 miles to southern Orcas Island. This beach is swash aligned with wave fronts approaching directly towards the shore. Following the field reconnaissance, this shore segment was determined to have low-moderate erosion potential. The homes located atop the bluff are setback approximately 75 ft from the bluff crest. The modification is located within drift cell LO-1, which exhibits eastward drift (Johannessen 1992). Up-drift sediment sources, including landslides and toe erosion were observed during the field reconnaissance.

Site 5. Enhancement Recommendations - There are several restoration opportunities in Shoal Bay, including Site 5, removal of an upper beach concrete pad further east at the base of the spit, and at the mouth of the lagoon. Because the shore modification at Site 5 infringes upon forage fish spawning habitat further than the area at the base of the spit, it should be of the highest priority. The beach enhancement action at this site is to simply remove the rock that is currently covering the intertidal beach, and to the extent possible, from the backshore area. Because the rock debris is scattered over only 69 ft this should not require considerable effort or funding, however alternative erosion control for the upland property and managing the rock removal from the beach will require additional consideration.

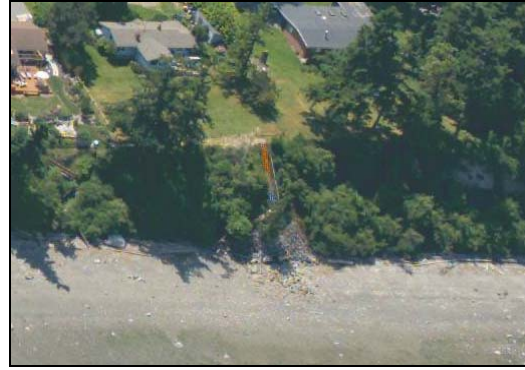
**Figure 13.** West Shoal Bay modification (2002 DOE oblique).

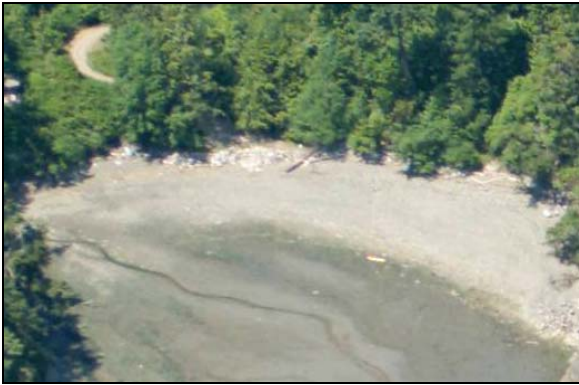
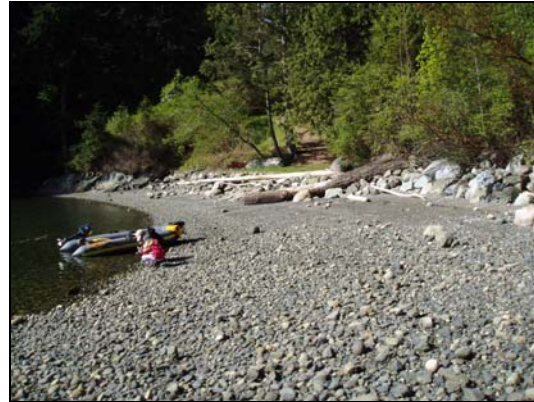
**Figure 14.** Jasper Bay beach, riparian cover and riprap (2002 DOE oblique).

**Figure 15.** Jasper Bay beach and rockery.

Site 6. Jasper Bay, Lopez Island - Jasper Bay is a small pocket beach located on the southeast shore of Lopez Island in Lopez Sound (Figures 14 and 15). A single property owner owns the uplands, though the tidelands are apparently held by DNR. The beach has potential forage fish spawning habitat, overhanging riparian vegetation across most of the shore, and small stream mouth with mature conifers surrounding the stream. An approximately 150 ft long rock revetment covers the upper intertidal and backshore area. This structure, comprised mainly of glacial erratic, was judged to be generally unnecessary for erosion control during field reconnaissance. The revetment contained several places where small boats were stored and the end of a rough track from the uplands. The revetment is recommended for removal along with beach nourishment if any structures were to remain.

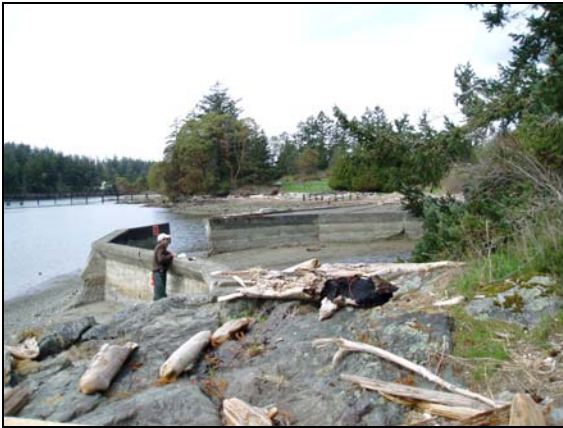
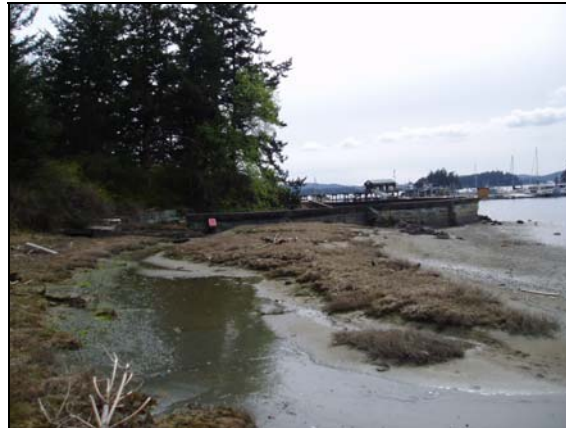
Figure 16. Deer Harbor pool, looking north.

Figure 17. Deer Harbor pool, looking south.

Site 7. Deer Harbor pool, Orcas Island - This derelict concrete community pool is located on the upper intertidal of a beach in northeastern Deer Harbor (Figure 16). The concrete pool frame was built into the beach and encompasses the entire upper intertidal and backshore of the beach. The structure has completely failed and the walls were cracked and falling in several places. Estuarine marsh vegetation covers the adjacent northern shore (Figure 17). Cayou Valley Creek estuary resides north of the site, contributing to the estuarine condition of northern Deer Harbor. It is probable that this creek was historically salmonid bearing (Deer Harbor Restoration Project Team 2005), thus increasing the restoration value of this site. This beach in this area was mapped as potential forage fish spawning habitat (if the site were not infringed upon by modifications).

Recommendations for enhancement at this site include removing the entire cement pool walls and footings, followed by backfilling sediment into the old footing areas (minor beach nourishment). Whether the concrete is anchored into bedrock would influence the removal. Riparian vegetation should be enhanced where damaged by removal work and marsh vegetation including *Distichlis spicata* and *Salicornia virginica*, should be planted to initiate recreation of estuarine-marsh conditions.

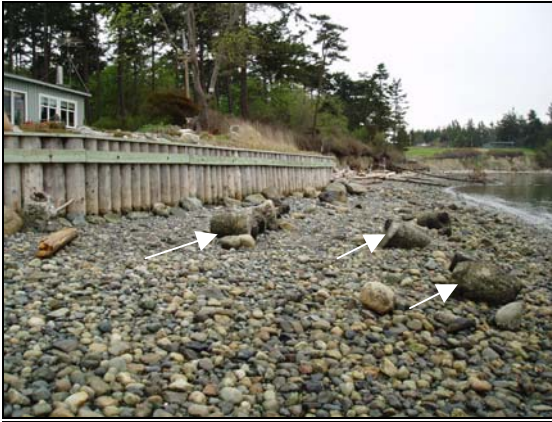
**Figure 18.** Aleck Bay soldier pile bulkhead.

Site 8. Aleck Bay (west), Lopez Island - This site scored quite well for habitat values, and moderately well for bulkhead removal feasibility. However, based on professional judgment of CGS staff this project should not be pursued for bulkhead removal. The apparently recent construction of the wooden soldier pile bulkhead and small setback distance of the house, make homeowner willingness highly unlikely (Figure 18). There are however, additional opportunities to enhance this beach, including removing the concrete pier footings on the beach (see arrows in Figure 18), restoring the hydrologic connectivity of the large marsh (located southwest of this site) to the marine environment and removing the large bulkhead and reconfiguring the community beach access at the eastern end of the site, which extends well into the intertidal (Figure 19).

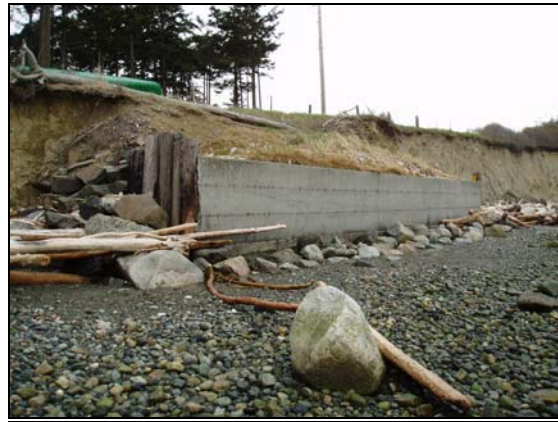
**Figure 19.** Aleck Bay beach access opportunity.

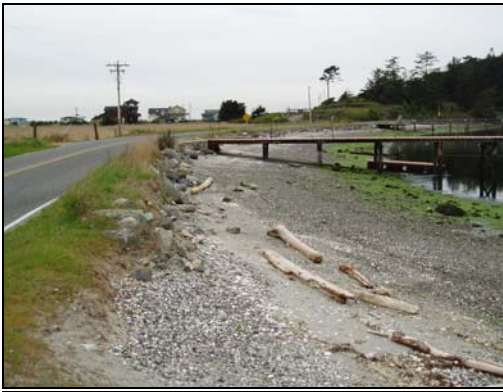
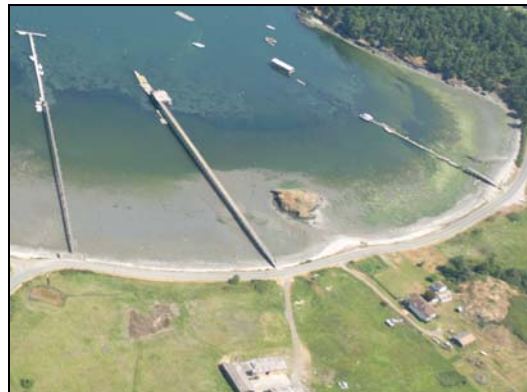
**Figure 20.** MacKaye Harbor Rd, looking west.

**Figure 21.** MacKaye Harbor Rd (2002 DOE oblique).

Site 9. MacKaye Harbor Rd. - Two sections of modified shore (comprised of loose rock revetment), found in the central and eastern portions of the bay, provide minimal function and could easily be removed (Figures 20 and 21). This would help reestablish dune and marsh vegetation found in the upper intertidal and backshore. Additionally, removing derelict piers, piles and debris from the intertidal would require minimal cost and effort, while providing considerable benefit.

Restoration of the natural hydrology of the Barlow Bay coastal wetlands presents a great opportunity to enhance the ecological value of the bay. At least two major tide gates (10" cement pipes) restrict flow and prohibit marine water from flowing into the backshore wetlands. It is likely that prior to installation of these tide gates an extensive tidal wetland complex was found landward of the modern beach. Freshwater wetlands have also likely been reduced by filling, draining and other hydrologic control. This large scale restoration would require a feasibility study to define the exact restoration potential of the area.

Relocation of the MacKaye Harbor Rd. to a more landward (higher elevation) location would prevent the road from infringing on the beach any further. It would also avoid the need for additional protection of the road, which will likely experience repeated overtopping and/or inundation based on anticipated sea level rise projections. Relocating the road could provide room for natural shoreline translation (an implication of sea level rise), without the loss of habitat.

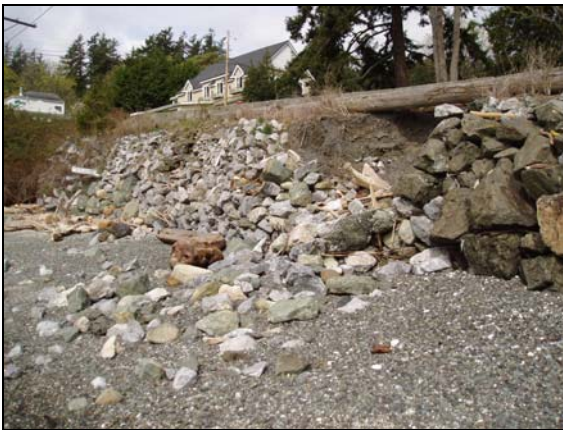
**Figure 22.** West Sound revetment failure.

Site 10. Deer Harbor Rd. Relocation – The Deer Harbor Rd., near the West Sound Grange Hall and the Yacht Club, is located over what would be the upper beach and backshore. A large rockery and riprap revetment were constructed at this low bank shore, apparently to defend the road. These structures infringe upon and degrade potential forage fish spawning habitat and impound bank sediment at this site. The integrity of much of the structures was observed to be poor, as it appears to have experienced numerous recent failures in the rock (Figure 22), likely resulting from the February 4<sup>th</sup>, 2006 windstorm. There was a considerable volume of toppled boulders on the beach that have fallen from the revetment. This has buried valuable intertidal habitat (Figure 23).

Habitat infringement and revetment damage resulting from storms are likely to be exacerbated as a result of sea level rise and global climate change. As a result the most sustainable management strategy is to bypass or relocate Deer Harbor Rd. at this location and remove this failing rockery and revetment and restore the beach. Beach restoration should include beach nourishment and planting a riparian buffer of native vegetation.

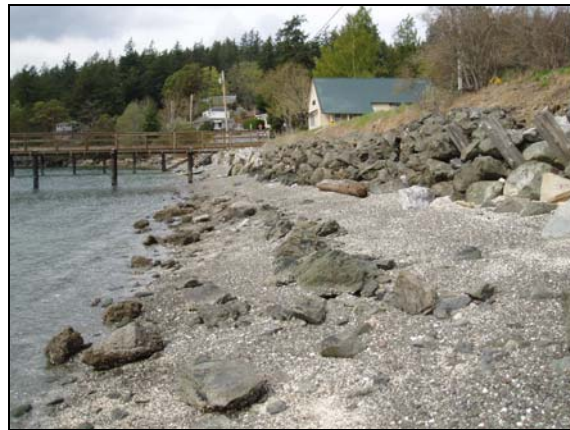
**Figure 23.** Toppling boulders over intertidal.

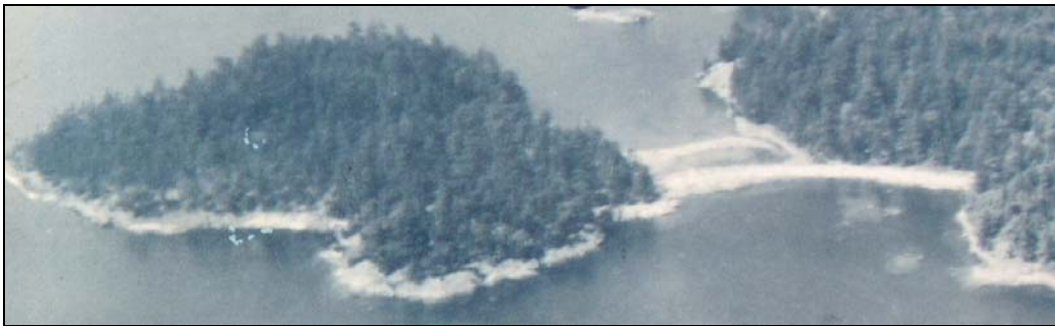
**Figure 24.** Camera copy of flyer publicizing Neck Point from 1940s-1950s era.

Neck Point Restoration, Shaw Island - Reconfiguring Neck Cove, located on western Shaw Island, to its original form would restore a number of lost intertidal habitats. Fill has been placed over the historic lagoon and the northern spit has been filled to create an isthmus and roadway between Neck Point and Shaw Island. This fill could be removed with a bridge built in its place, which would allow for cutting a new tide channel where it once was prior to alteration.

Recreating the original configuration of the shore would restore the natural tidal flushing between Neck Point and Shaw Island, which could have numerous indirect benefits to the habitat conditions historically found therein. For example, local elders on Shaw Island have made observations of the gradual infilling of the northern bay, and the associated reduction in eelgrass beds. Restoring this section of shoreline could recover lost shoreline complexity, a coastal lagoon and tide channel, as well as backshore, dune and salt marsh habitat (Figures 24 and 25). The original configuration of the shore in this area would need additional investigation as part of a larger feasibility study that could result in restoration designs. It is likely that the original configuration was similar to the shores visible in Figures 24 and 25.

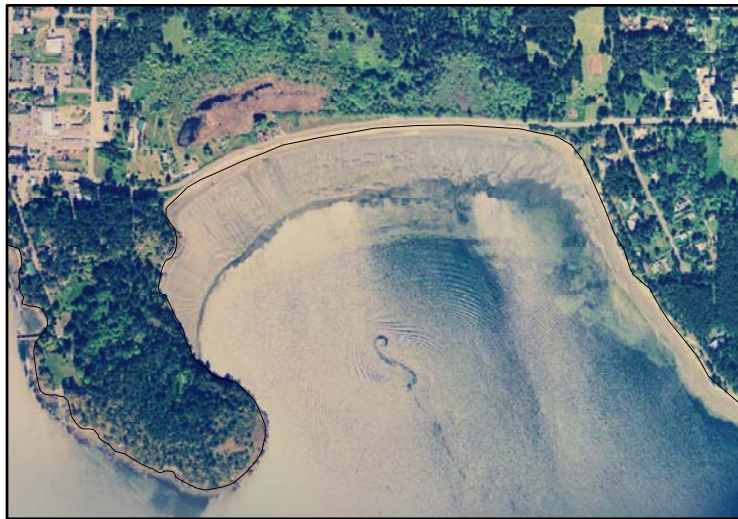
**Figure 26.** Crescent Beach road by-pass and beach restoration, 2004 air photo.

Crescent Beach Road Bypass, Orcas Island - This opportunity entails bypassing Crescent Rd. where it runs adjacent to the bayhead beach in northern Eastsound (Figure 26). The road suffered considerable damage from the February 4<sup>th</sup>, 2006 windstorm, affirming the vulnerability of roads that directly abut higher energy beaches. This shore has considerable exposure to predominant southerly wind waves. The elevation of the road is only slightly higher than the beach and was likely built atop the original storm berm of the historic beach profile. The presence of the large backshore wetland (located immediately north of the road) is evidence of continual overtopping of the road and/or historic storm berm, and represents a common beach configuration. As a result continued overtopping of the road should be expected. Overtopping, washouts and storm damage will also likely occur at this site with greater frequency as an implication of accelerated sea level rise. If additional shore protection were permitted, impacts to nearshore habitats would inevitably be incurred as a result of “the coastal squeeze”.

Bypassing this road would allow for removal of the road, recreation of the beach profile (and storm berm), restoration of the hydrologic connectivity of the backshore wetland and preservation of numerous valuable nearshore habitats. Recreating the natural beach profile would require beach nourishment. Nourishment material would be configured to form a functioning storm berm with a natural transition to dune habitat and the coastal wetland. Restoring the beach profile would allow for natural shoreline translation, which will prevent unnecessary habitat loss as a result of sea level rise. Due to the close proximity to town, this restoration opportunity would be highly visible and could provide considerable recreational value.

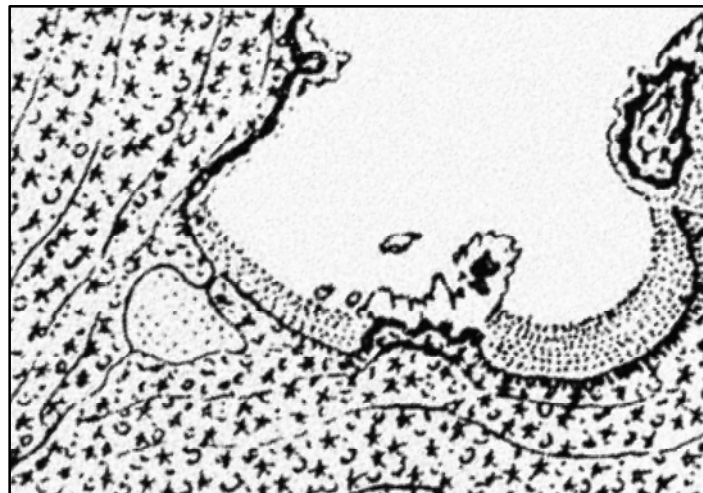
Figure 28. T-sheet no t2229 showing southern Cove, 1895.

Cove South of Indian Point, West Sound, Orcas Island - This site scored well for restoration, however after an additional step in reviewing historic maps of the site was completed, the site appears to be even higher restoration value. The current shoreline is armored with logs, and a culvert controls the outflow of freshwater from a wetland (with ponded water) just landward of the bank crest. If the property owners are willing, fill could be removed from the low bank shore to recreate a mini-estuary comprised of a lagoon, two converging spits and a tide channel (Figure 27, 28). The shore modifications could be removed and the natural beach profile restored along with tidal flow to the lagoon. This unique opportunity could cumulatively restore considerable shallow water intertidal area (with high edge-to-area ratio), a pocket estuary and marsh habitat. In addition, this proposed project offers sustainability, as it would recreate original conditions and the site has low erosion potential.

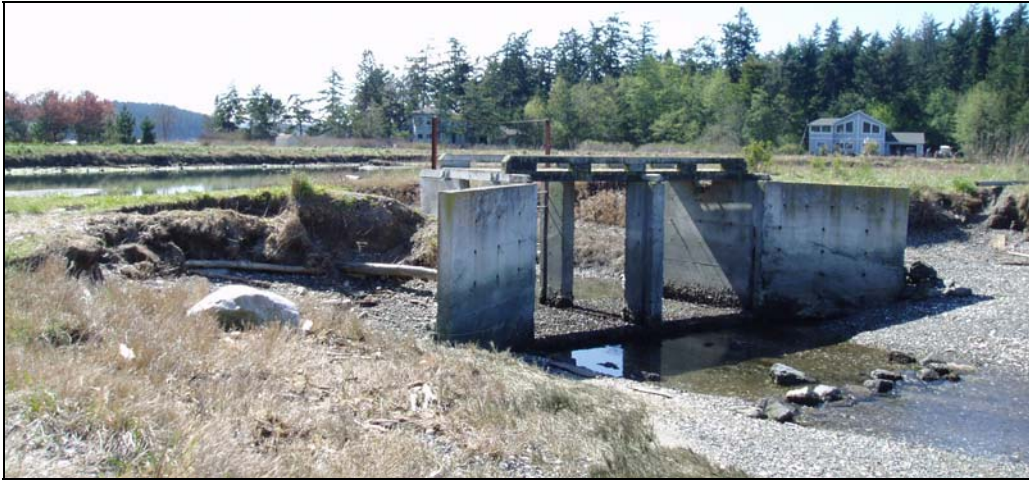
**Figure 29.** Failed tide gate and constriction at the mouth of Shoal Bay lagoon.

Shoal Bay Lagoon Tide Gate Removal - There are several additional restoration opportunities in Shoal Bay. Removal of the large cement tide gate located within the tide channel waterward of the lagoon in the eastern corner of the bay should be of high priority. The tide gates do not appear to be functional, and the tide channel is scoured out on either side of the cement walls (Figure 29). The structure appears to constrict flow and impede fish passage through the channel at lower water due to its artificially high concrete base in addition to other impacts. The Department of Fish and Wildlife (WDFW) has mapped the lagoon wetland system and the Shoal and Swift's Bays estuarine system as priority habitat and species areas, as these areas are used by several species. Additionally the lagoon is located within a conservation area. Additional study of the tide channel hydraulics and morphology should be conducted prior to initiating structure removal.
