## APPENDIX B. MARINE RIPARIAN INVENTORY FOR SAN JUAN COUNTY

**San Juan County**  
**Marine Riparian Inventory Mapbook**  
**Forest Coverage Class**

**San Juan County**  
**Marine Riparian Inventory Mapbook**  
**Shrub Coverage Class**

**San Juan County**  
**Marine Riparian Inventory Mapbook**  
**Below 2 Ft. Vegetated Coverage Class**

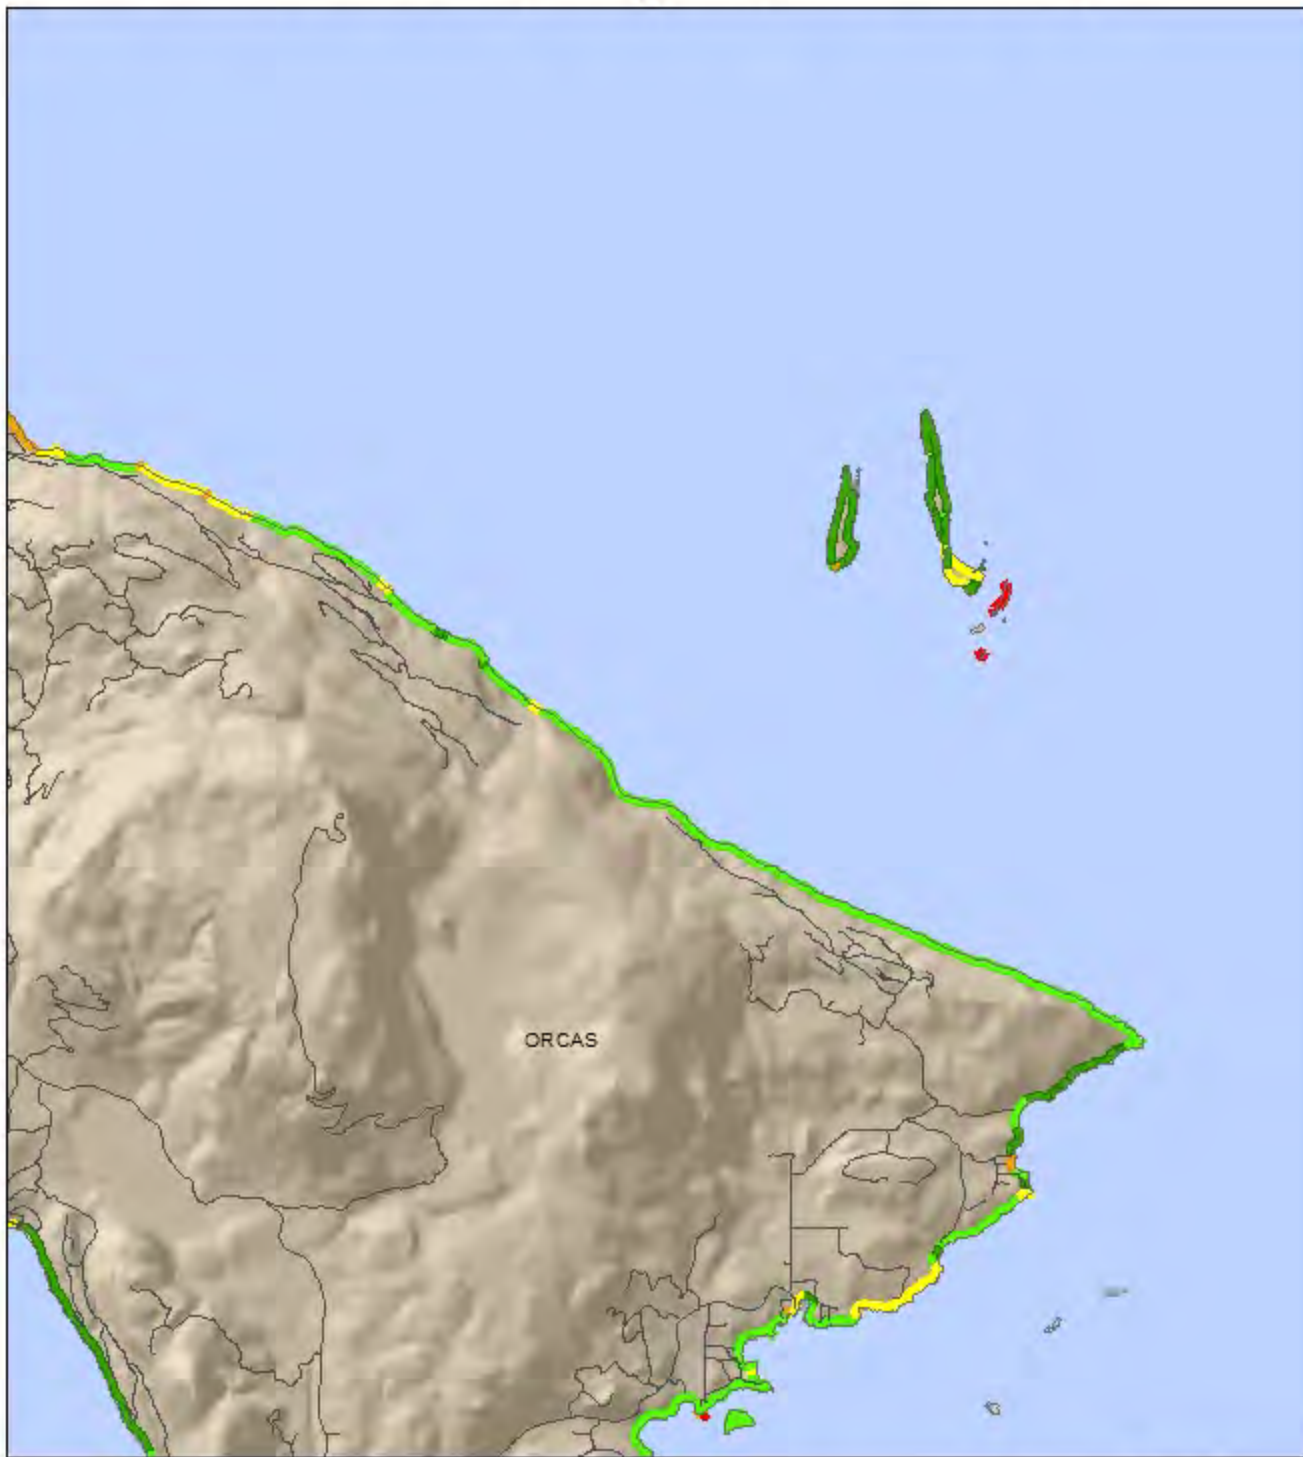
**B4**

- 0 = No Coverage
- 1 = .01-25%
- 2 = 26-50%
- 3 = 51-75%
- 4 = 76-100%

## FOREST CLASS % of Coverage

Length: Geomorphic Shoreform, Width: 200 ft.

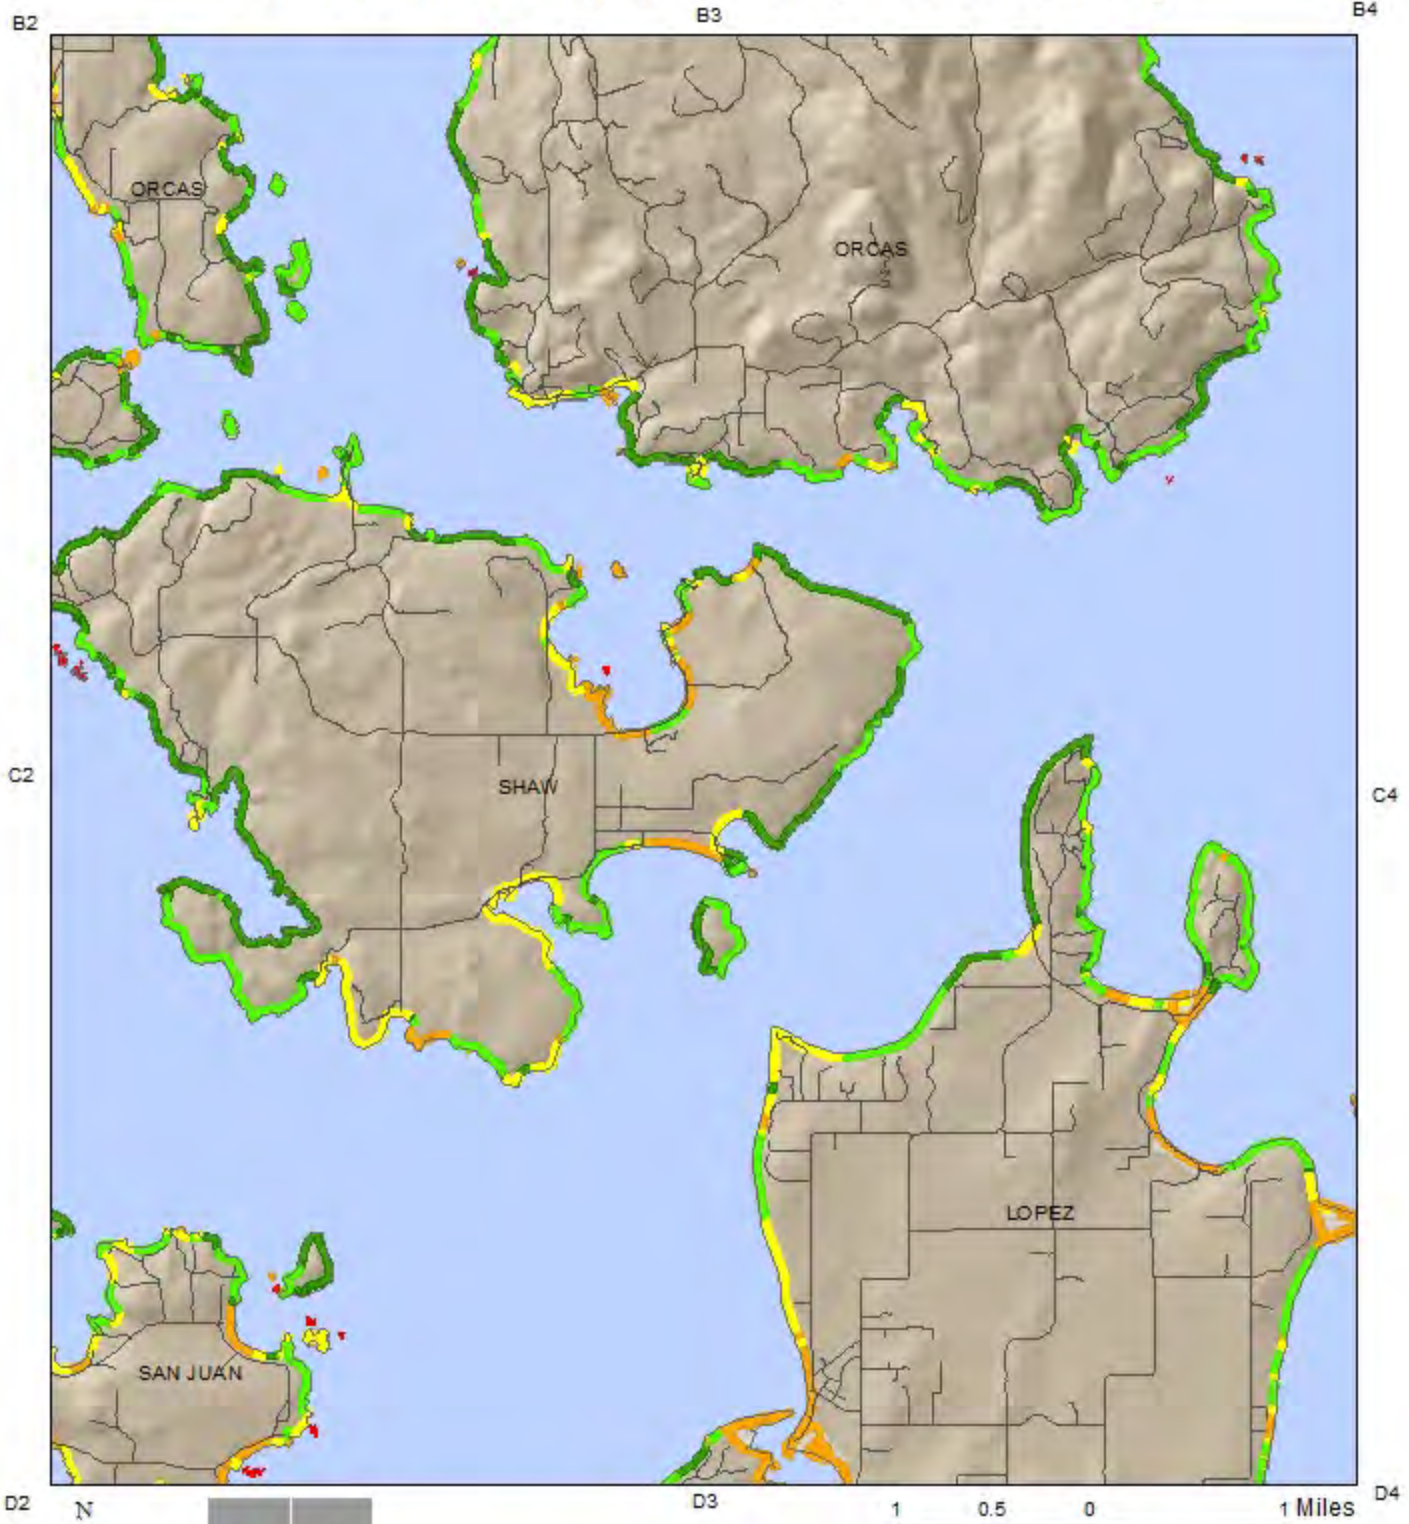
**C3**

## FOREST CLASS % of Coverage

Unit of Analysis:  
Length: Geomorphic Shoreform, Width: 200 ft.

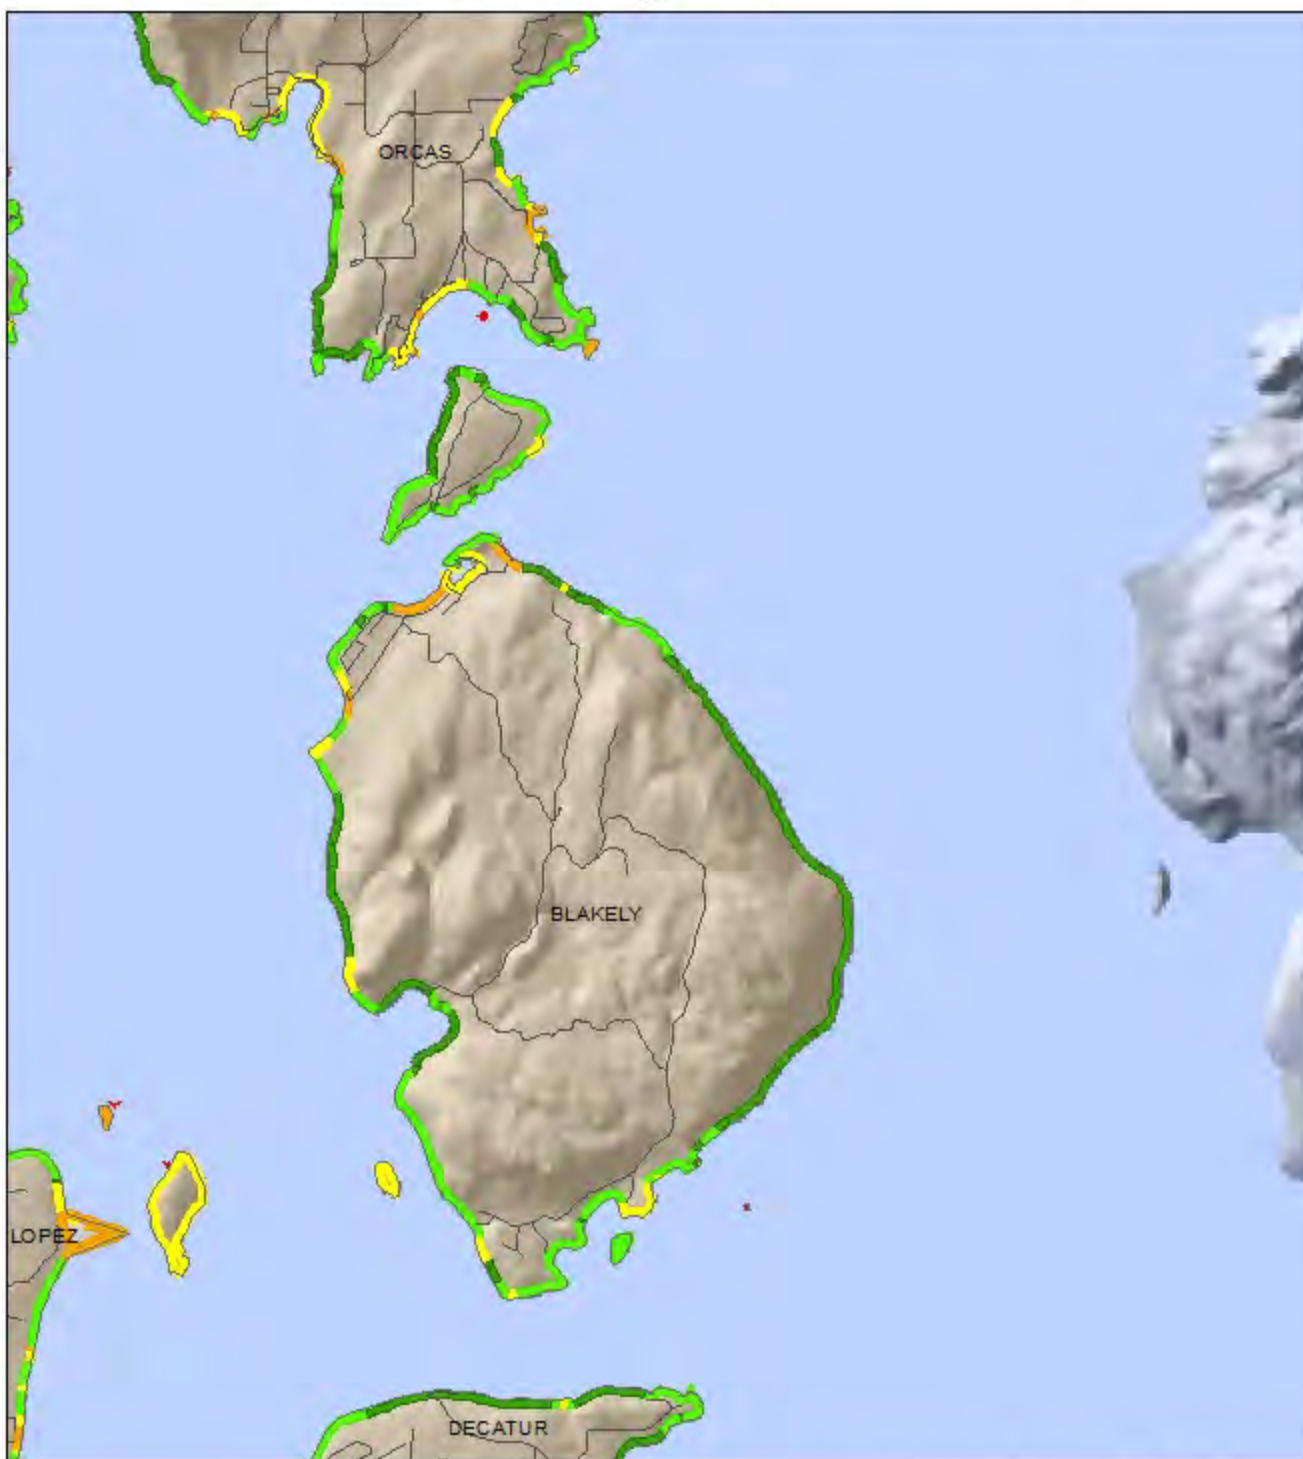
# C4

## FOREST CLASS % of Coverage

Length: Geomorphic Shoreform, Width: 200 ft.

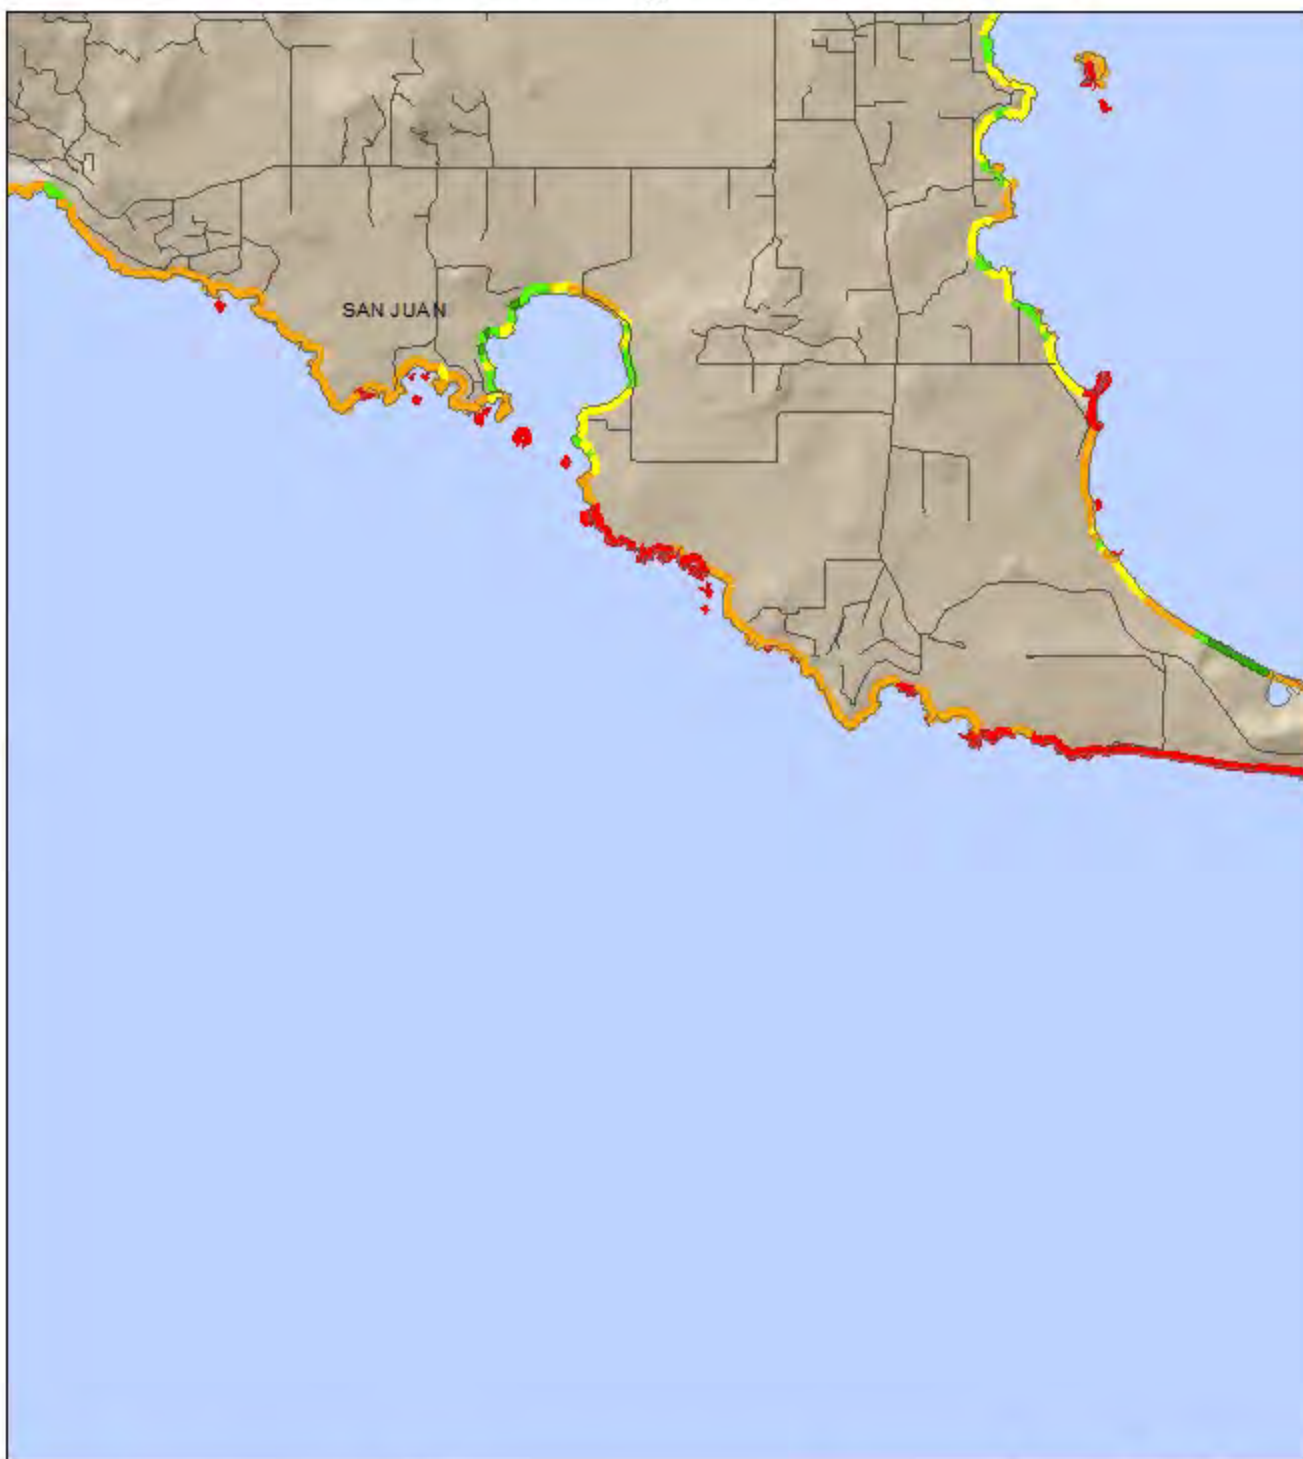
**D2**

- 0 = No Coverage
- 1 = .01-25%
- 2 = 26-50%
- 3 = 51-75%
- 4 = 76-100%

## FOREST CLASS % of Coverage

Length: Geomorphic Shoreform, Width: 200 ft.

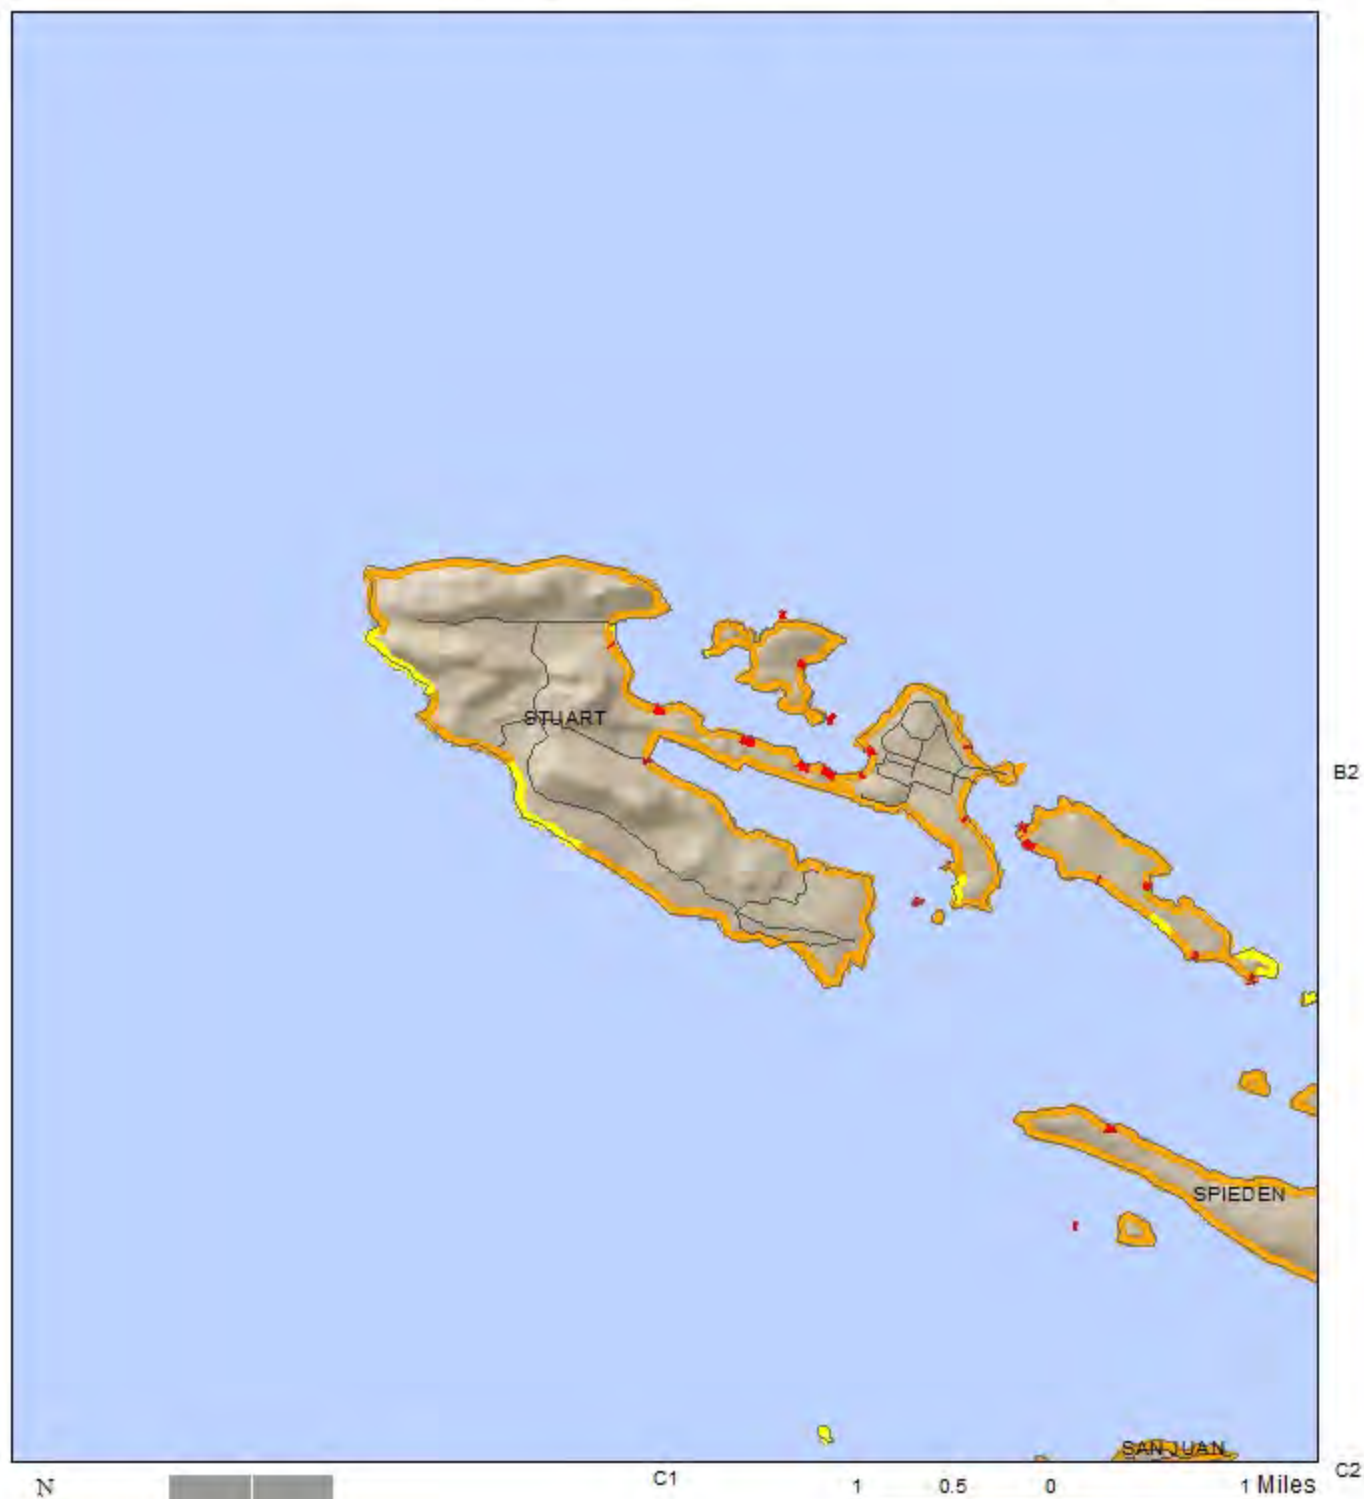
**B1**

## Shrub Class % of Coverage

Unit of Analysis:  
Length: Geomorphic Shoreform, Width: 200 ft.

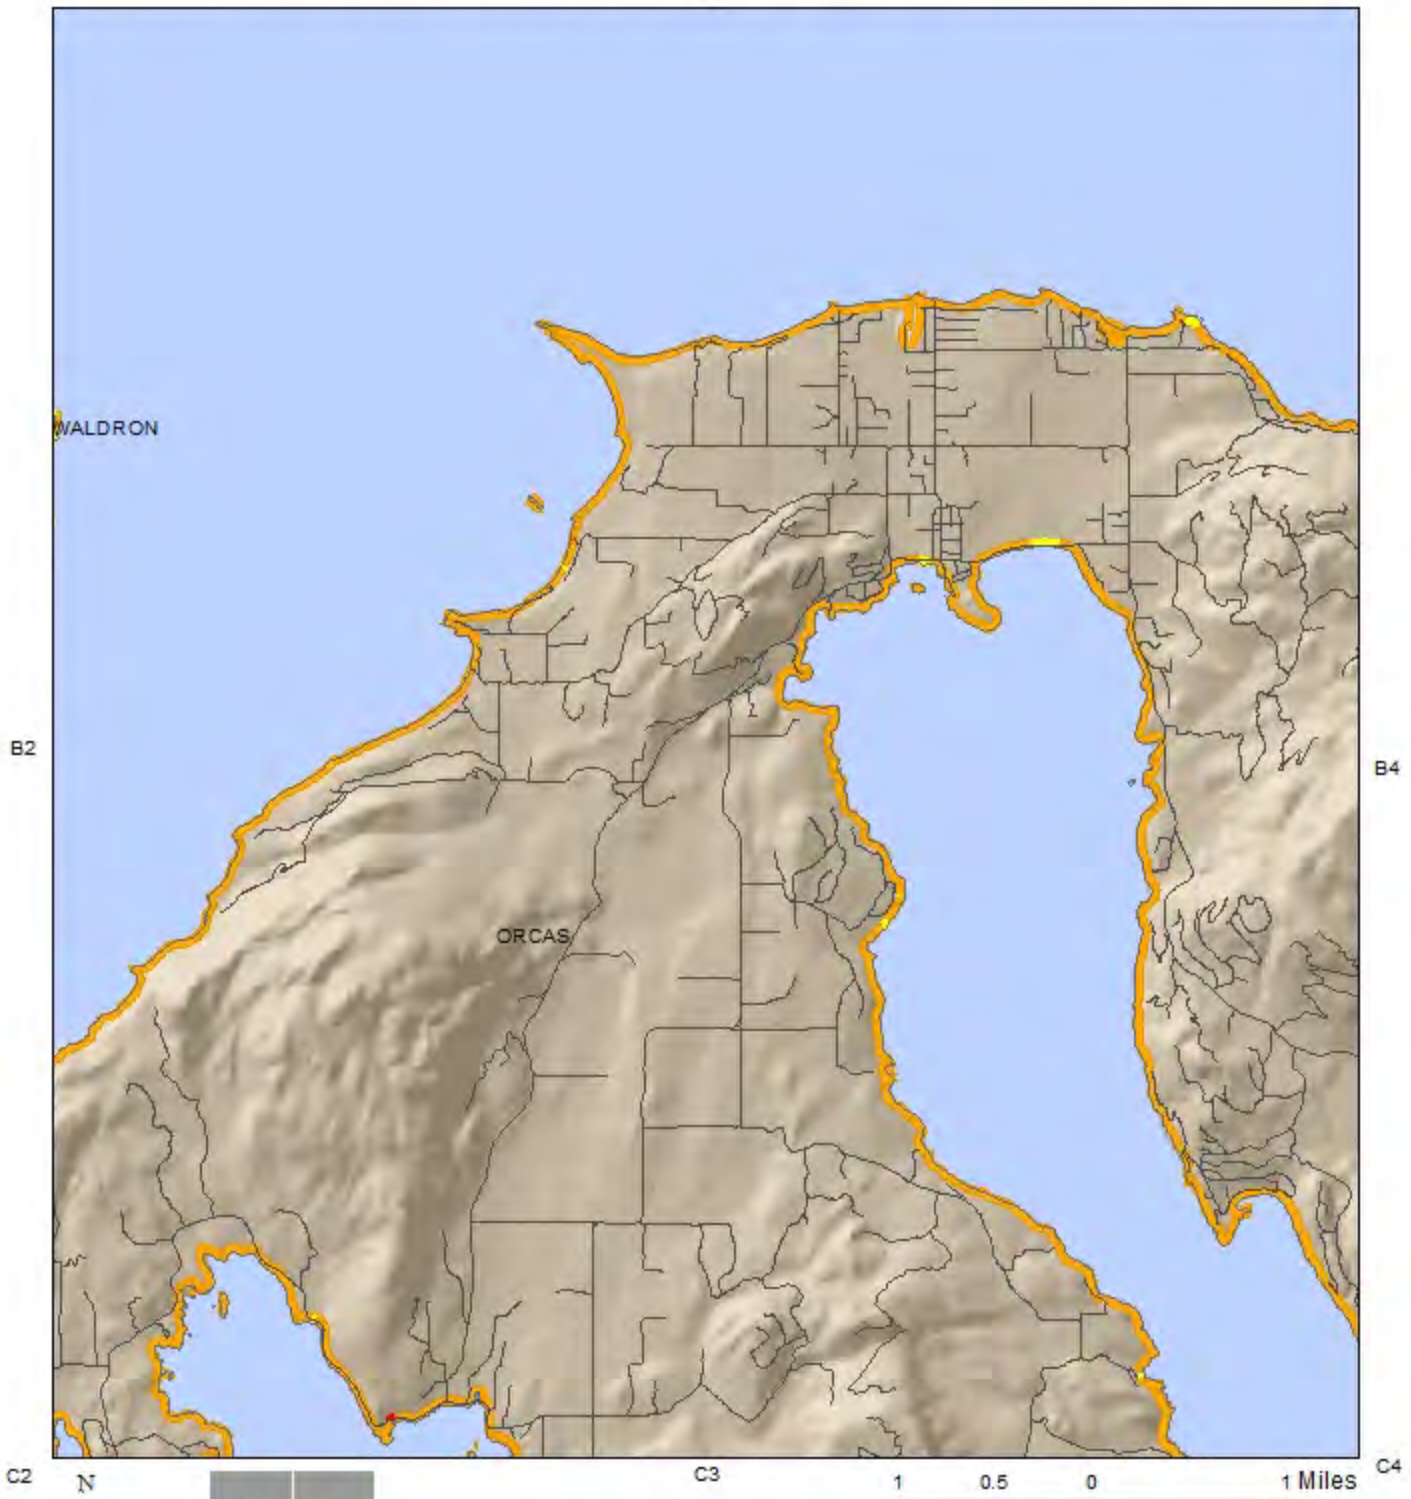
**B3**

## Shrub Class % of Coverage

Unit of Analysis:  
Length: Geomorphic Shoreform, Width: 200 ft.

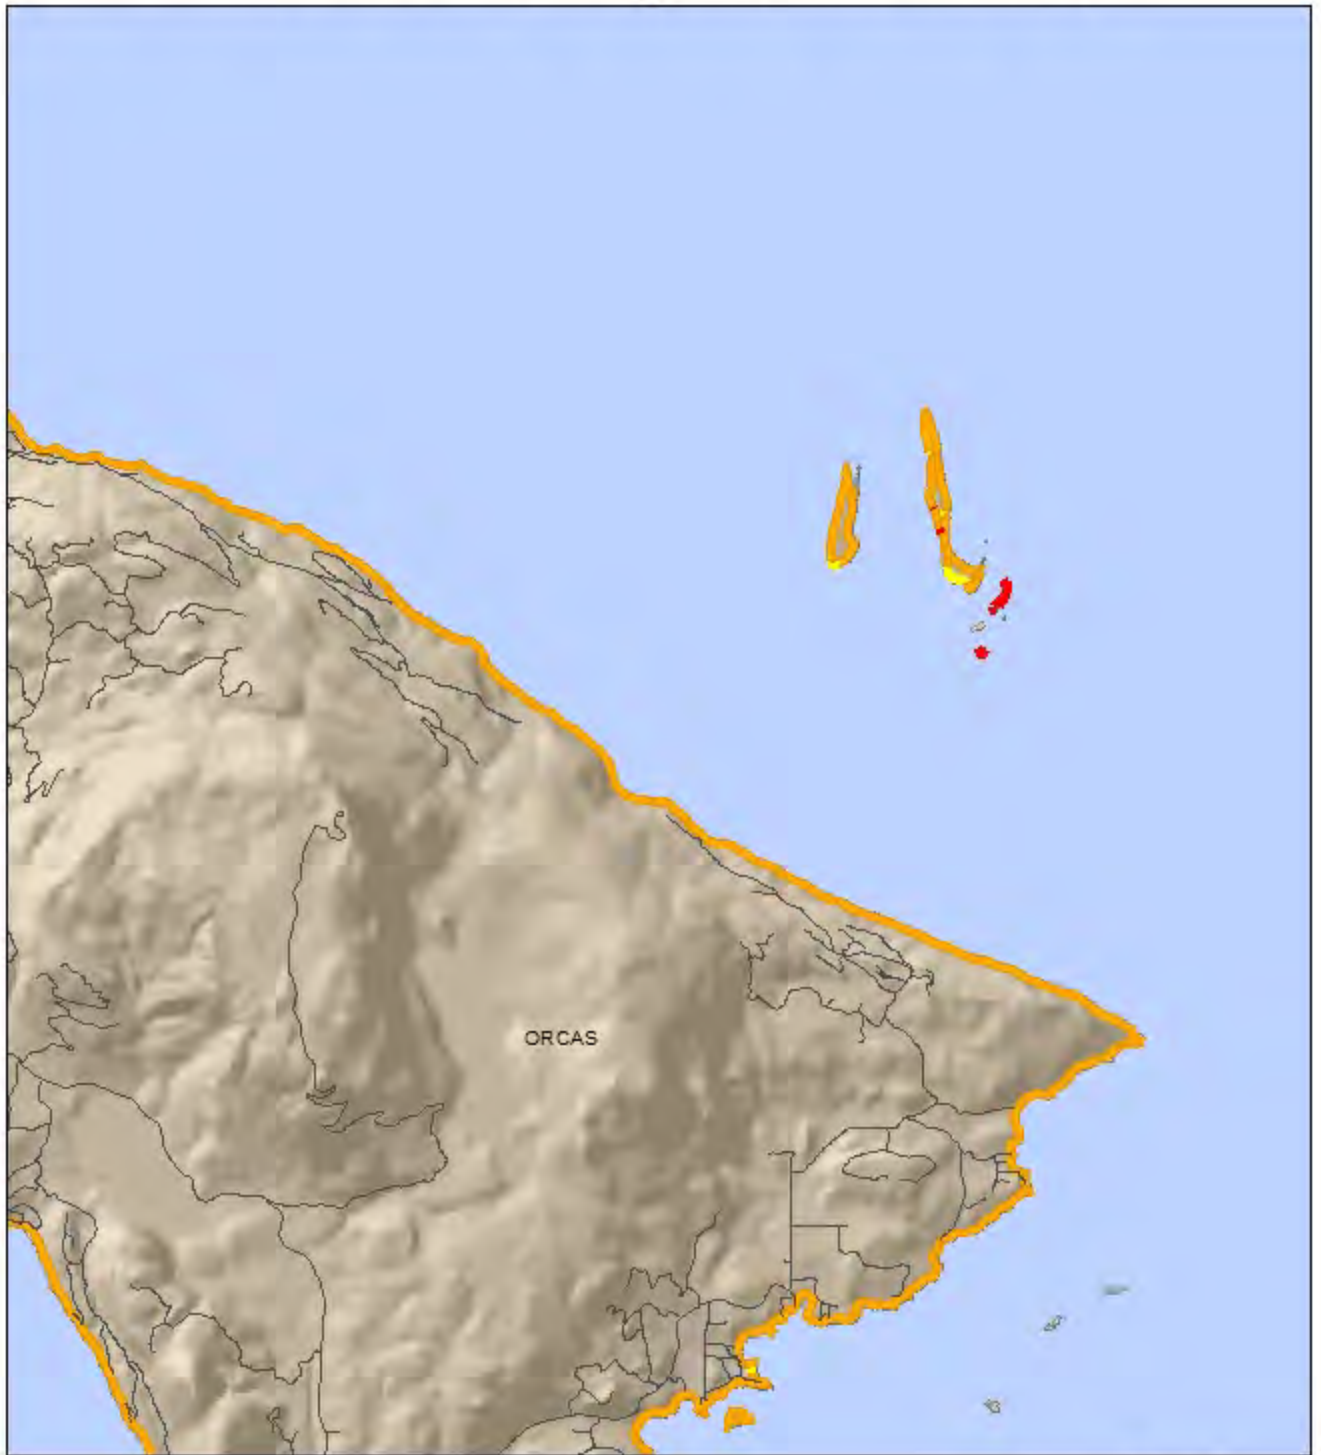
**B4**

- 0 = No Coverage
- 1 = .01-25%
- 2 = 26-50%
- 3 = 51-75%
- 4 = 76-100%

## Shrub Class % of Coverage

Length: Geomorphic Shoreform, Width: 200 ft.

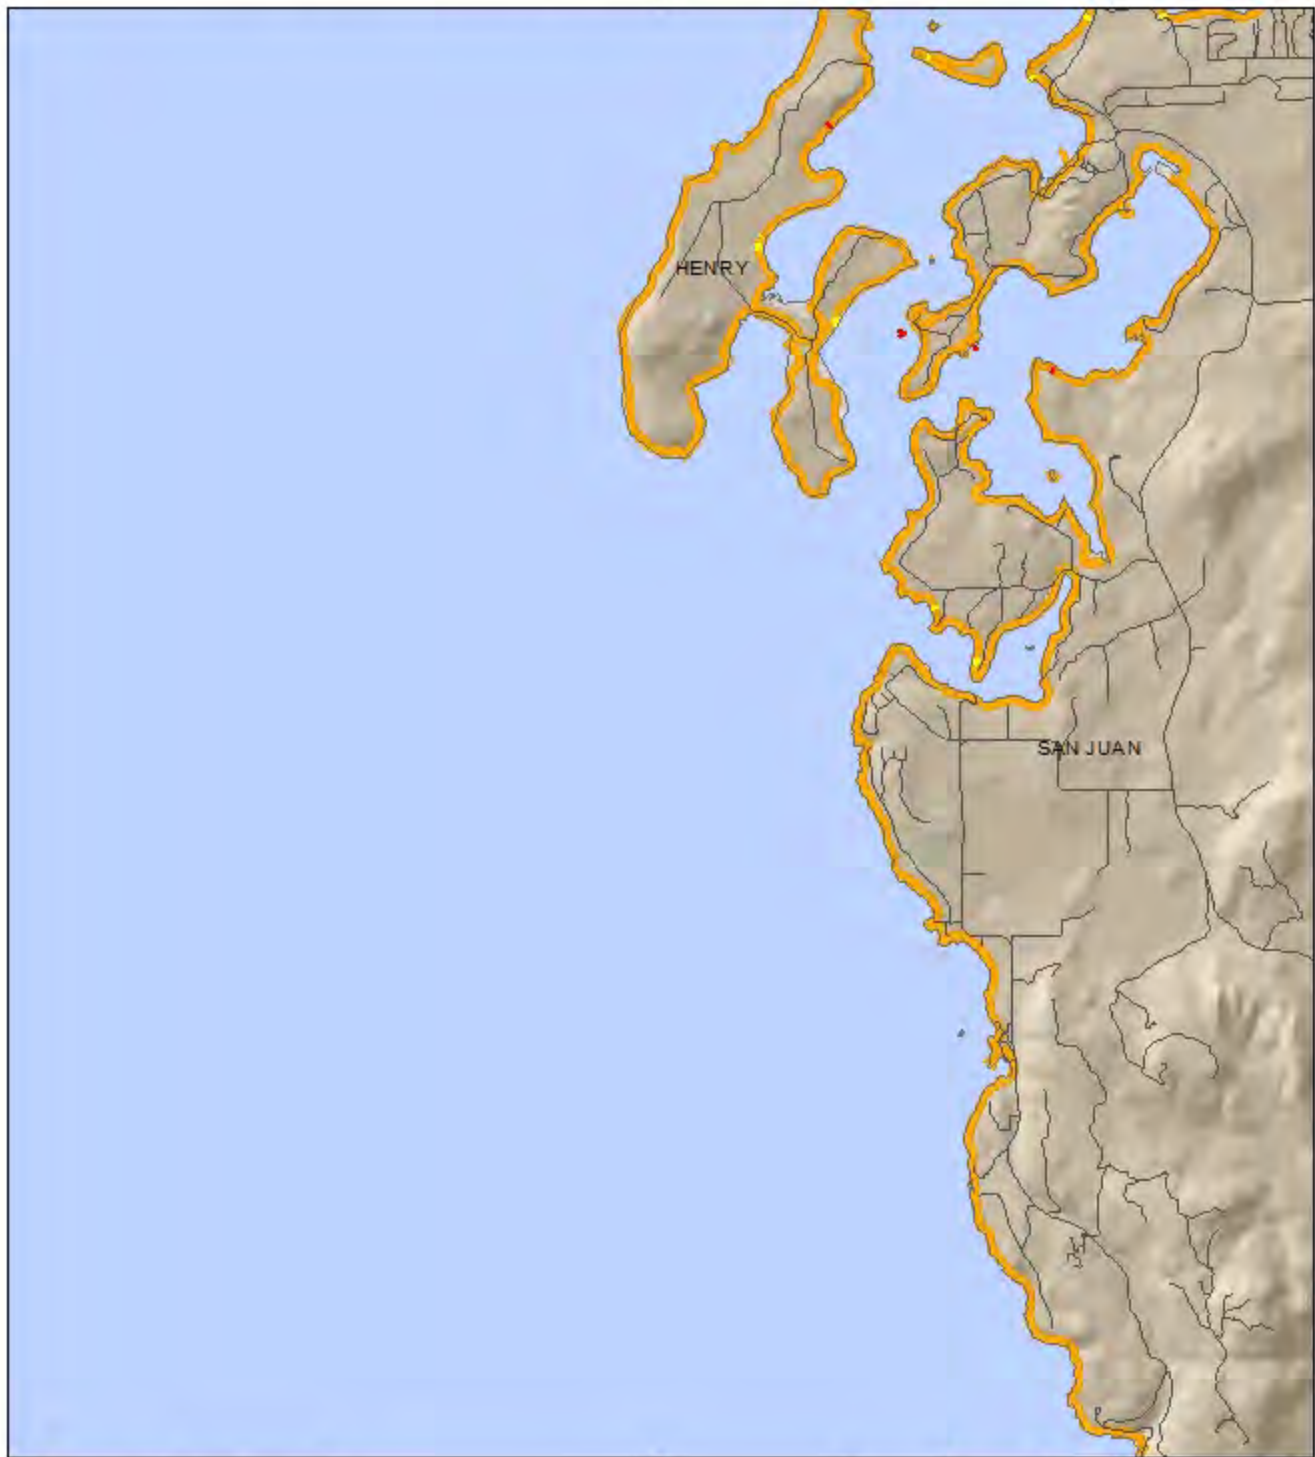
C1

## Shrub Class % of Coverage

Unit of Analysis:  
Length: Geomorphic Shoreform, Width: 200 ft.

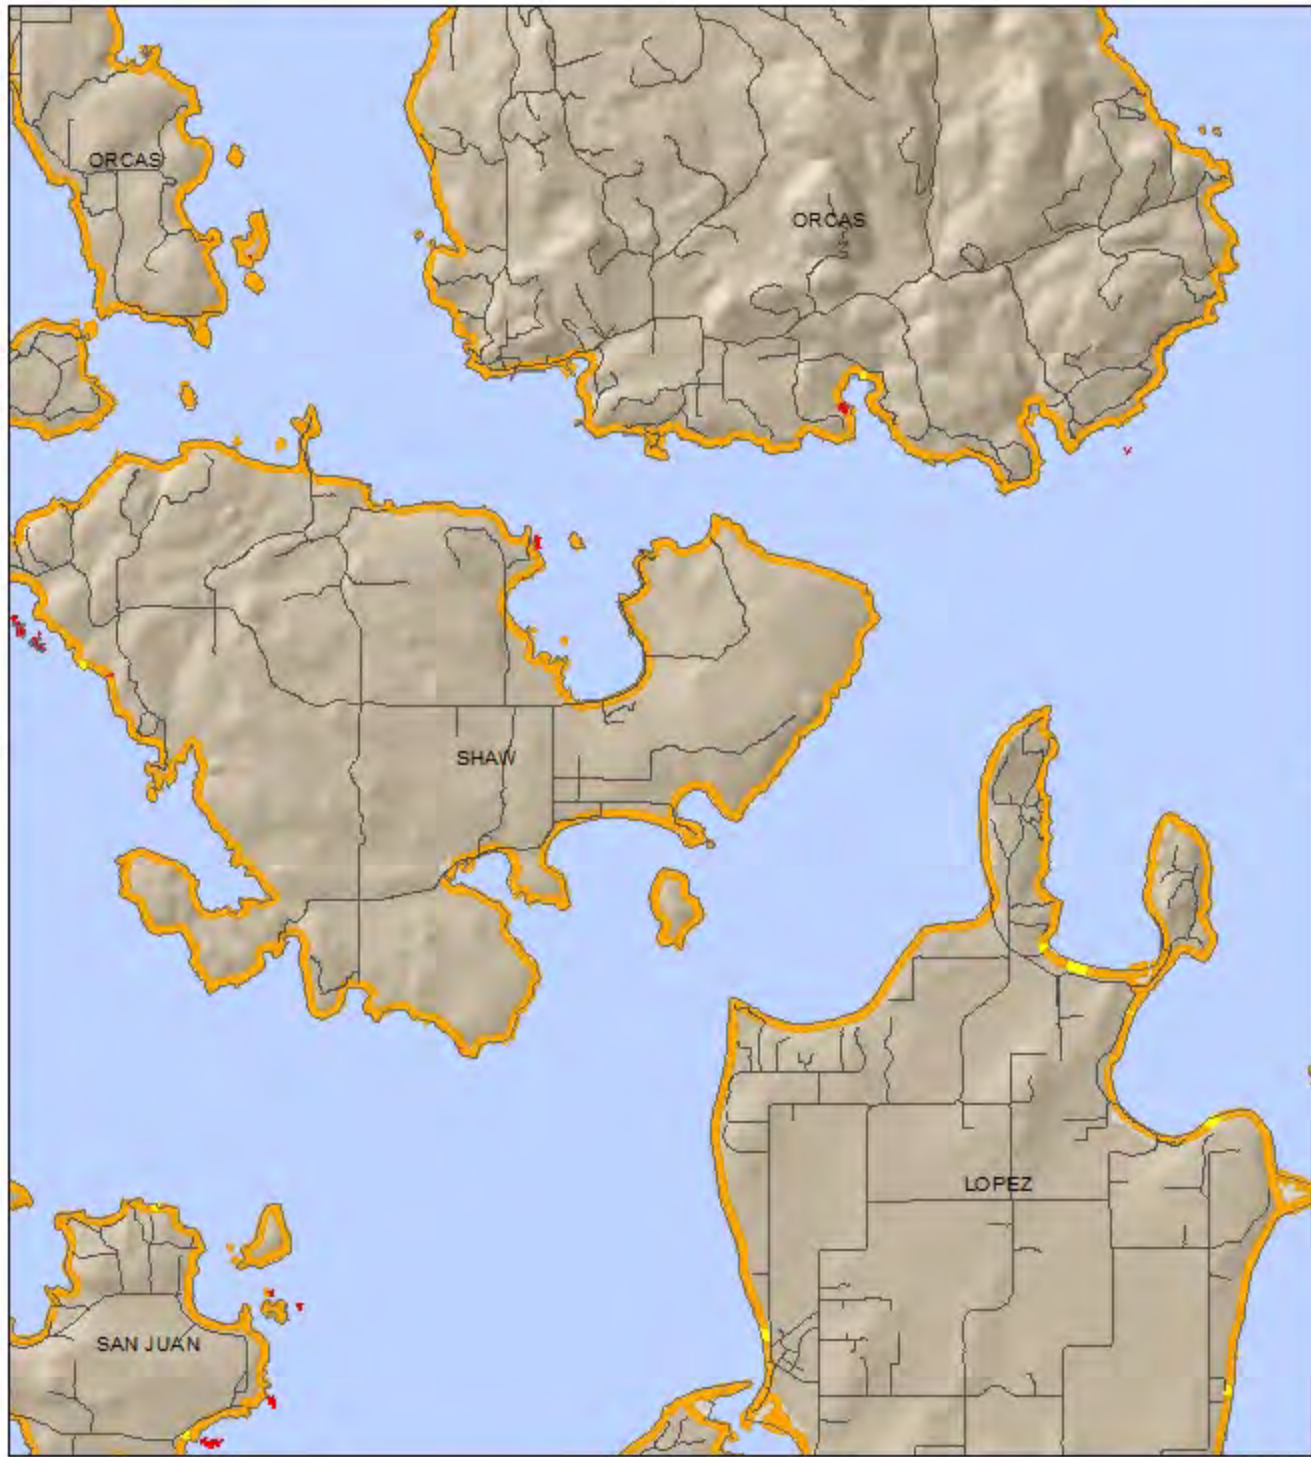
C3

## Shrub Class % of Coverage

Unit of Analysis:  
Length: Geomorphic Shoreform, Width: 200 ft.

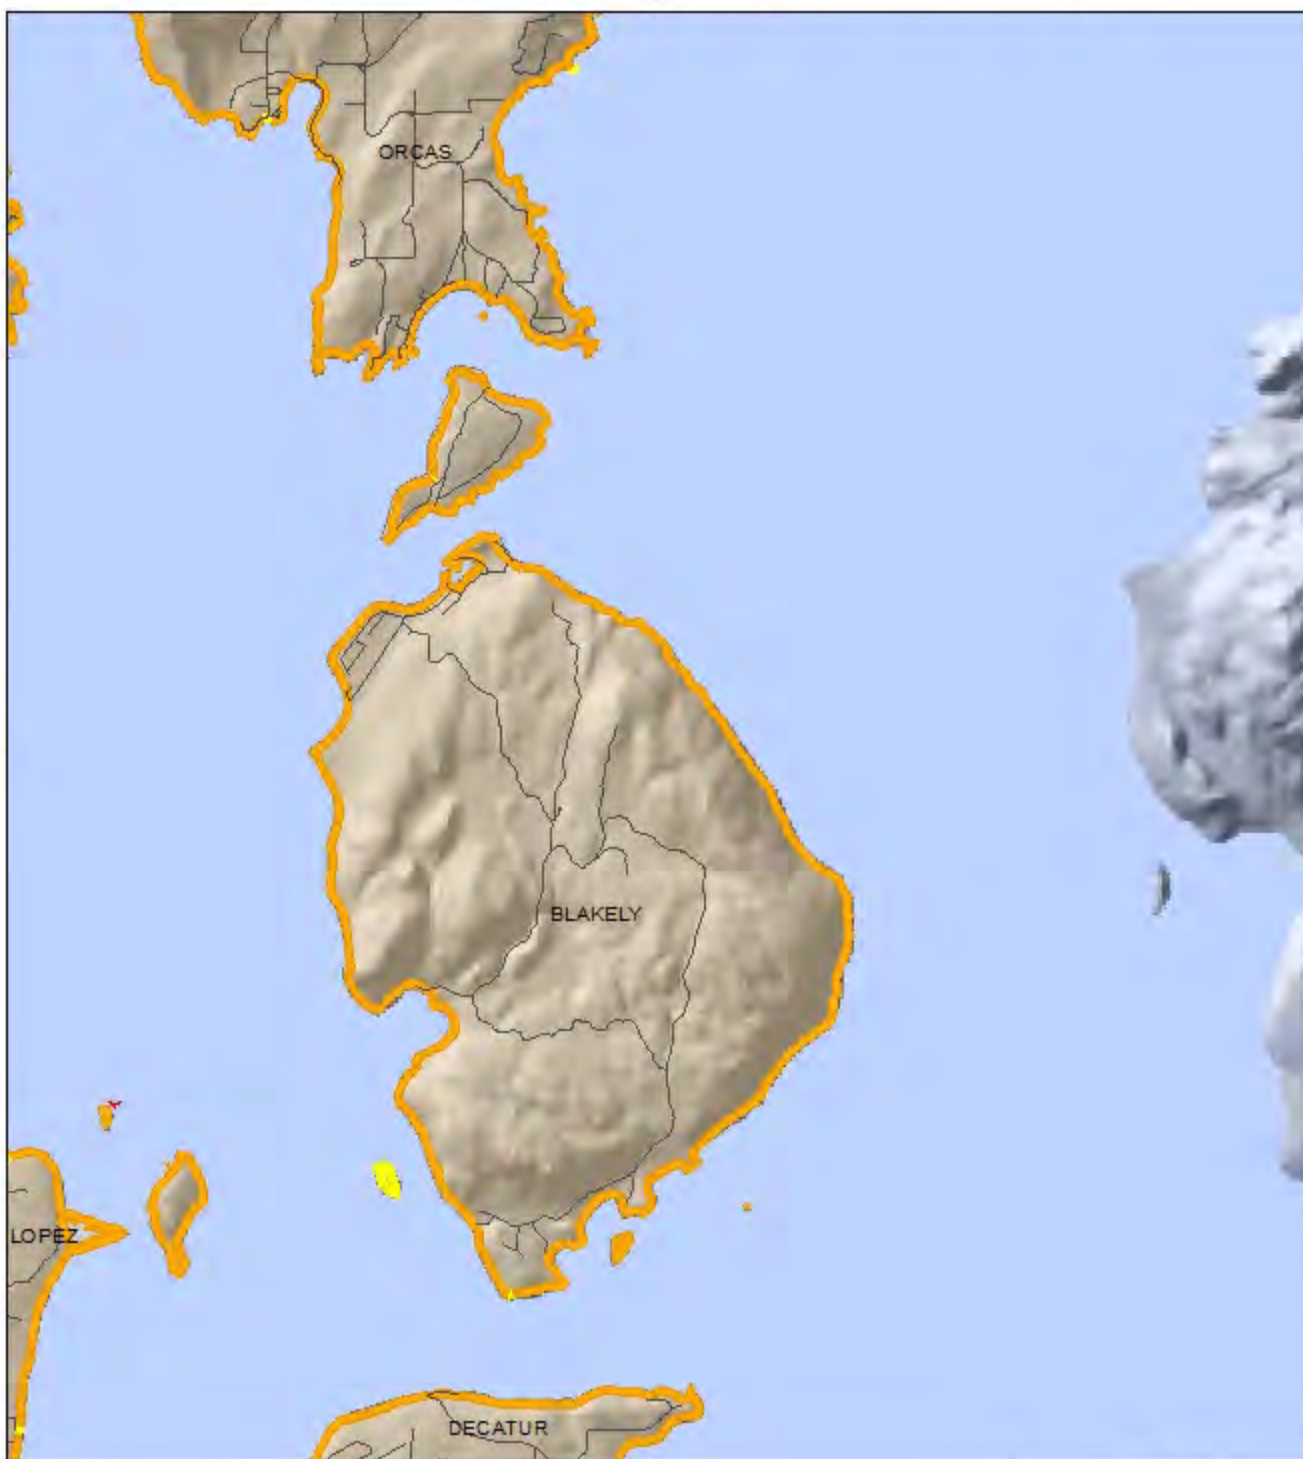
**C4**

- 0 = No Coverage
- 1 = .01-25%
- 2 = 26-50%
- 3 = 51-75%
- 4 = 76-100%

## Shrub Class % of Coverage

Length: Geomorphic Shoreform, Width: 200 ft.

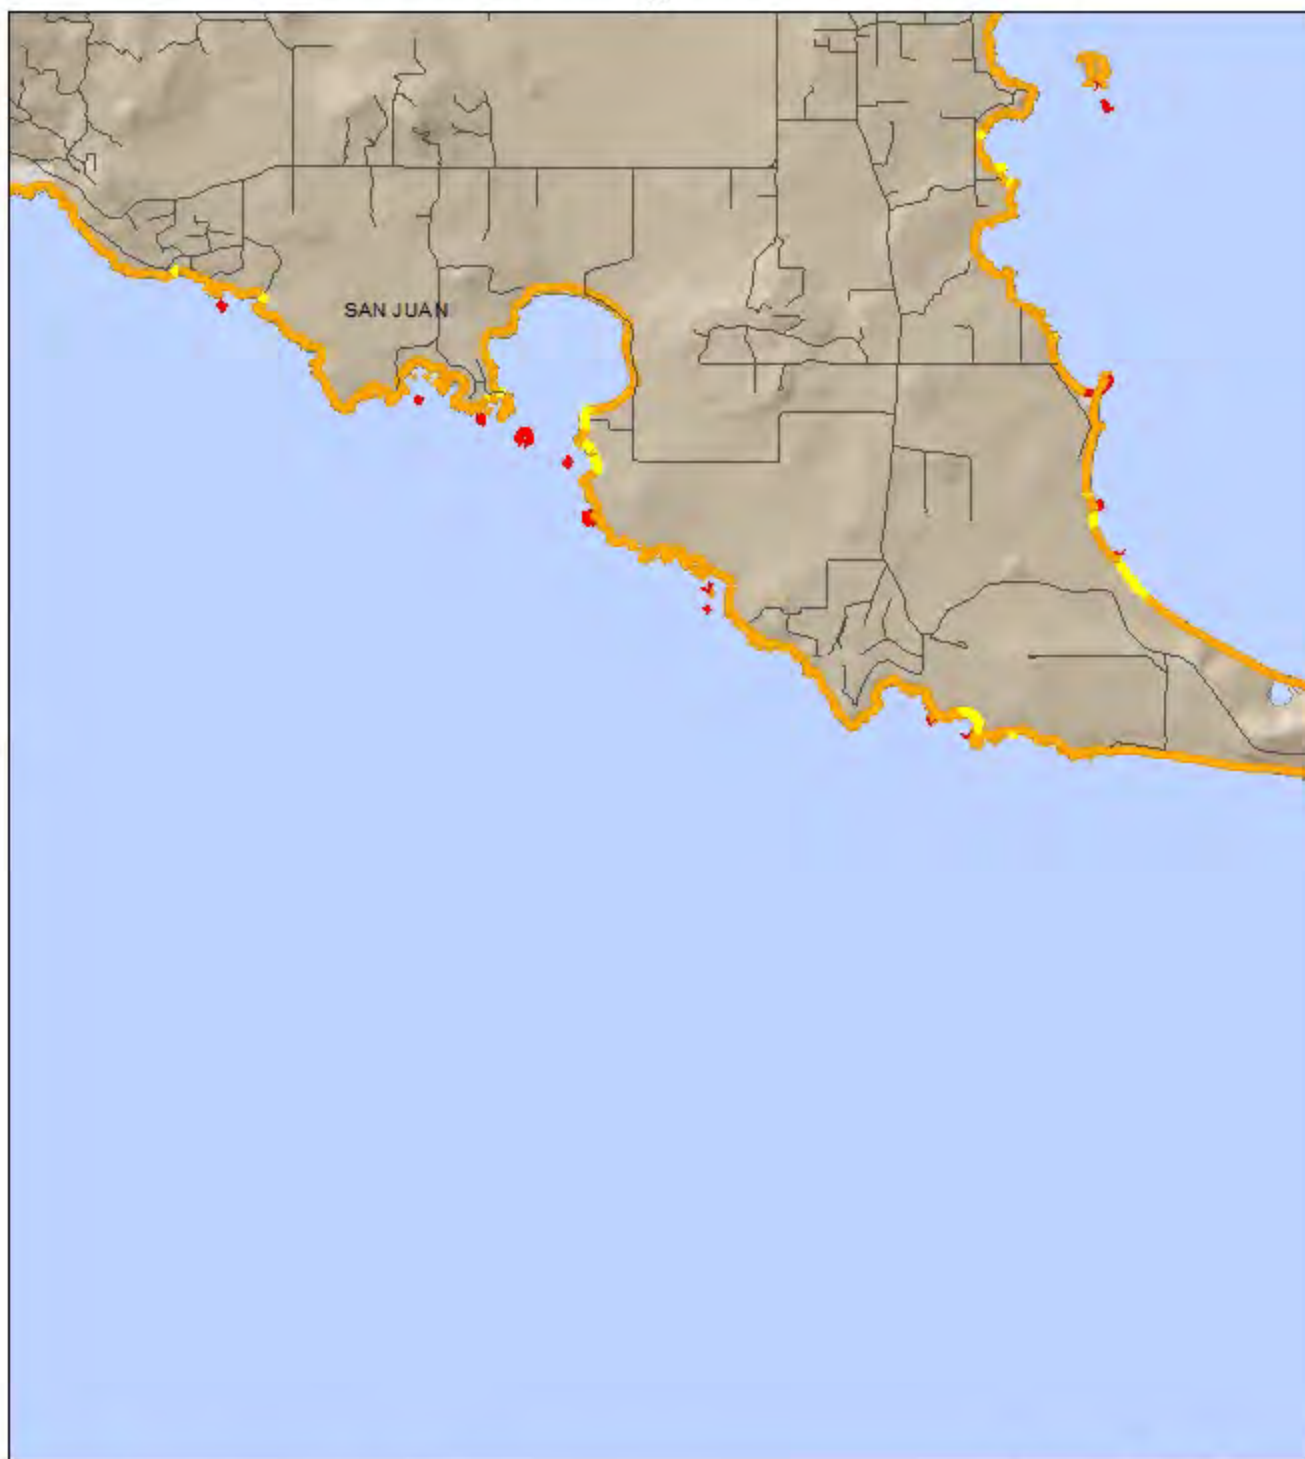
**D2**

- 0 = No Coverage
- 1 = .01-25%
- 2 = 26-50%
- 3 = 51-75%
- 4 = 76-100%

## Shrub Class % of Coverage

Length: Geomorphic Shoreform, Width: 200 ft.
