## APPENDIX B. MARINE RIPARIAN INVENTORY FOR SAN JUAN COUNTY

**San Juan County**  
**Marine Riparian Inventory Mapbook**  
**Forest Coverage Class**

**San Juan County**  
**Marine Riparian Inventory Mapbook**  
**Shrub Coverage Class**

**San Juan County**  
**Marine Riparian Inventory Mapbook**  
**Below 2 Ft. Vegetated Coverage Class**

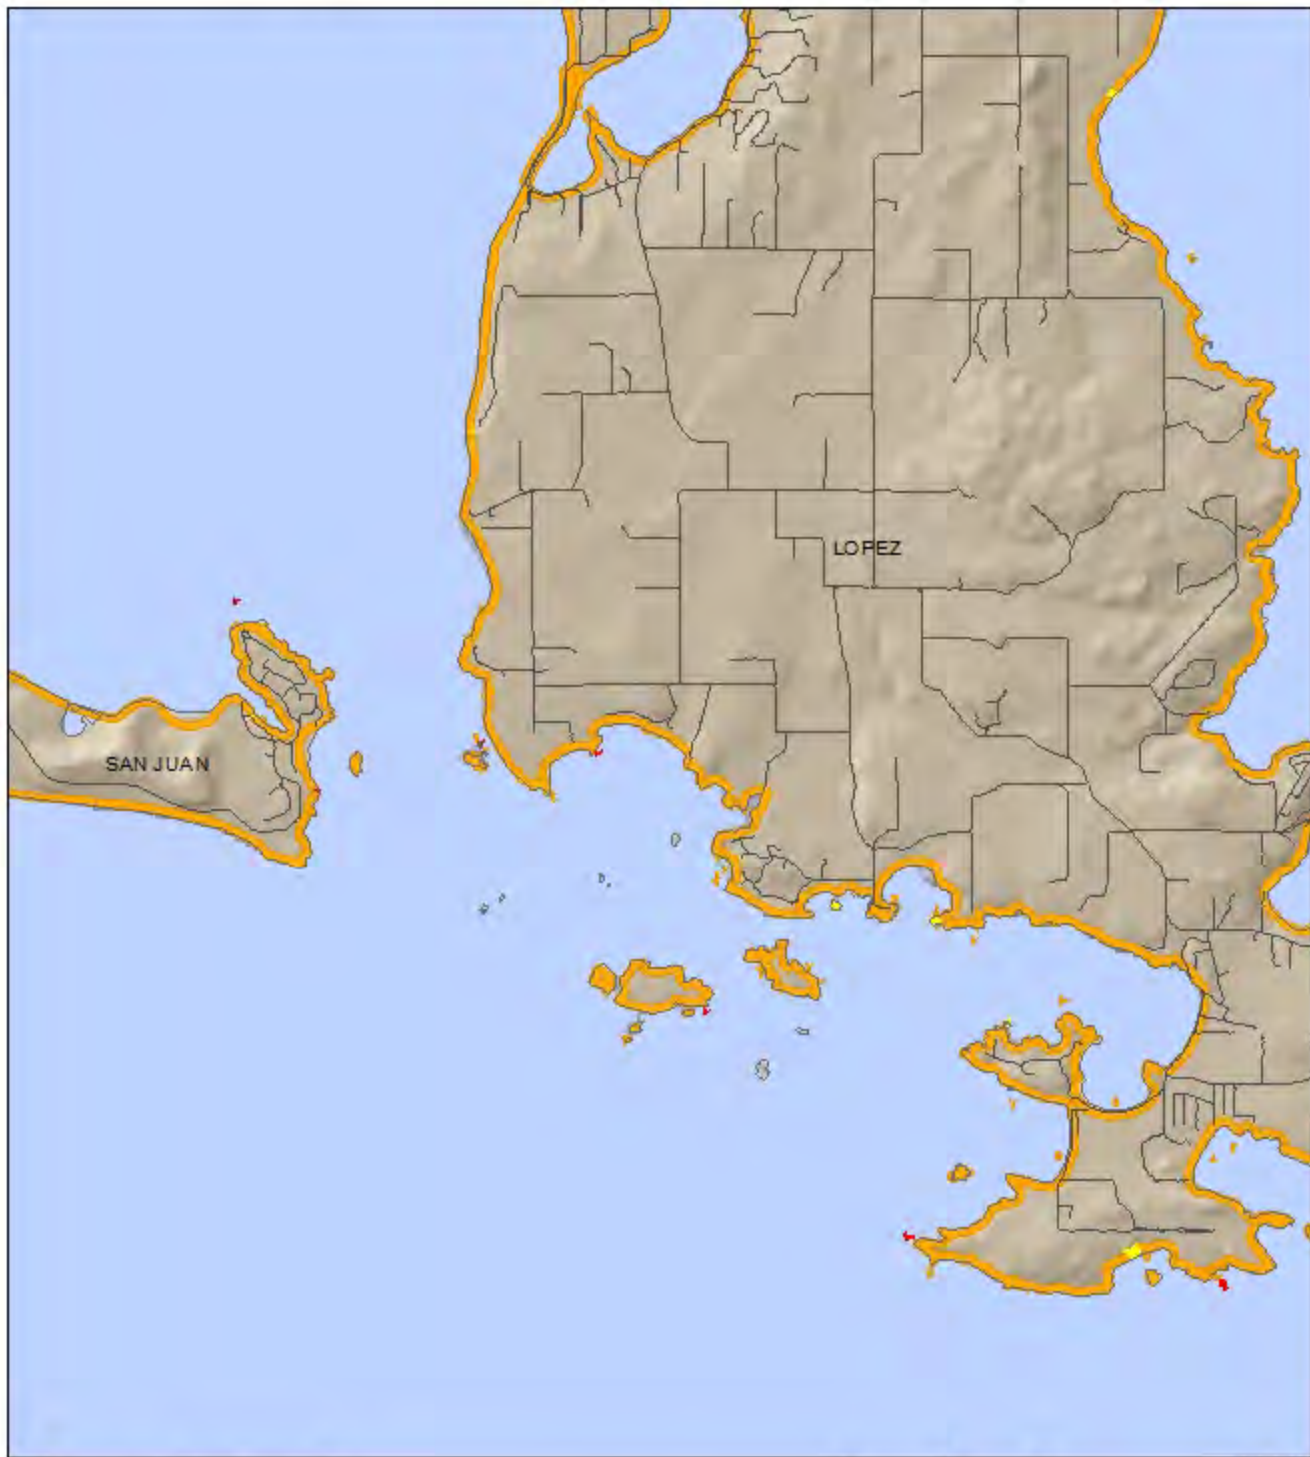
**D3**

## Shrub Class % of Coverage

Unit of Analysis:  
Length: Geomorphic Shoreform, Width: 200 ft.

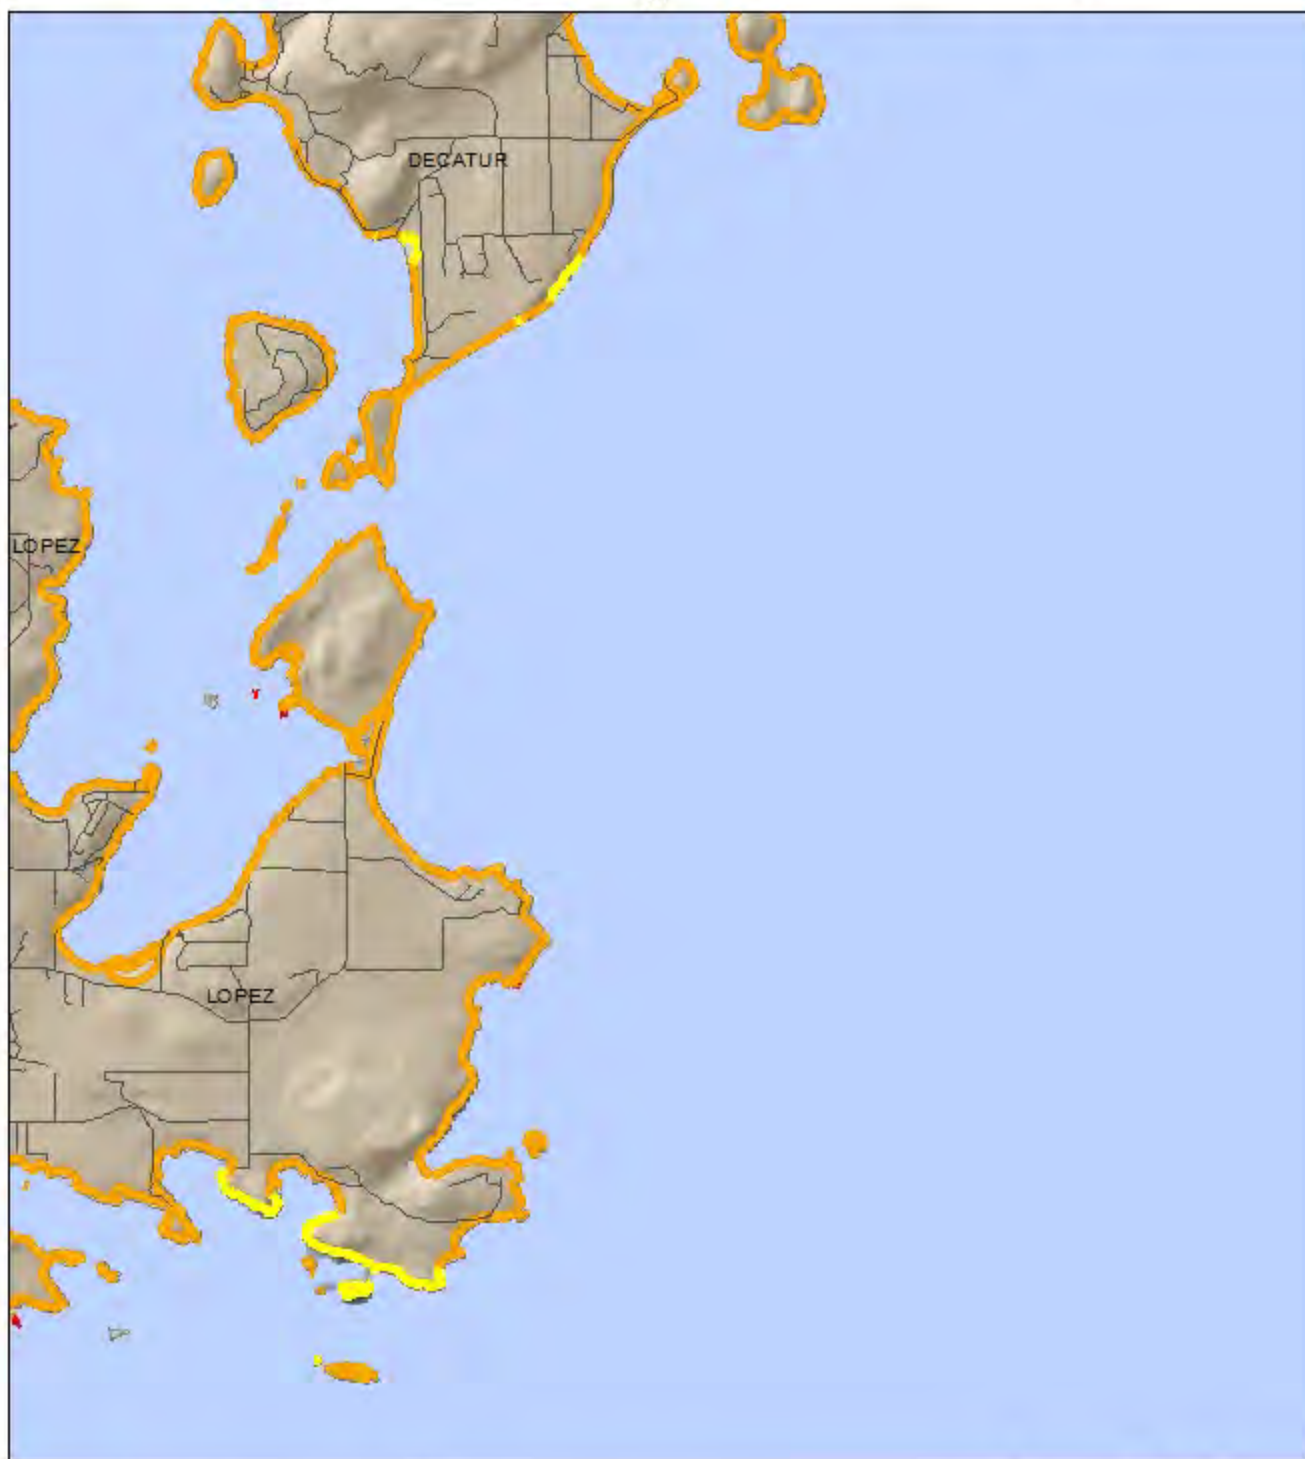
# D4

- 0 = No Coverage
- 1 = .01-25%
- 2 = 26-50%
- 3 = 51-75%
- 4 = 76-100%

## Shrub Class % of Coverage

Length: Geomorphic Shoreform, Width: 200 ft.

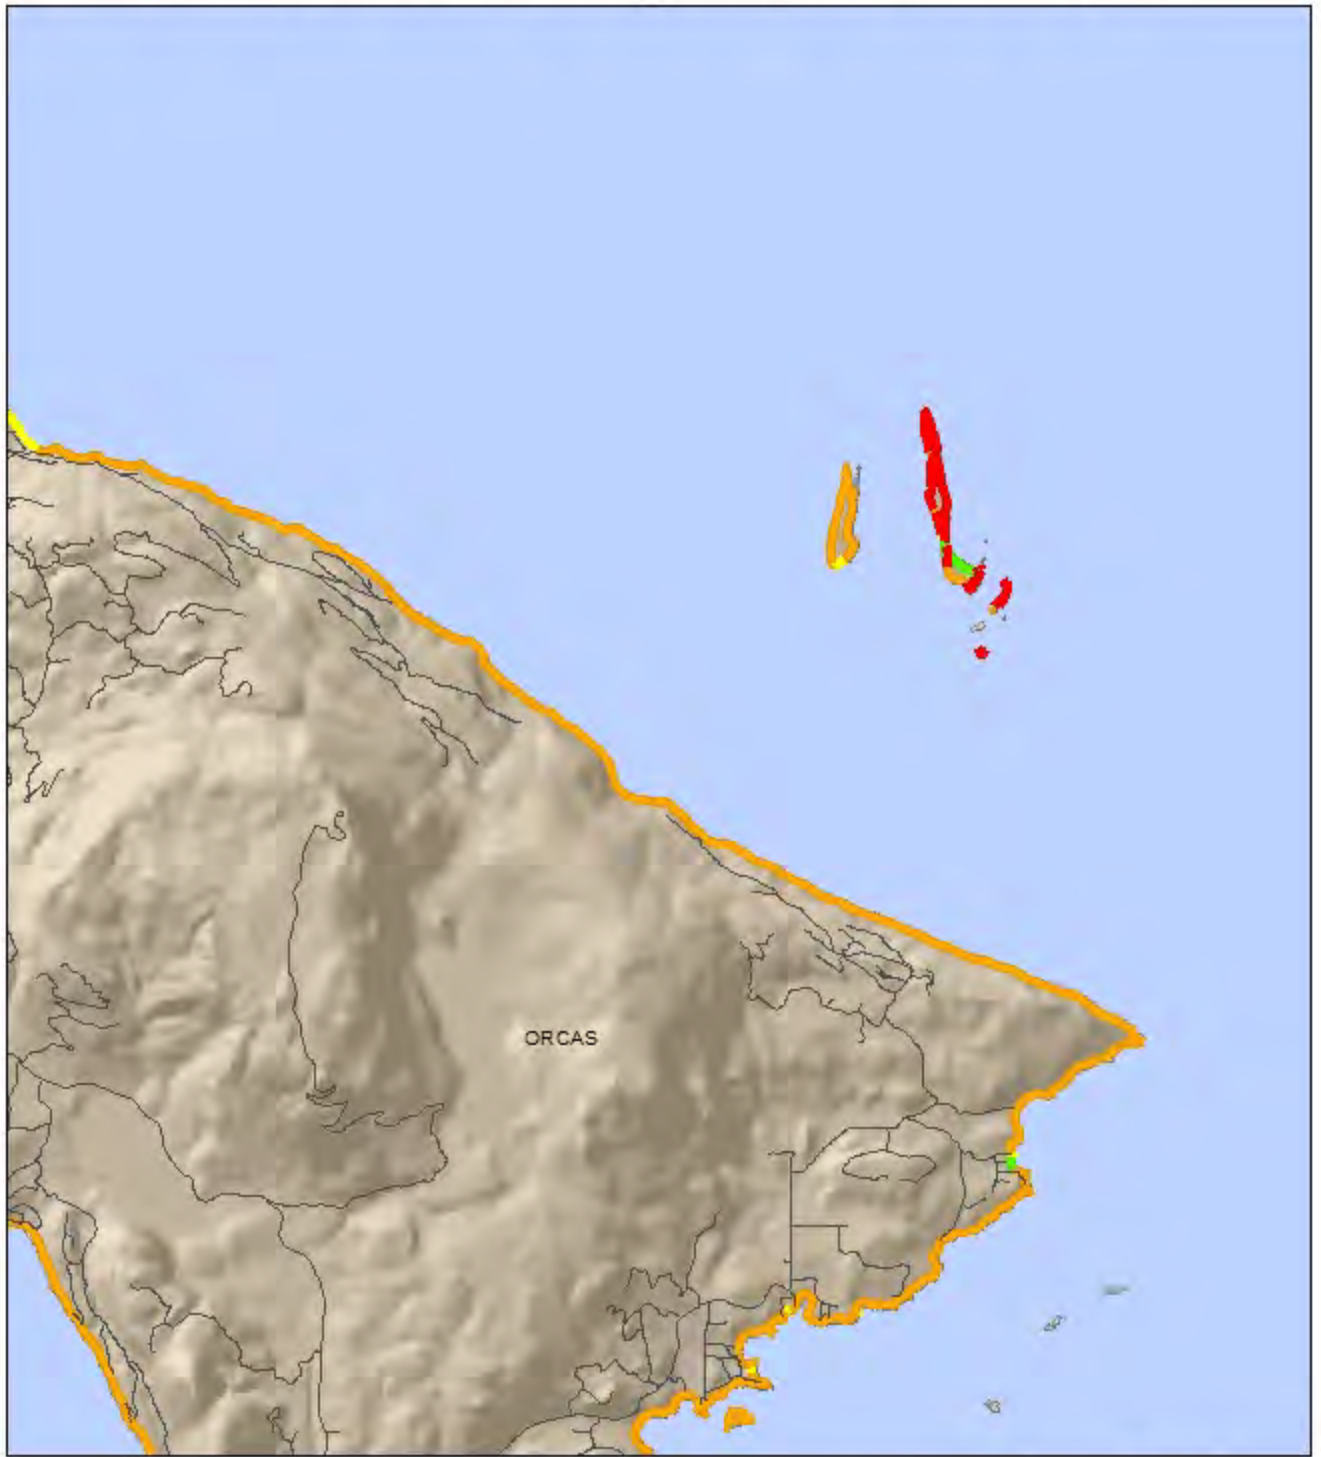
**B4**

- 0 = No Coverage
- 1 = .01-25%
- 2 = 26-50%
- 3 = 51-75%
- 4 = 76-100%

**Below 2 Ft. Vegetated  
% of Coverage**

Unit of Analysis:  
Length: Geomorphic Shoreform, Width: 200 ft.

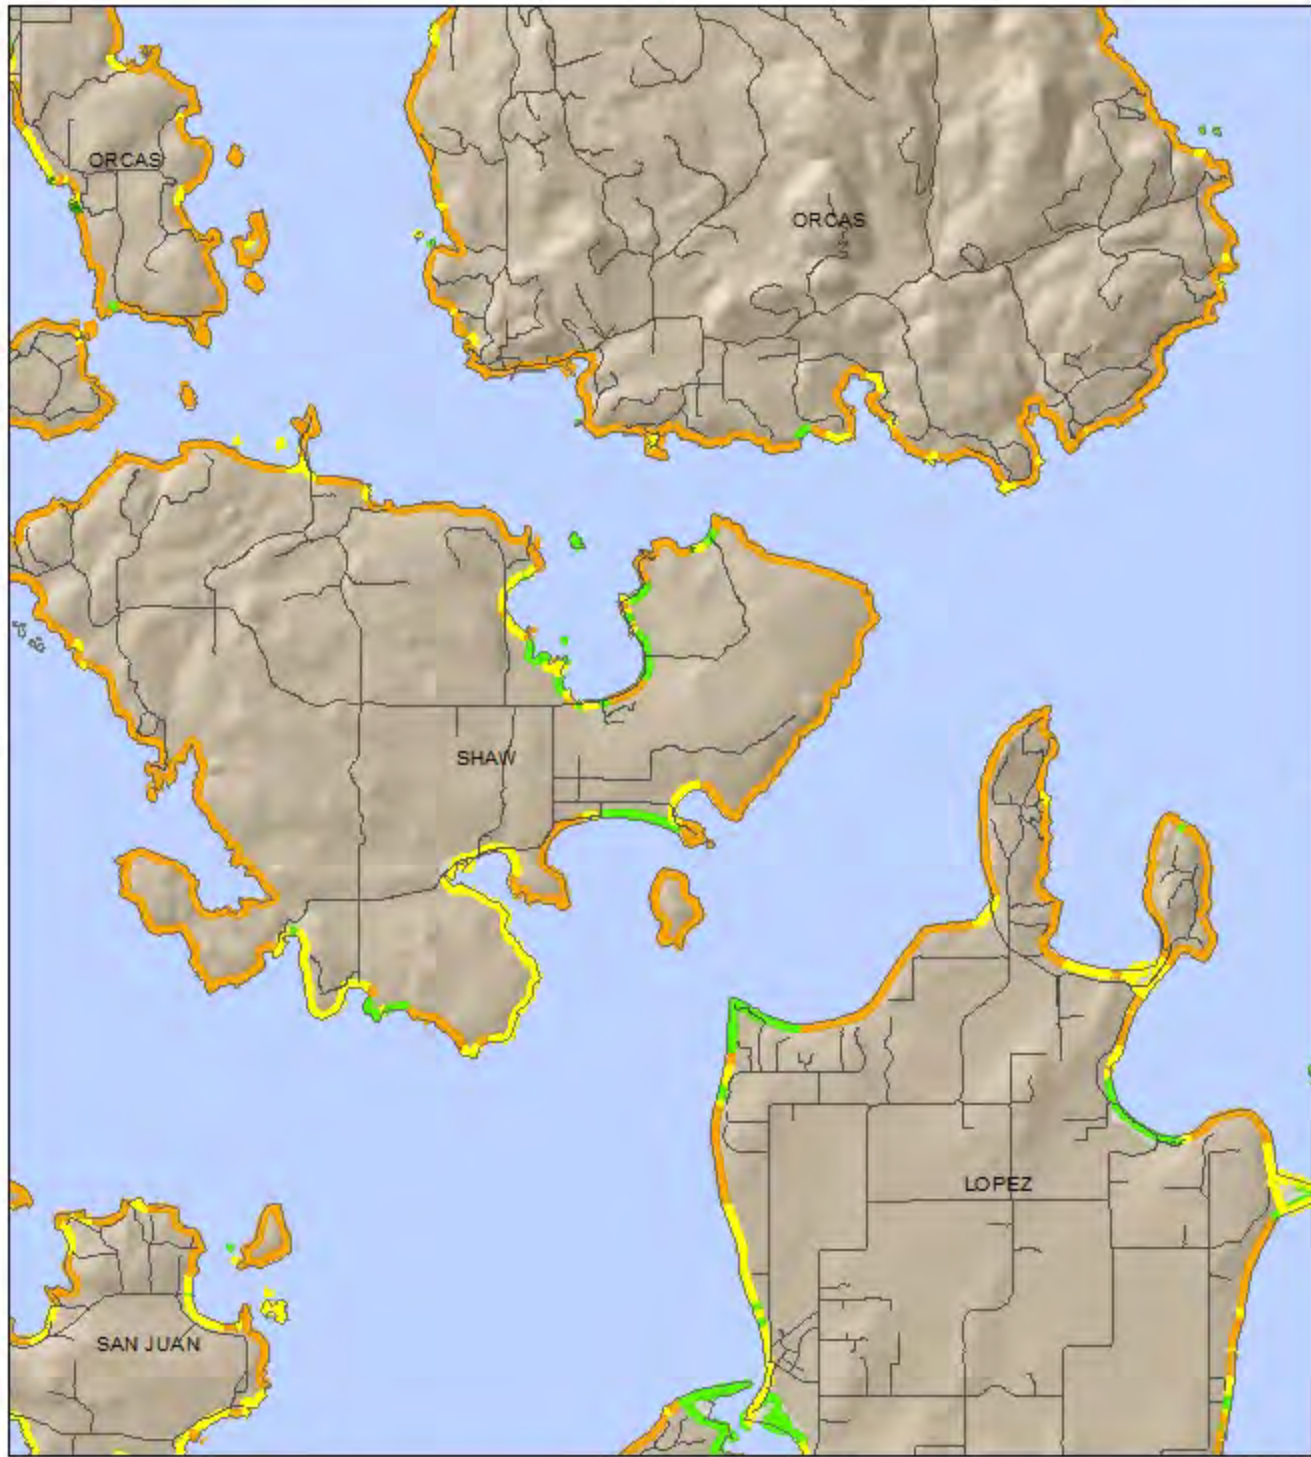
C3

## Below 2 Ft. Vegetated % of Coverage

Unit of Analysis:  
Length: Geomorphic Shoreform, Width: 200 ft.

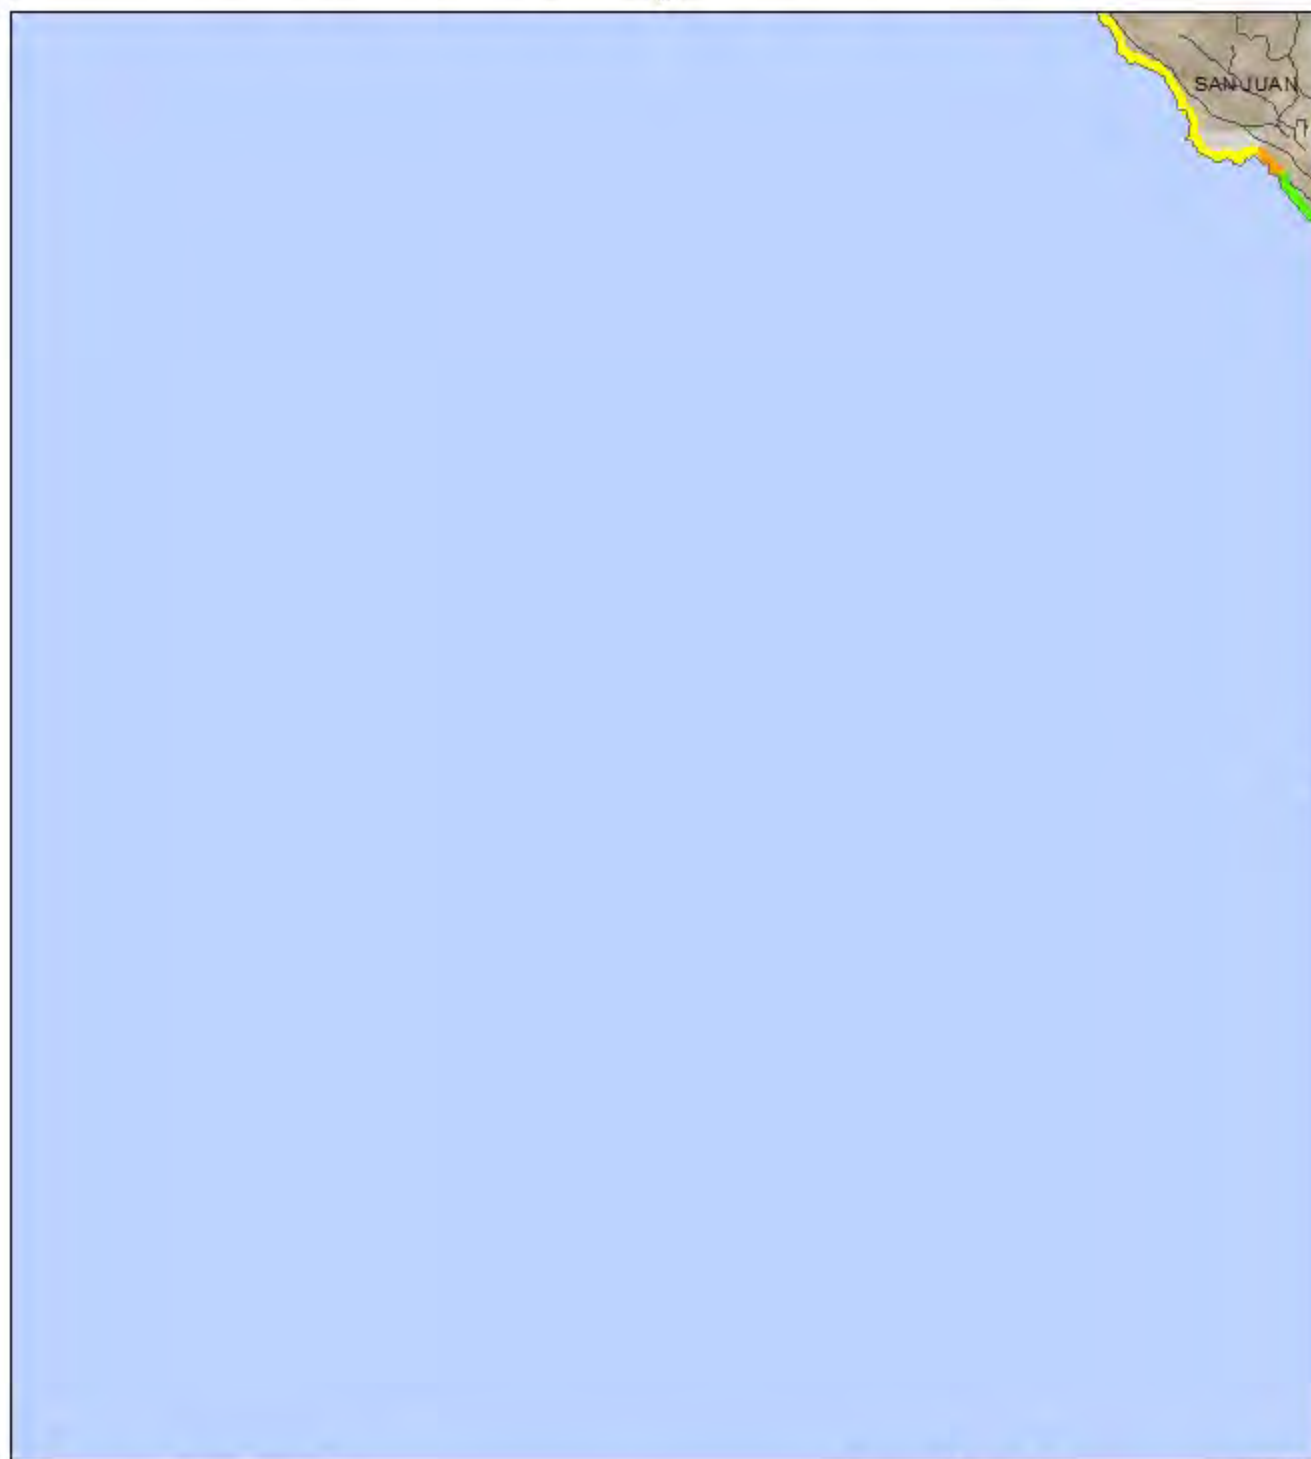
D1

## Below 2 Ft. Vegetated % of Coverage

Unit of Analysis:  
Length: Geomorphic Shoreform, Width: 200 ft.

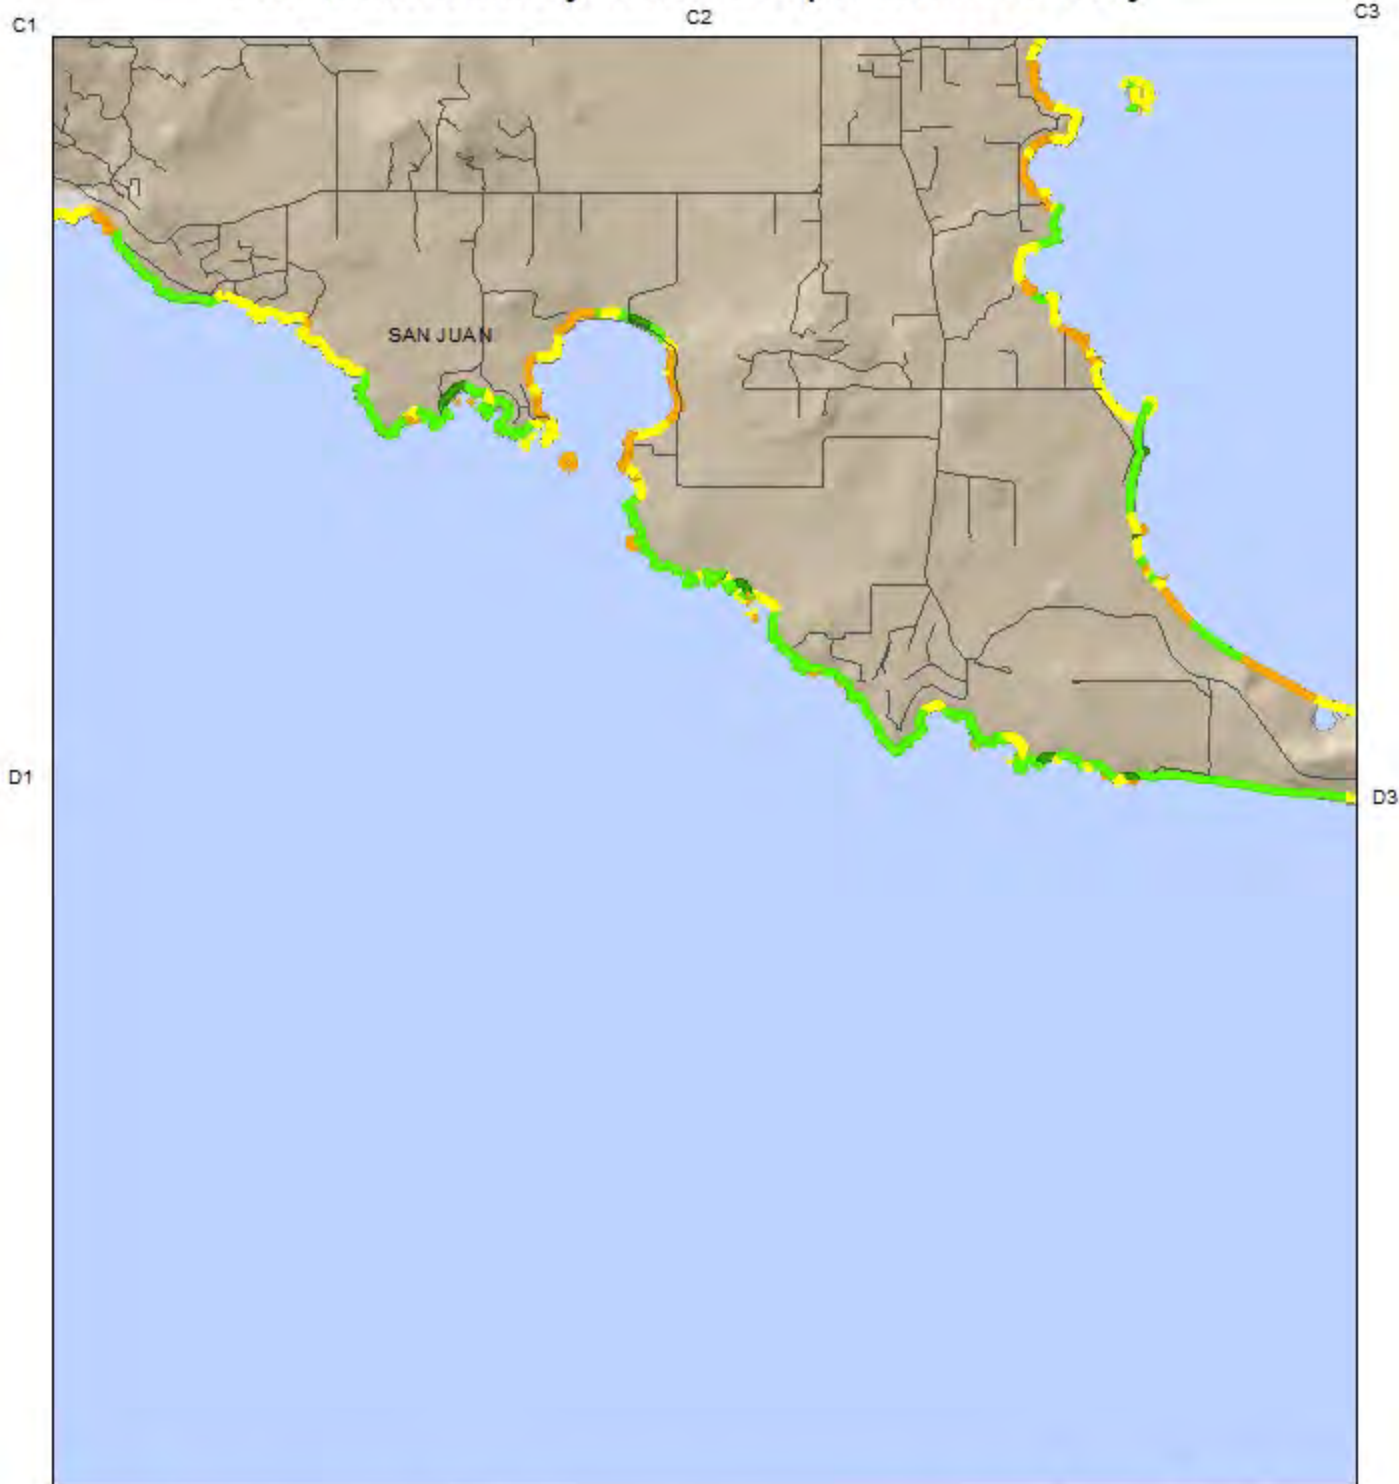
**D2**

- 0 = No Coverage
- 1 = .01-25%
- 2 = 26-50%
- 3 = 51-75%
- 4 = 76-100%

**Below 2 Ft. Vegetated  
% of Coverage**

Unit of Analysis:  
Length: Geomorphic Shoreform, Width: 200 ft.

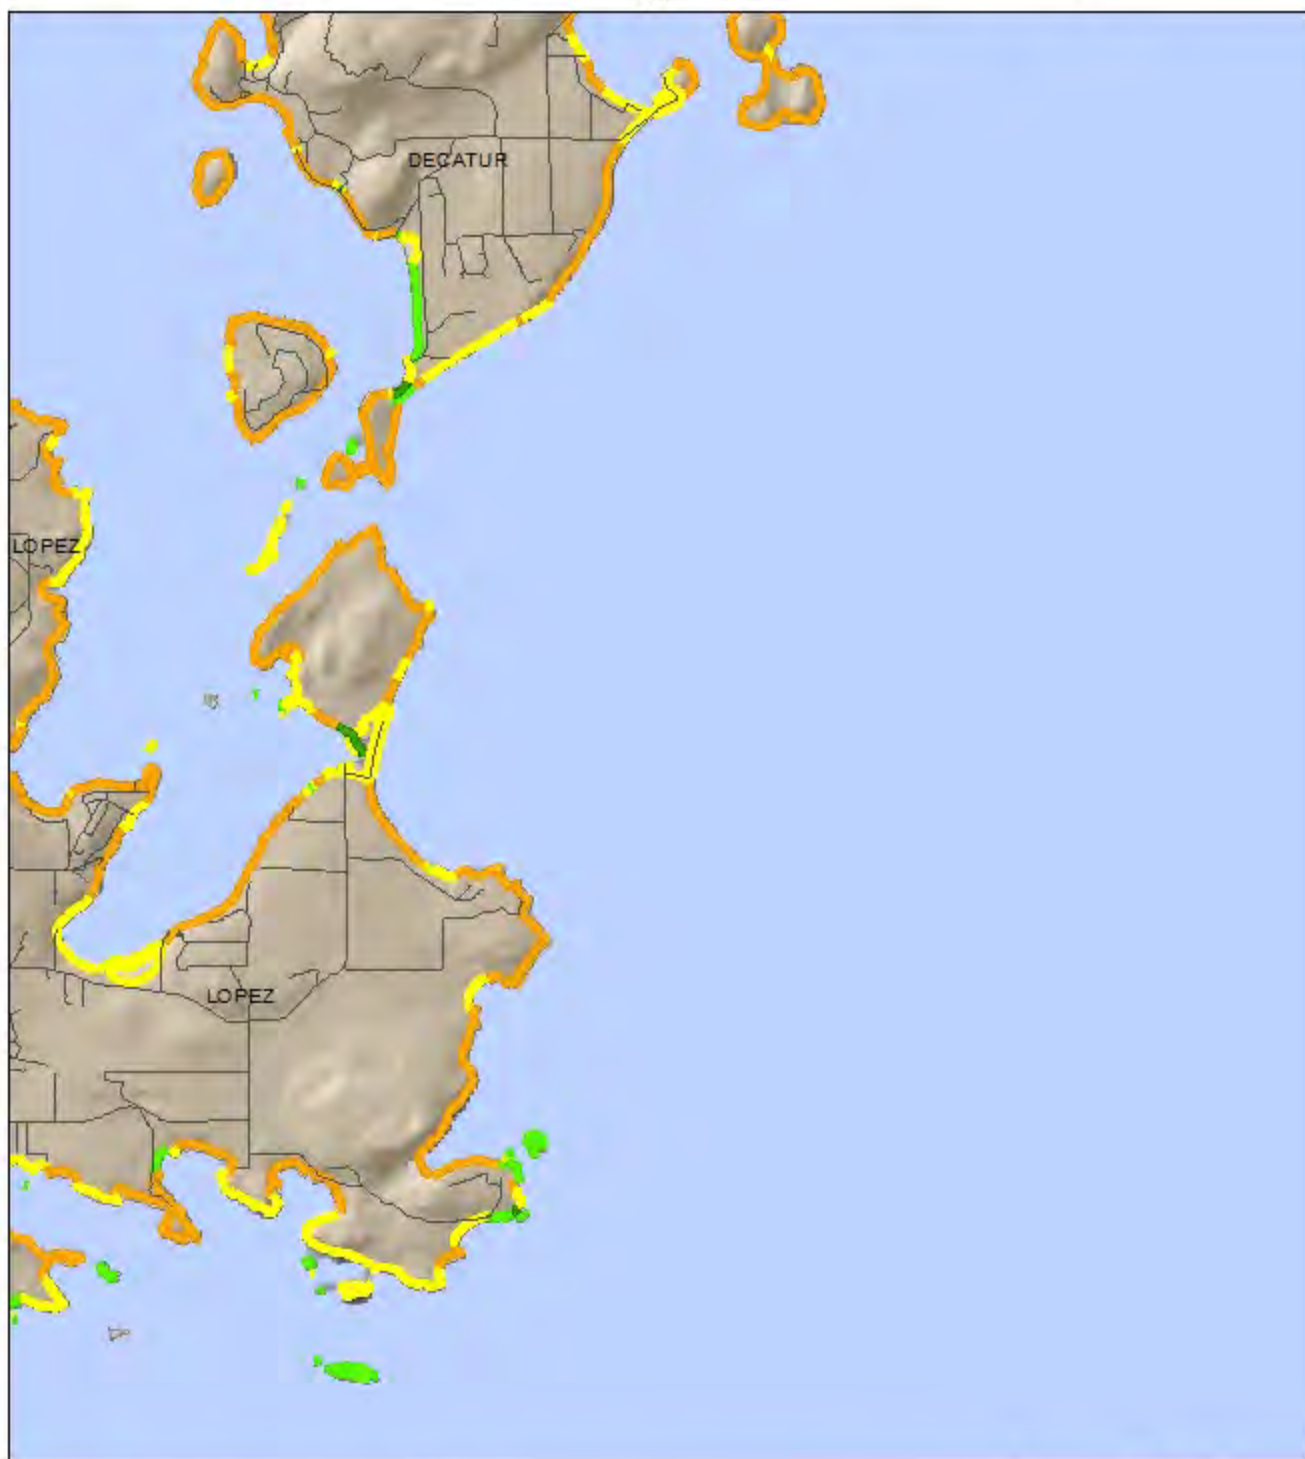
**D4**

- 0 = No Coverage
- 1 = .01-25%
- 2 = 26-50%
- 3 = 51-75%
- 4 = 76-100%

**Below 2 Ft. Vegetated  
% of Coverage**

Length: Geomorphic Shoreform, Width: 200 ft.

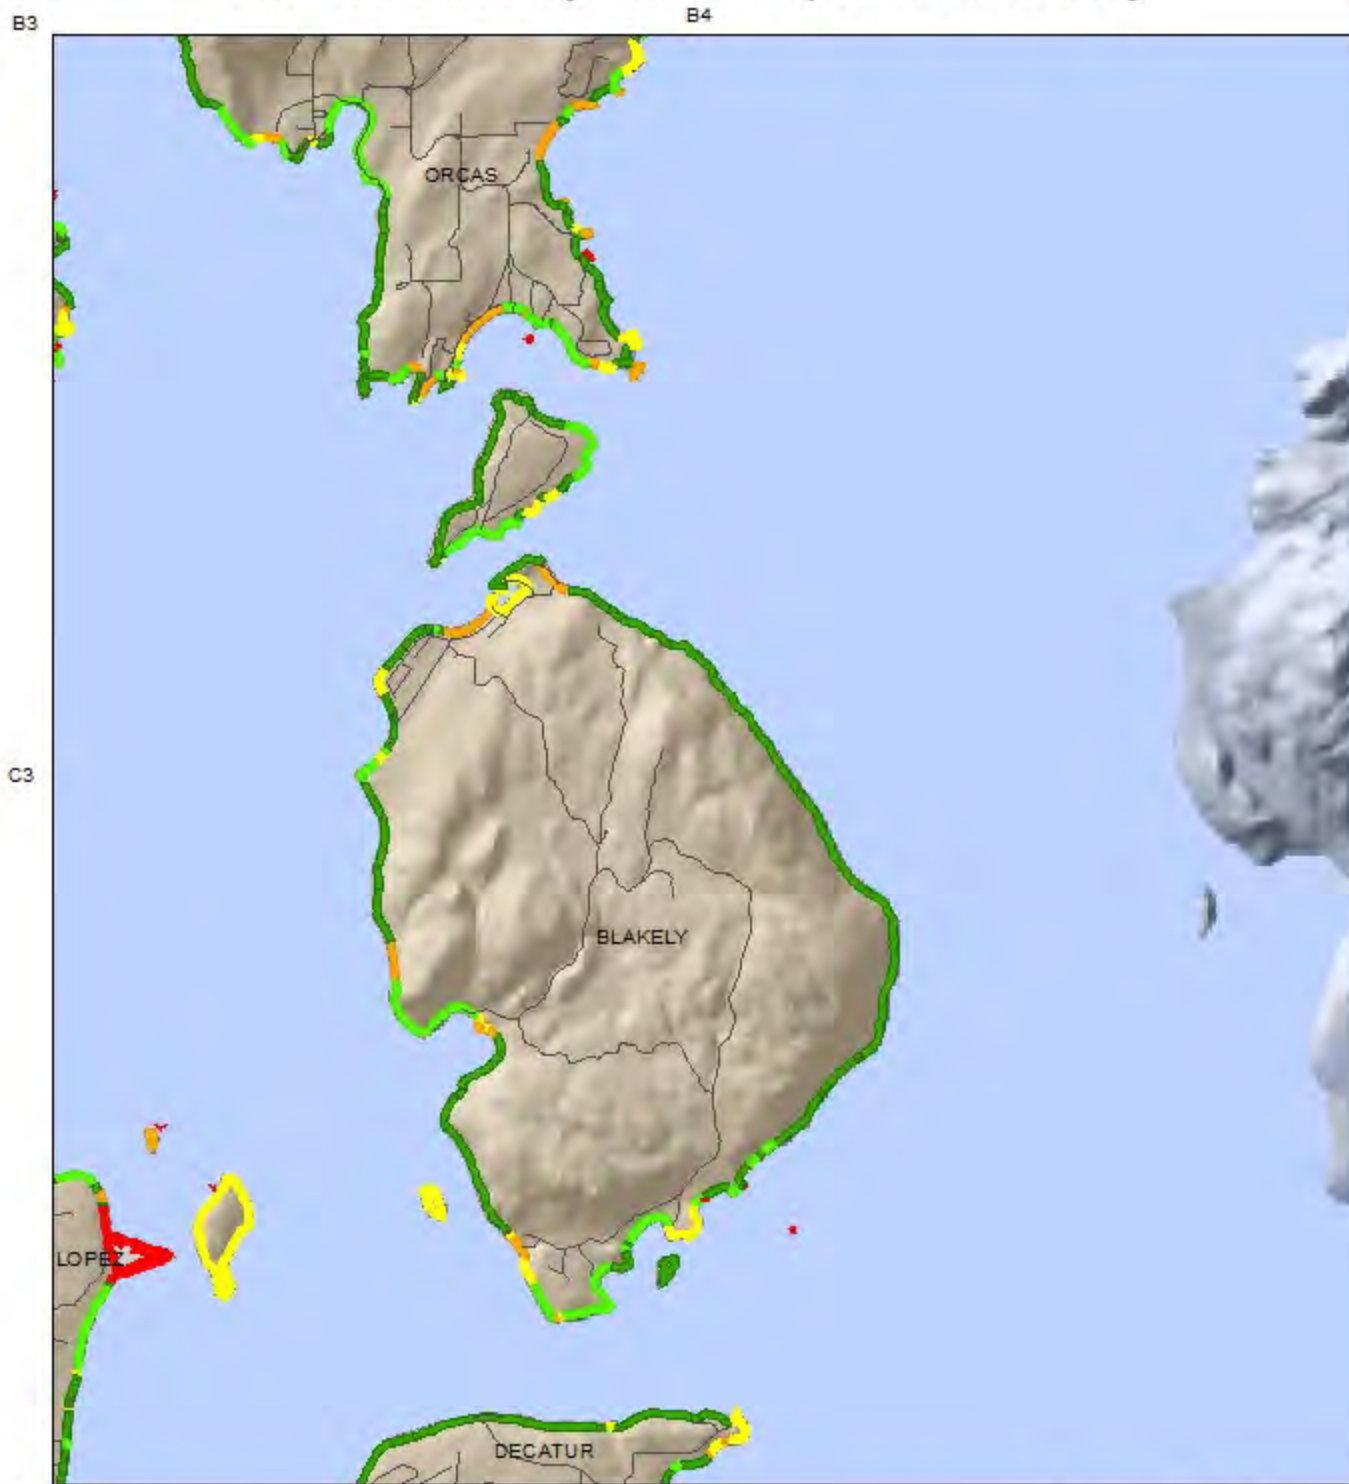
**C4**

- 0 = No Coverage
- 1 = .01-25%
- 2 = 26-50%
- 3 = 51-75%
- 4 = 76-100%

**Overhanging Vegetation  
% of Coverage at Shoreline**

Unit of Analysis:  
Geomorphic Shoreform

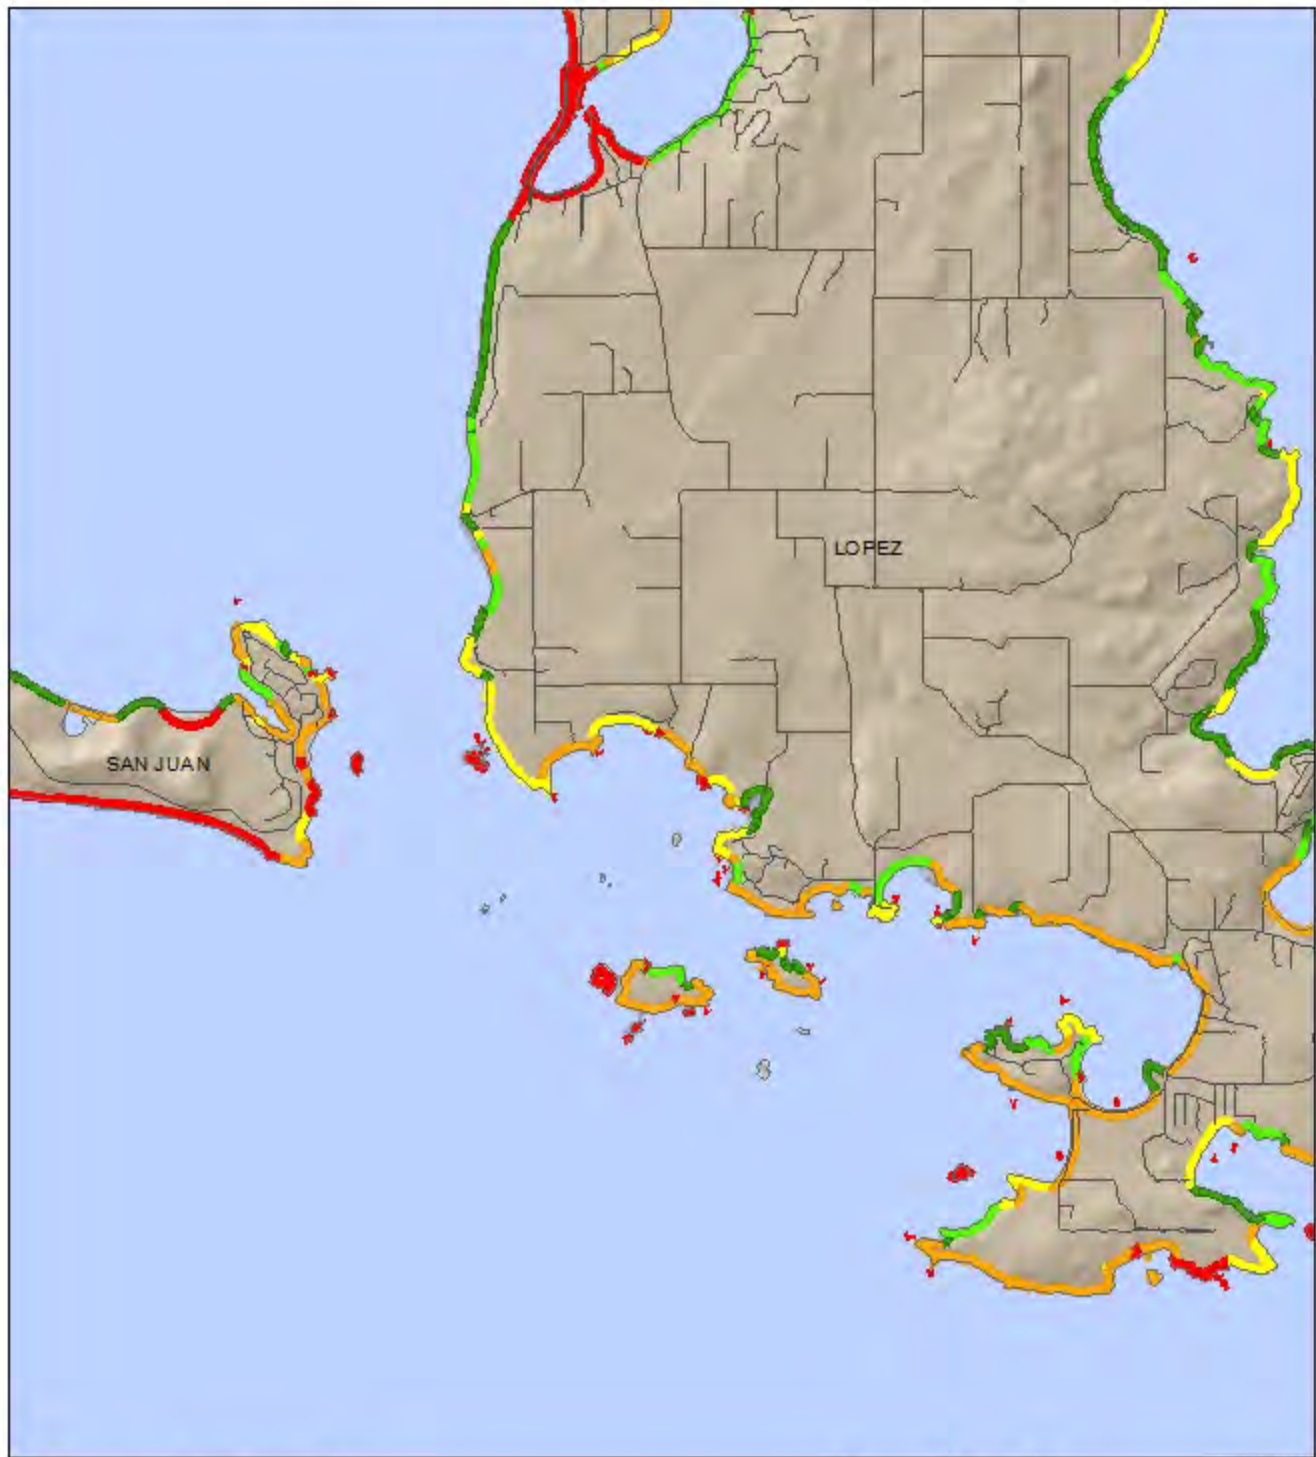
**D3**

## Overhanging Vegetation % of Coverage at Shoreline

Unit of Analysis:  
Geomorphic Shoreform

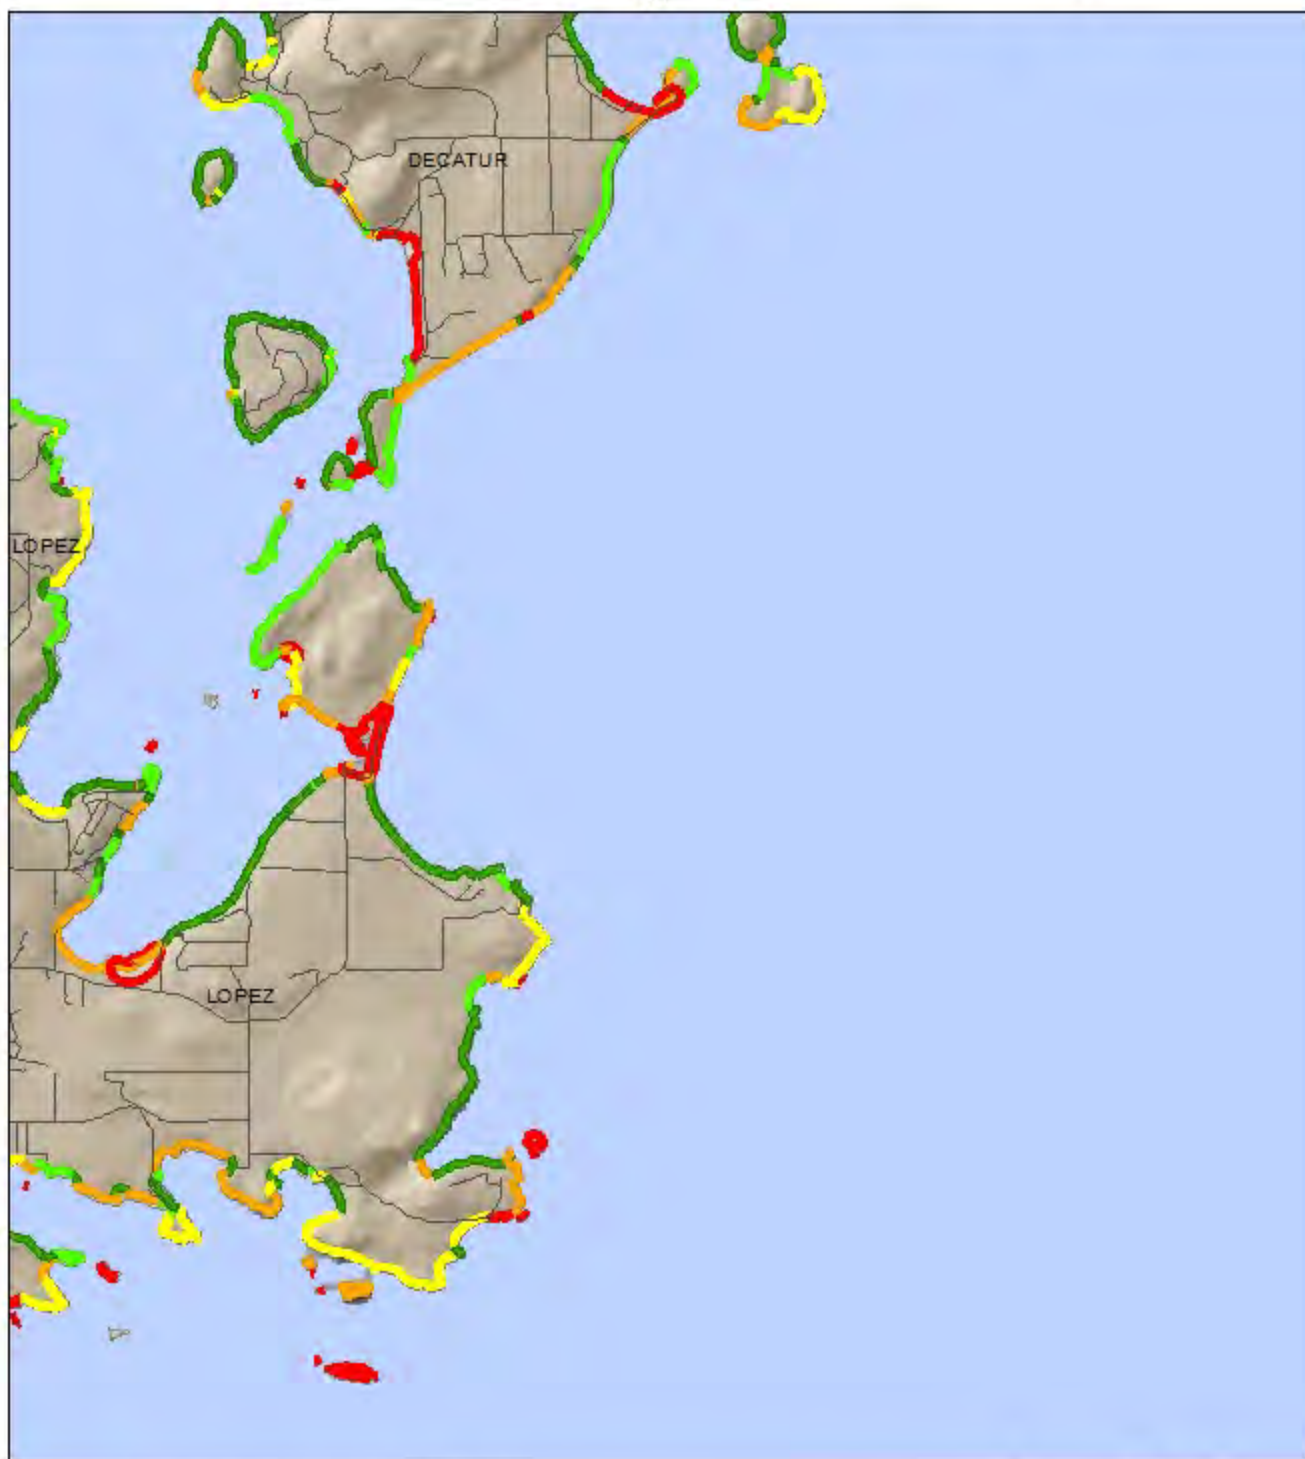
**D4**

- 0 = No Coverage
- 1 = .01-25%
- 2 = 26-50%
- 3 = 51-75%
- 4 = 76-100%

**Overhanging Vegetation  
% of Coverage at Shoreline**

Unit of Analysis:  
Geomorphic Shoreform
