Changes in Shoreline Armoring in San Juan County, Washington, 2009–2019: *Mapping, Analysis, and Regulatory Review*

Tina Whitman, Science Director

Friends of the San Juans

San Juan County Armor Change Analysis and Regulatory Review Project

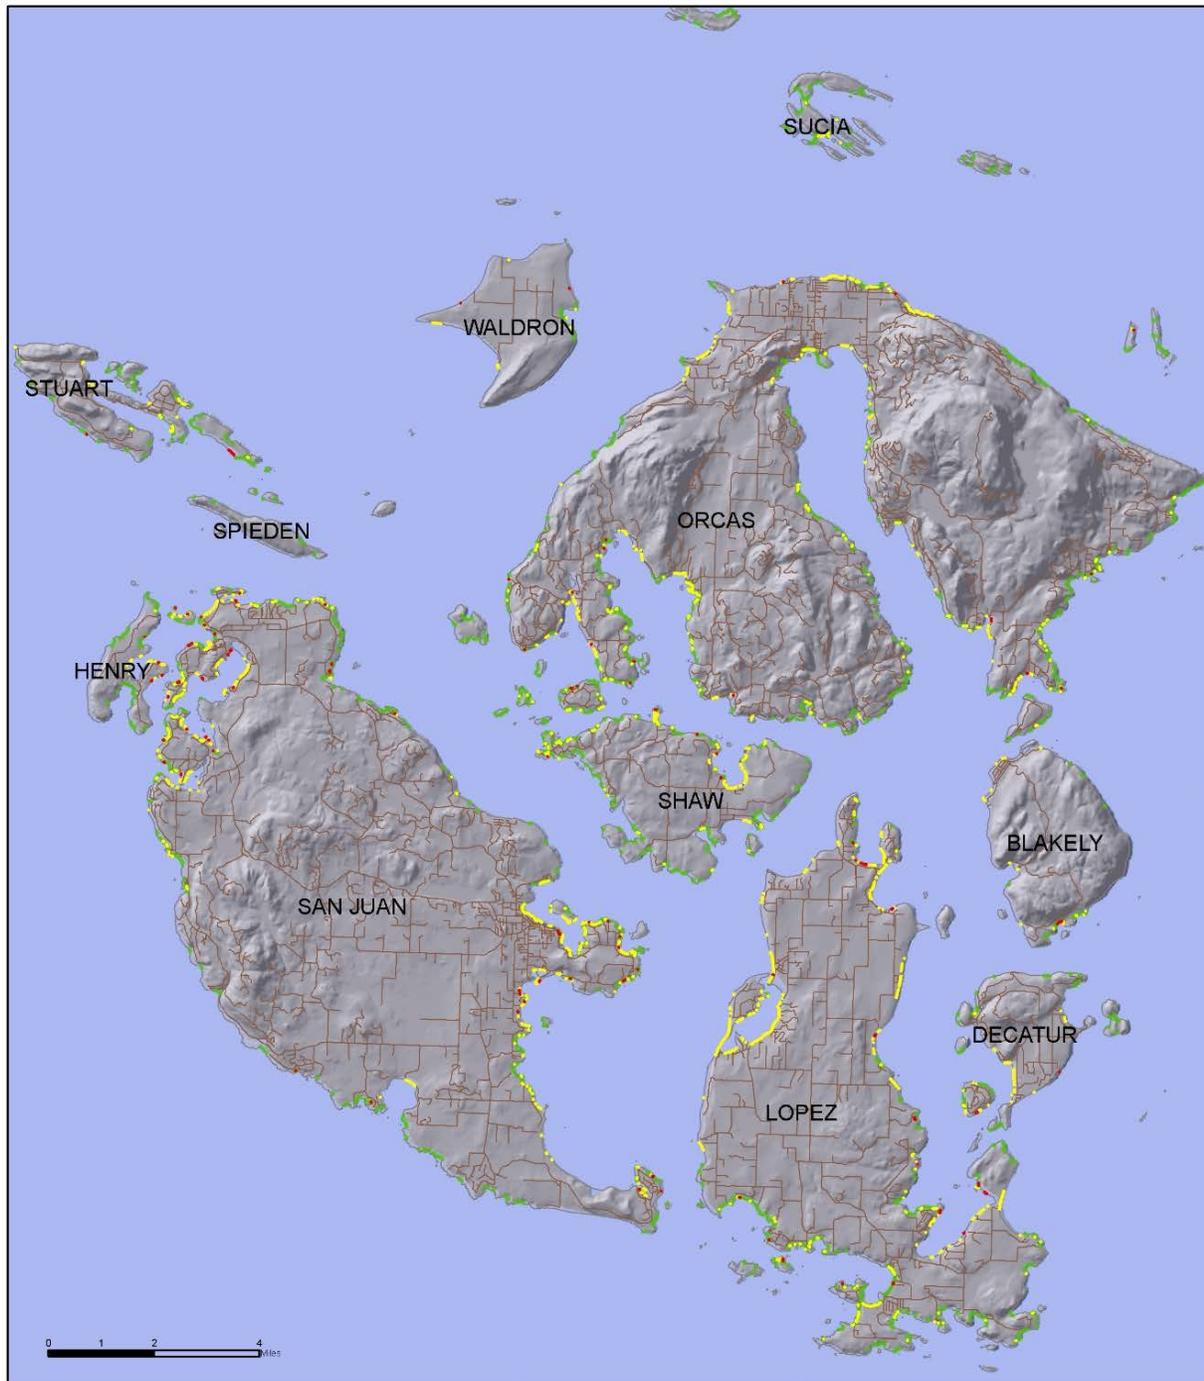
Figure 4. Shoreline Armor and Pocket Beaches, San Juan County

**Shoreline armor and pocket beaches in
San Juan County, WA. 2019**

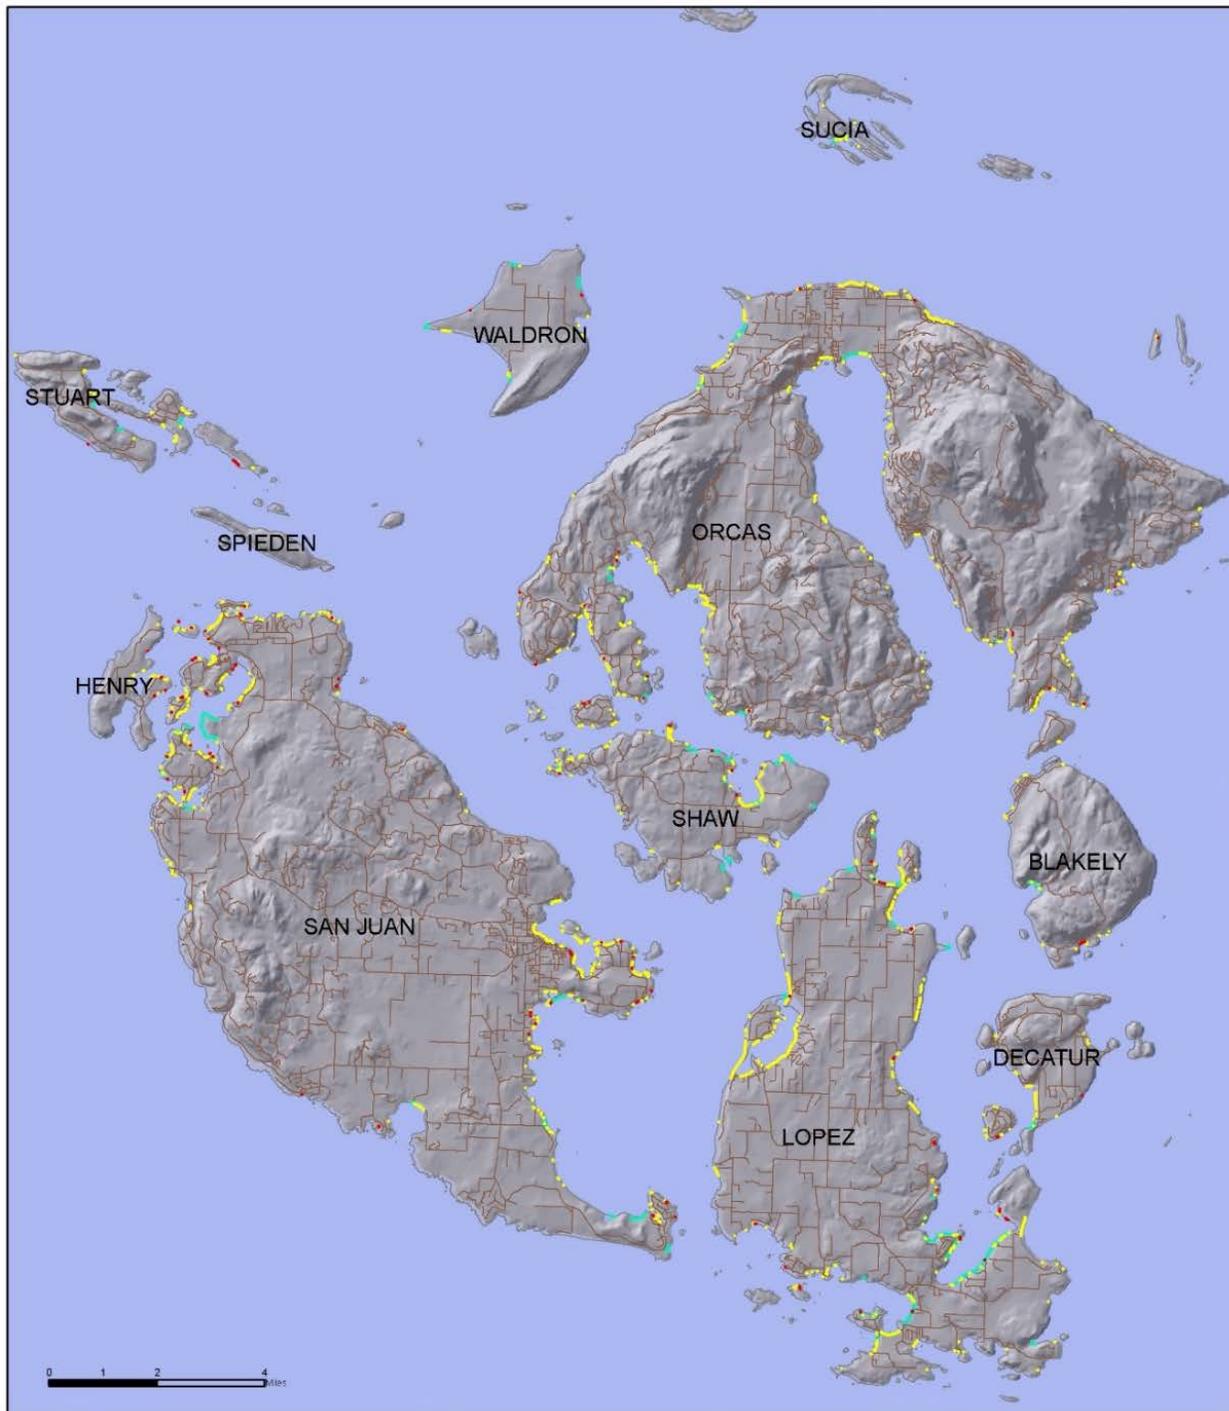
Figure 5. Shoreline Armor and Forage Fish Spawning Beaches in San Juan County, WA 2019

Total Length Known Spawning Beaches (miles)	Total Armor, 2009 (miles)	New Armor, 2009-2019 (miles)	Total Armor, 2019 (miles), (%)
12	2.94	.19	3.13 (27%)

**Shoreline armor and forage fish spawning sites
in San Juan County, WA. 2019**
