San Juan County Shoreline Modification Inventory Restoration Opportunities Report

San Juan County Shoreline Modification Inventory

Restoration Opportunities Report

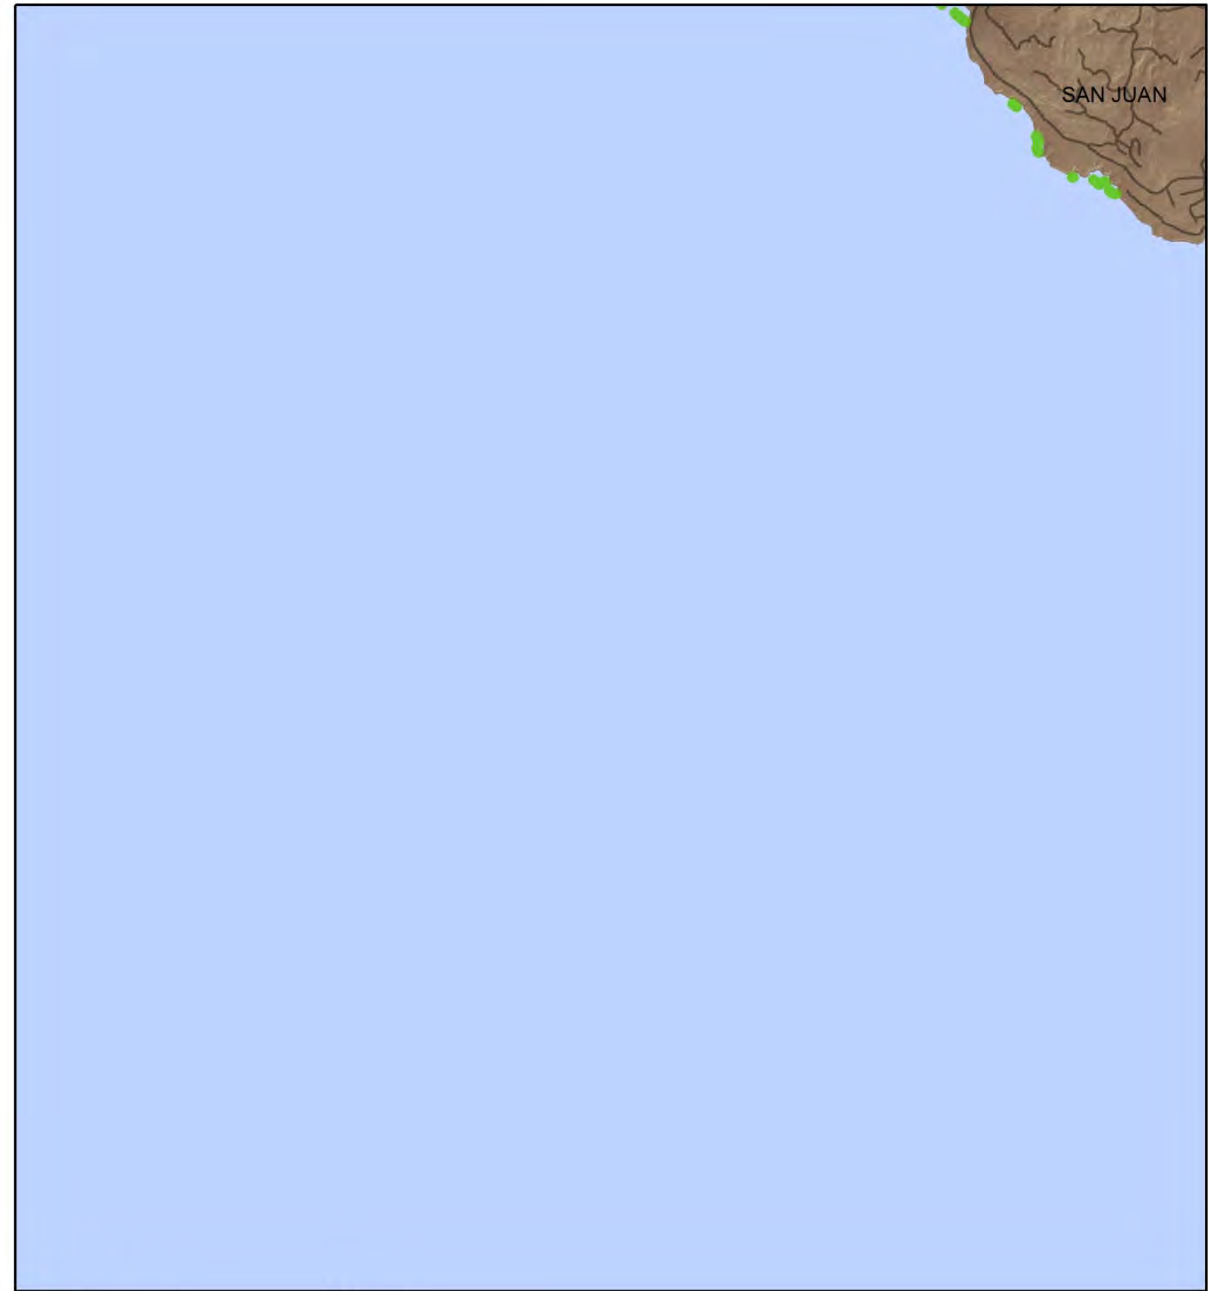
San Juan County Shoreline Modification Inventory ON BEACH STRUCTURE Restoration Prioritization
